0768-02-568

21 April 2011

WATER DAMAGE ASSESSMENT

WRM Ref.	0768-02-568
Address of Loss	[REDACTED] Brisbane
Insured Name	[REDACTED]
Land Use	Commercial
[REDACTED]	[REDACTED]
Adjuster	Cunningham Lindsay
Adjuster Name	Barry Porter
Adjuster Reference	8082743

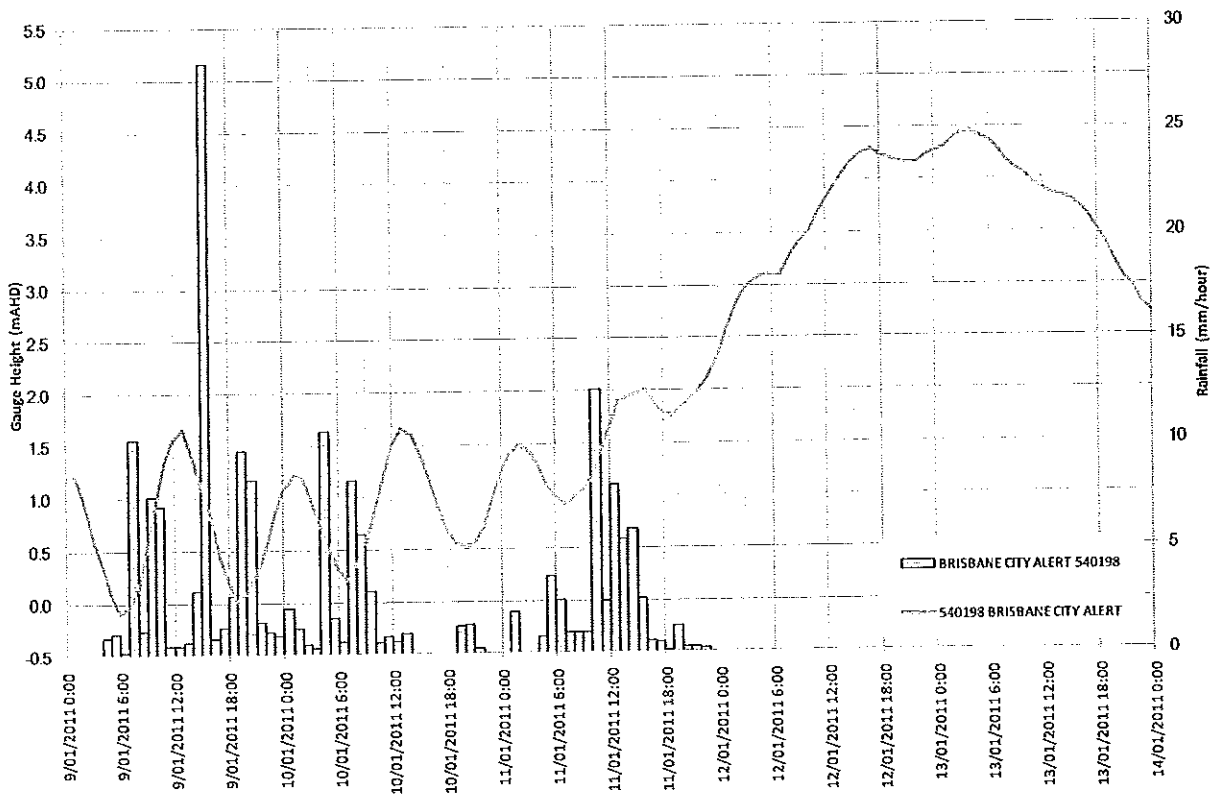
Figure 1 - Recorded Water Level and 1-Hour Rainfall Data for Brisbane City

Local Rainfall & Runoff	<ul style="list-style-type: none">• Total rainfall of 180mm was recorded for the period 9th-13th January at the Brisbane City Alert Station (540198) approximately 350m east of the subject property. Recorded hourly rainfalls and water levels at Brisbane City Alert are shown in Figure 1.• Peak 1-hour rainfall intensity of 28mm/hr occurred at 1600 hours on Sunday 9th January. Similar rainfall intensities are regularly experienced in Brisbane.• Peak stormwater runoff from the surrounding local catchment would have occurred within 10 to 30 minutes of peak rainfall.• There was no rain of significance recorded after 1500 hours on Tuesday 11th January and no rain was recorded after 0000 hours on Wednesday 12th January (See Figure 1)• Given that the property was not inundated until Wednesday when the
-------------------------	---
