Submission to Queensland Floods Commission of Inquiry Order (No. 1) 2011

Aura Apartments: A Case Study for Reviewing Planning in Flood-prone Areas in Brisbane

36 Units in Ferry Road, West End, Brisbane

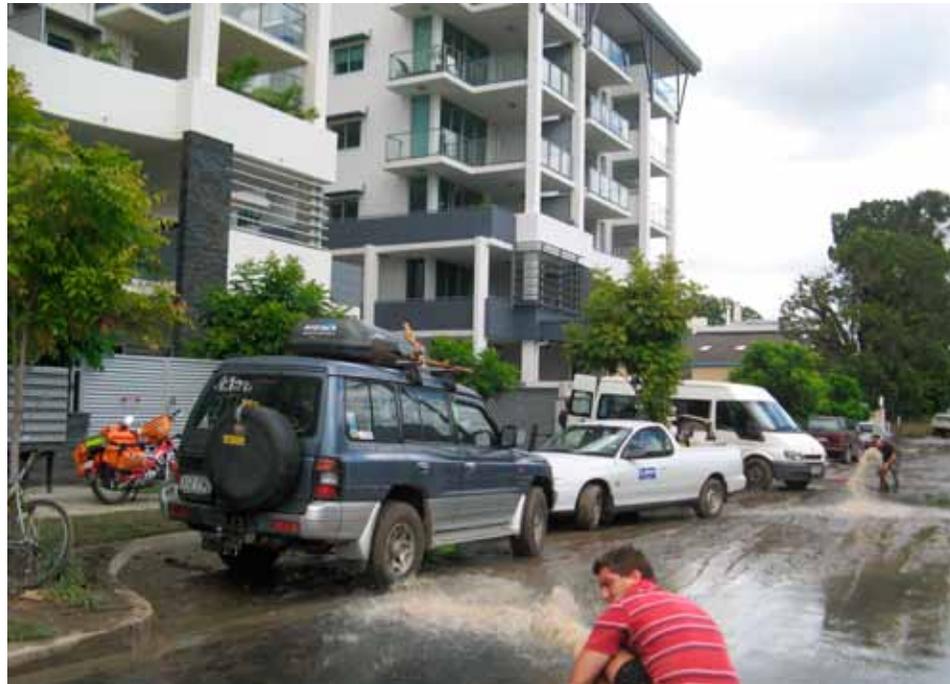
Cleaning the mud outside Aura Apartments on 14/01/11 at 12.04 pm

Aura Apartments were flooded in the January 2011 Brisbane floods up to approximately 0.5 metres above the ground floor level at RL5.9, badly damaging the building, furniture and contents of the common rooms, swimming pool, and four ground floor apartments.

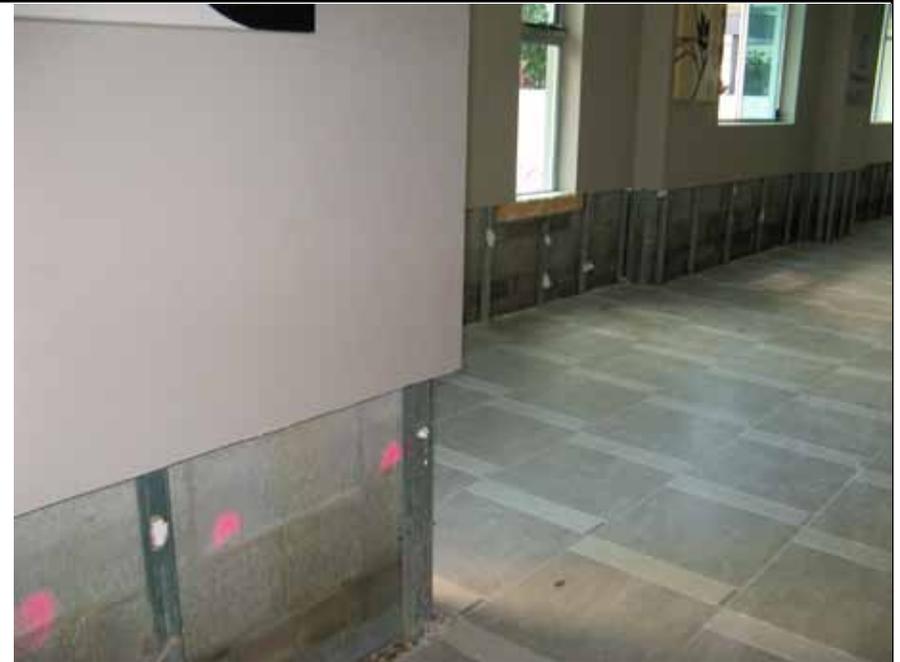
With over \$400,000 damage (including the walls and contents of ground floor units), this Aura Case Study highlights the inadequacies of the regulations in relation to managing flood impacts. This document explains the impact of existing planning regulations in a flood affected area; the non-effectiveness of flood prevention and stormwater infrastructure in West End; and some thoughts on the reasons for flooding in West End around Riverside Drive.

Damaged walls in the Aura foyer

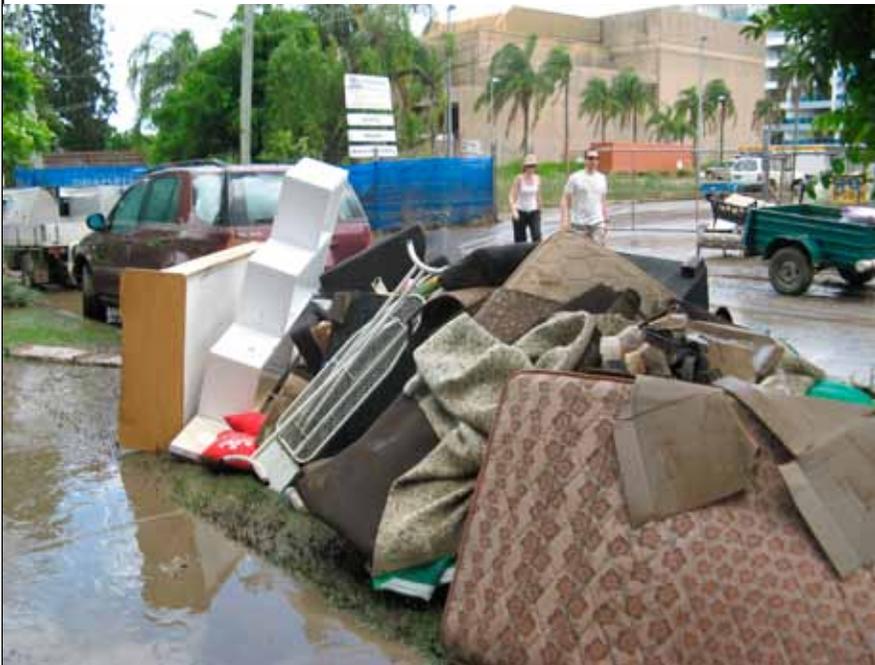
Pile of damaged contents from Aura

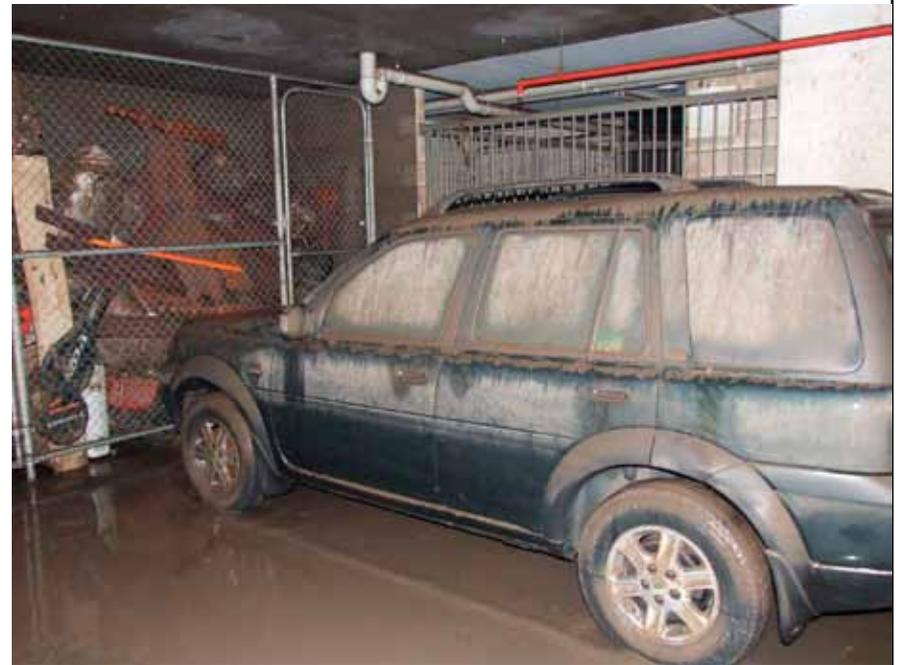
Car and contents submerged in Aura basement

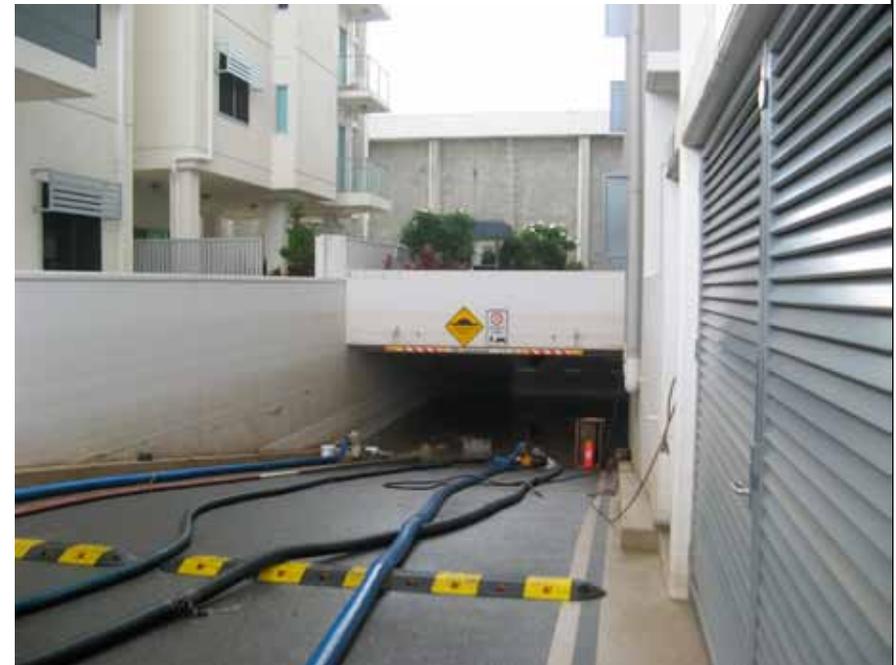
The ground floor was built at RL5.9, a level approved under the existing regulations. This was inadequate for Aura as water rose up to around 6.4 metres in our building and street in the January 2011 floods. This implies a design Q100 flood level of RL5.4. This level was far too low in Riverside South, West End and may even have been below the 1974 flood.

Carpark entrance with a mud line showing the height of the water

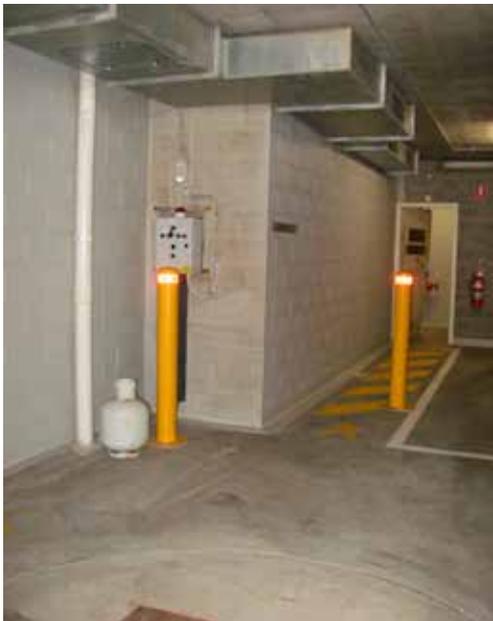
The building's normal de-watering system consists of a sump below the floor of Basement 2 with electric sump pumps under automatic level control. The power controls to the sump pumps are on the wall in Basement 2. Any basement de-watering fails when power is lost or when the control panel is flooded. Such control panels should be above the design flood level and buildings should have backup power in case of power outages.

De-watering pump controls in Basement 2

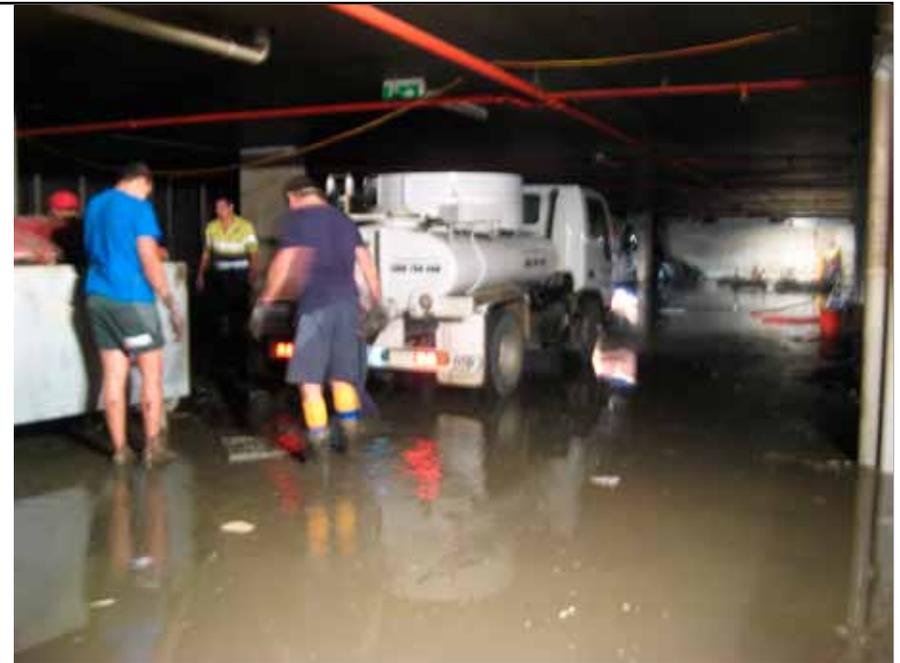
The building has two basement carpark levels. It took 2 days to remove water from the first level, but another 7 days to empty the second level. Regulations need to stipulate building designs with access holes that make it easier to pump water out of second or lower level basements.

Pumping out the mud from the sump pumps on 29/01/11

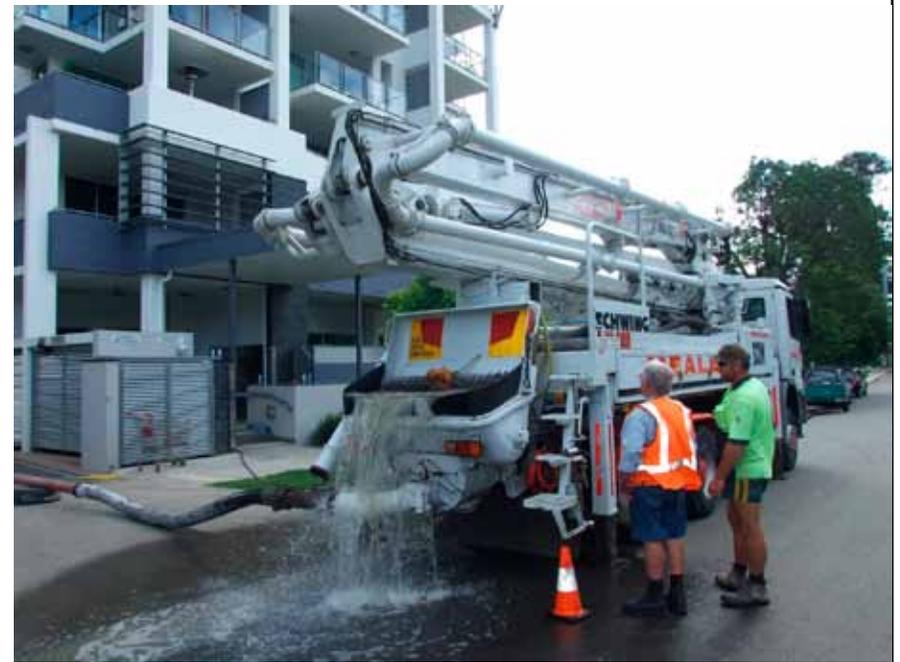
Pump truck needed to pump out Basement 2

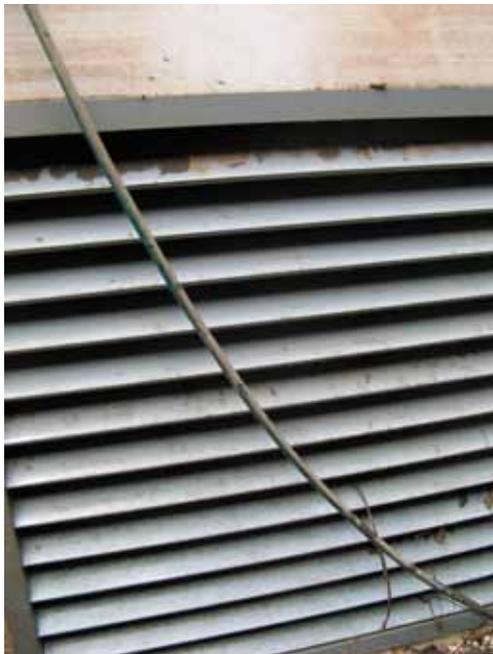
The Council approved building plans for grills for ventilation into the B1 carpark. These grills are well below the ground floor level of the building, and below the design Q100 flood level.

Close up of vents where water spilled into the B1 carpark basement

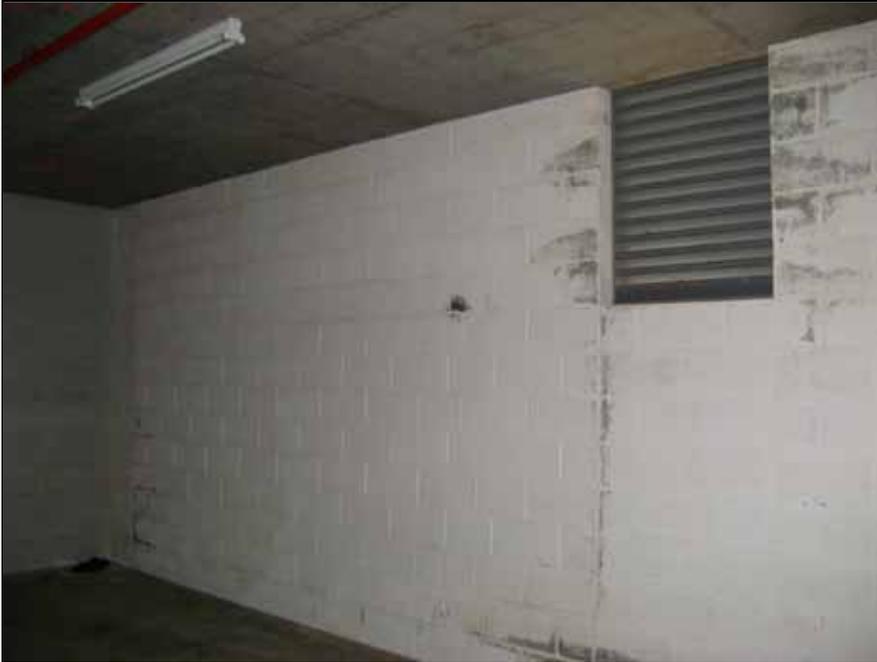
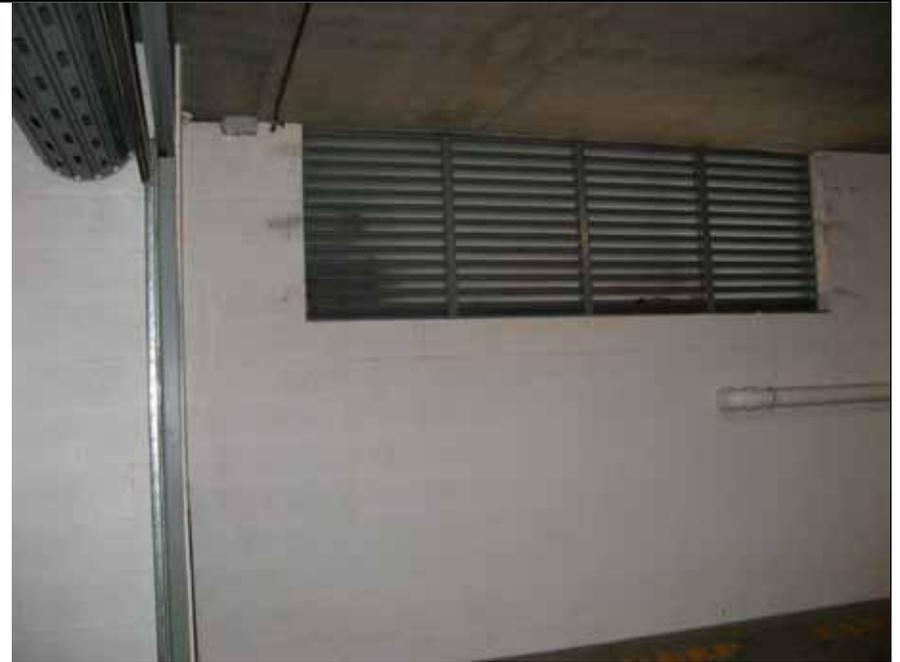
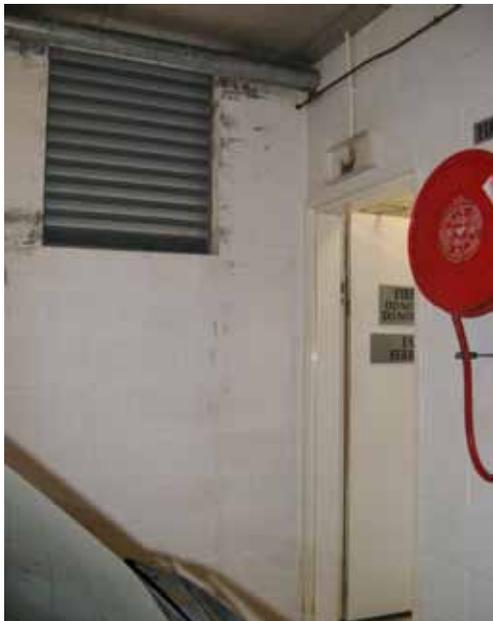
Basement 1 vents where water entered carpark

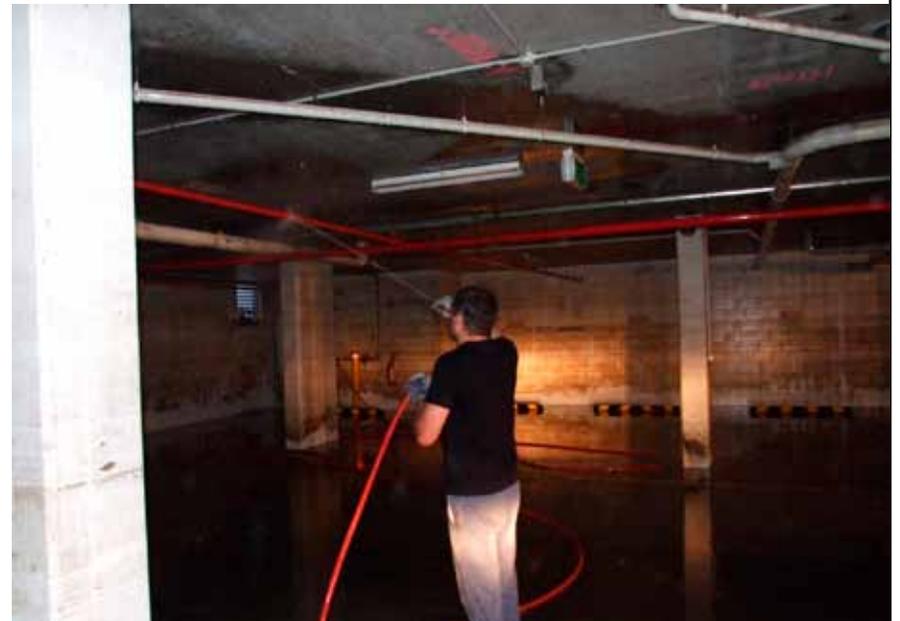
Inside view of one set of vents where water entered Basement 1 carpark

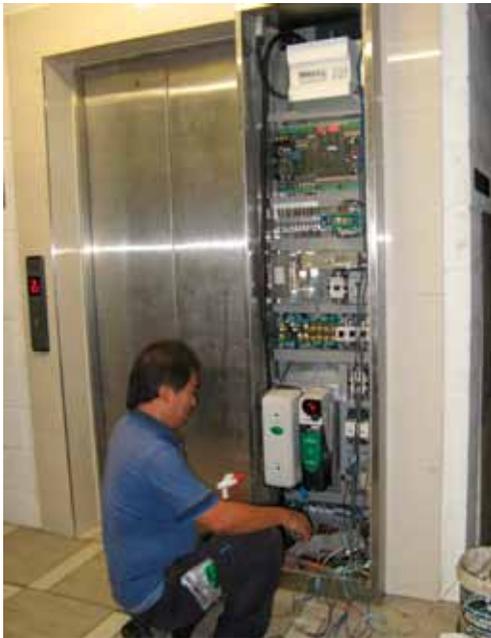
The lift motors and controls are located in the Basement 2, so they were badly affected by flood water and they are very expensive to replace, costing over \$40,000. In Aura there is room for the lift to be placed at the top of the lift shaft, but relocating the motor and controls is very expensive at over \$250,000. Regulations requiring lift motors and controls to be put above flood water levels would have saved residents in Aura many thousands of dollars.

Aura lift control panel beside the lift in Basement 2 positioned at the lowest point in the building

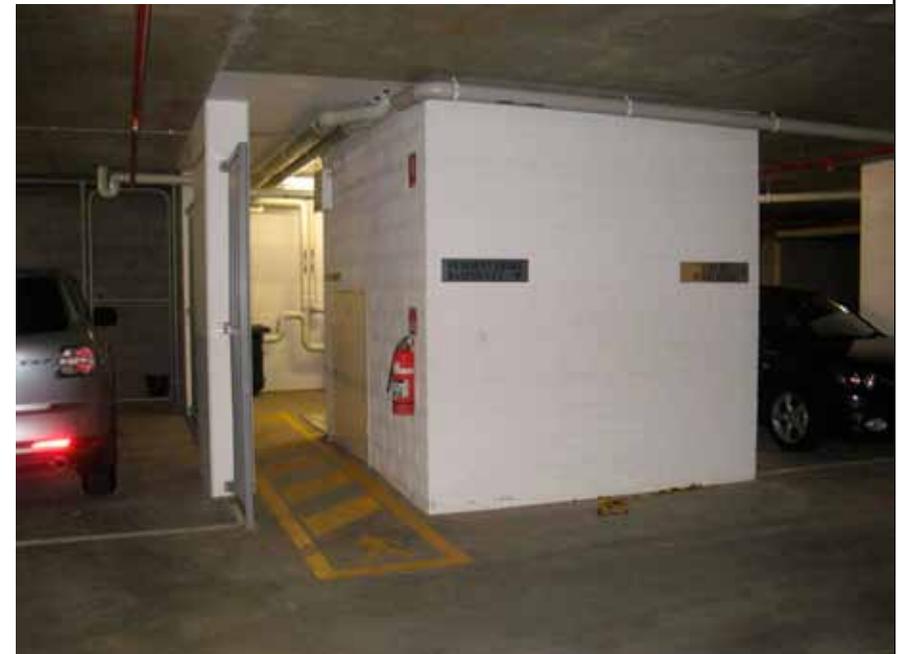
Lift well in Aura in Basement 2 with the main lift motor behind the yellow door in the wall near the fire extinguisher

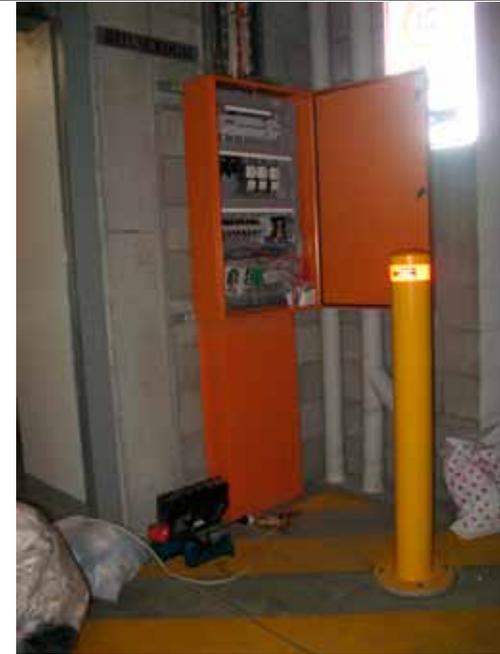
The control panel for the CO₂ ventilation system is located in Basement 1, so this was another expensive service to replace. Repairs will cost over \$20,000. Not all parts of this system can be relocated, but the control panel could be. However, retrofitting this panel is expensive. In flood-prone areas buildings should have the control panel above flood levels.

CO₂ Panel controls in Basement 1 beside the lift shaft

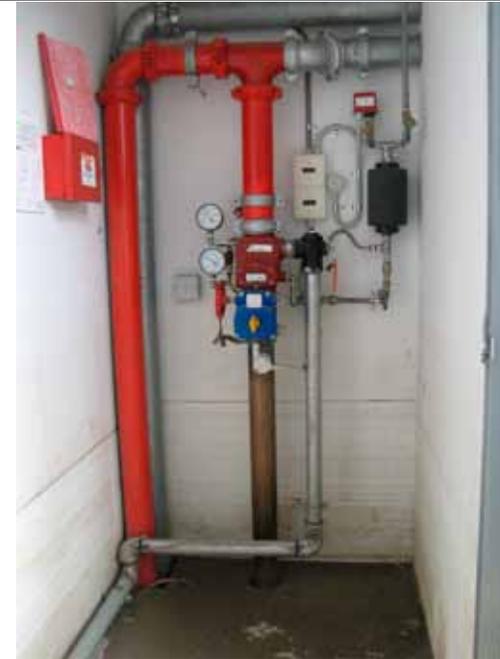
The fire services in Aura were located below the RL5.9 level required for the ground floor. (The roof of the carpark seen in the photo below indicates the ground floor level.) As a result, the sprinkler system, the booster pumps and control board were badly affected by the flood waters and these cost over \$27,000 to replace.

Inside the fire sprinkler system that was damaged by water

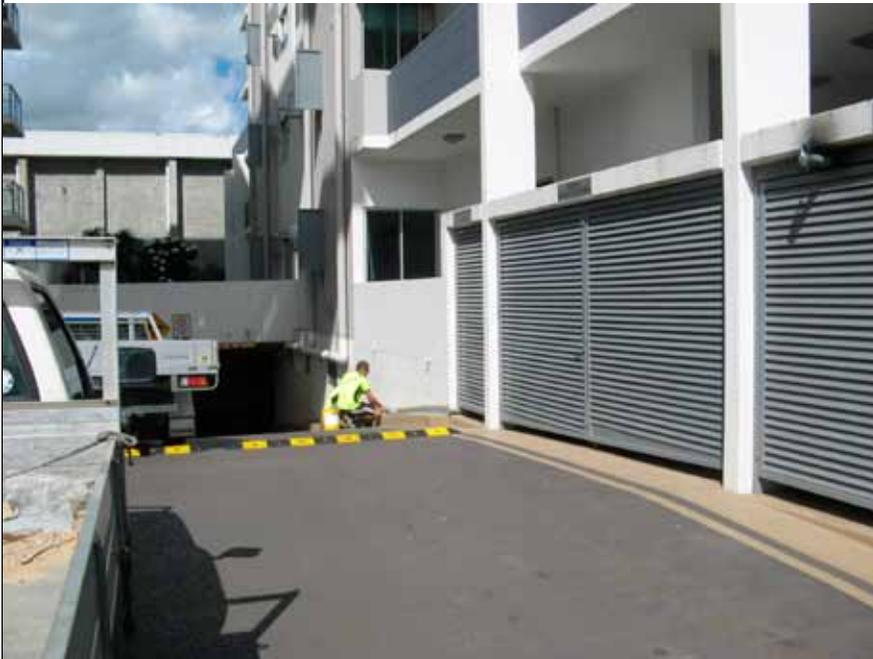
Two rooms either side of refuse room below ground floor beside the carpark entrance housing the fire sprinkler pump (left), the main fire pump and controls (right)

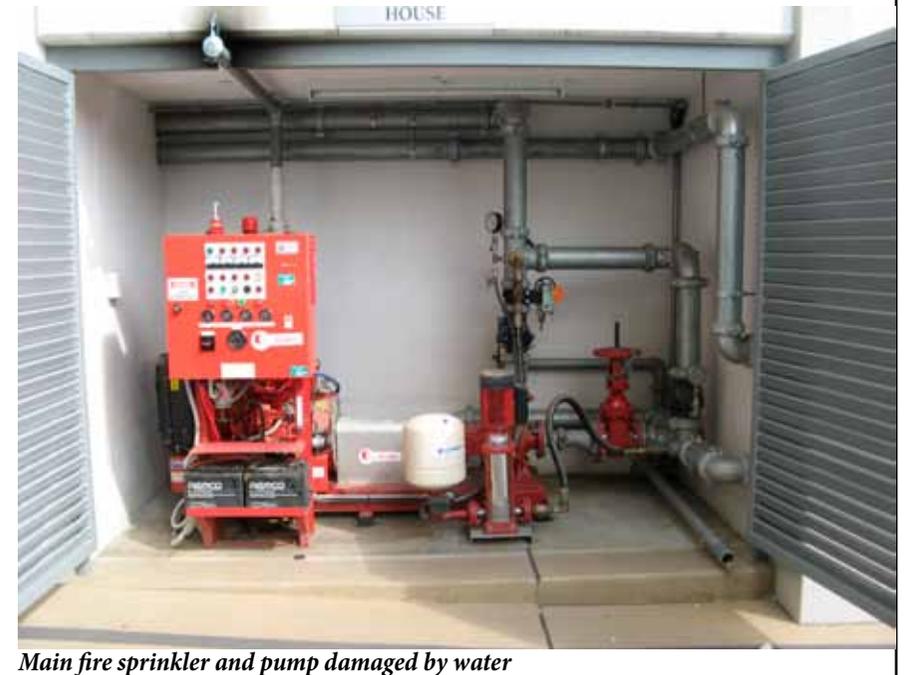
Main fire sprinkler and pump damaged by water

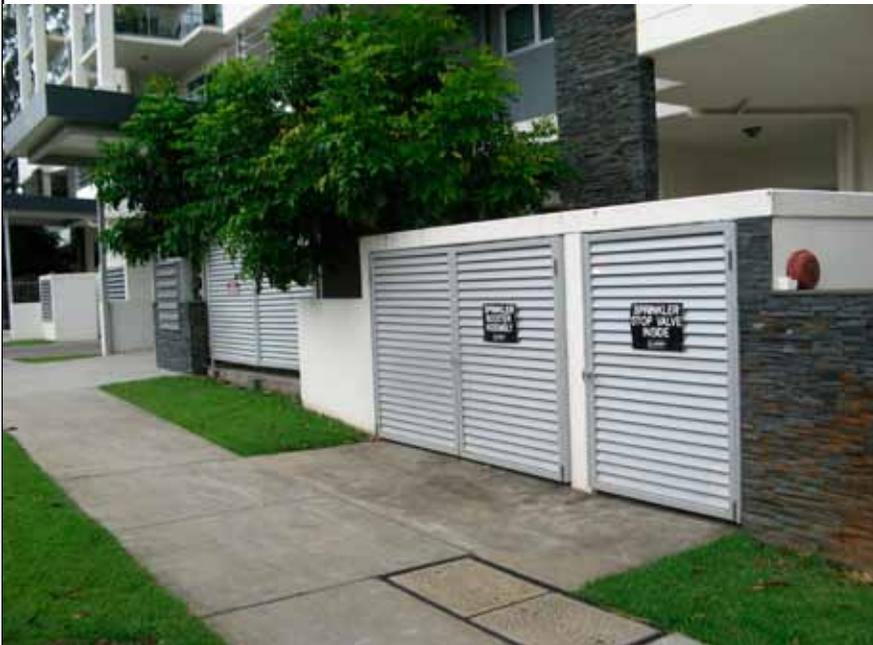
The Energex transformers for the Aura and Arriva Apartments are located in front of Aura's sister building next door and sit at ground floor level, so the transformers were affected by water inundation and had to be turned off when flood waters began rising. That meant that the pumps in the basements stopped working and residents could no longer live in the buildings, even if they were not directly affected by water. The regulations need to stipulate that vital services, such as energy supplies, should be well above any flood levels.

Room on left under tree housing Energex transformer for Arriva & Aura Apartments where water entered

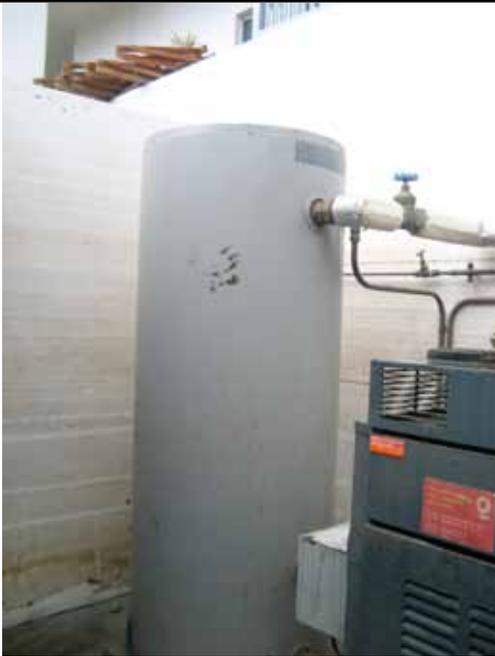
The gas-fired water heaters and electric pumps were completely submerged and needed to be replaced. Residents did not have hot water for some time and then a limited service until units could be replaced. Located in the sunken garden, these heaters are well below the ground floor level of RL5.9.

Water heaters that were completely submerged and damaged beyond repair

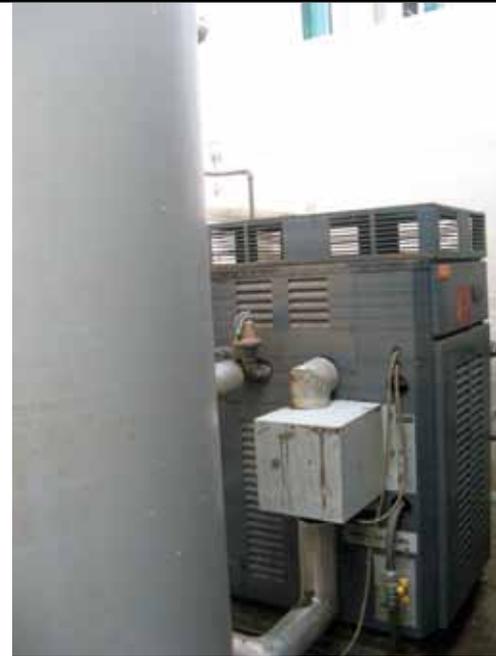
Water heater controls that were completely submerged and damaged by water

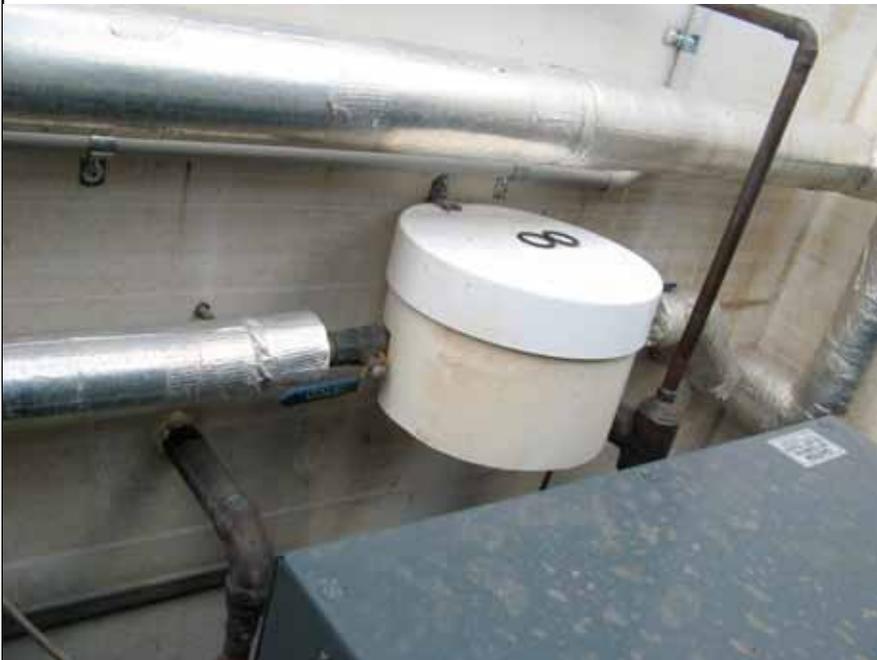
Hot water recirculation pump that cost Aura \$450 to replace

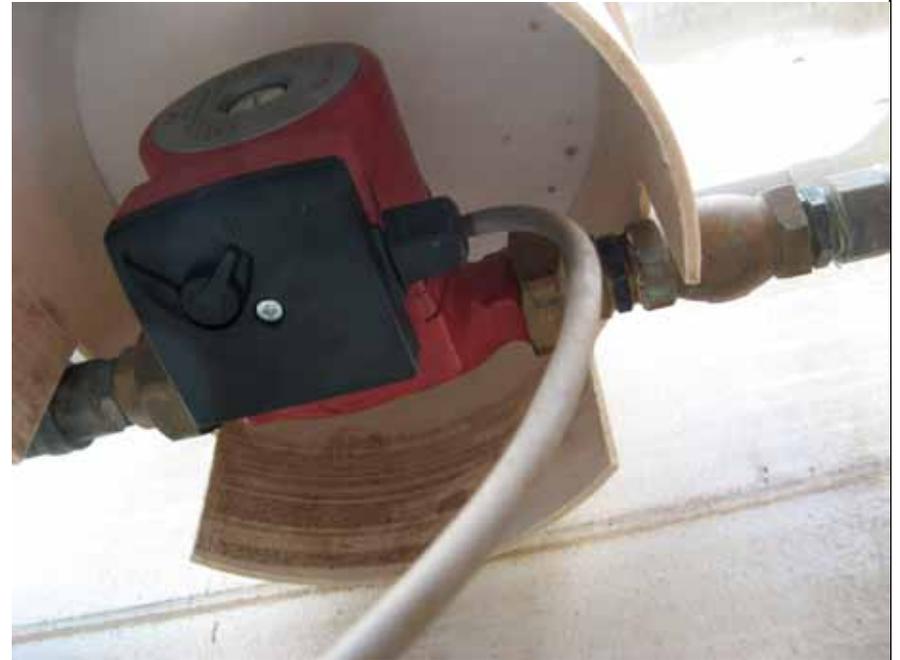
Close up of hot water recirculation pump that needed to be replaced

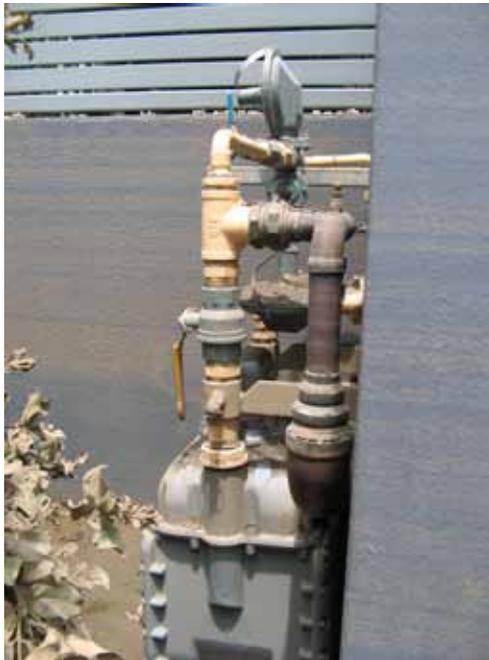
The gas valves in Aura are located in the sunken garden below ground floor level and were completely submerged by water.

Main gas valve

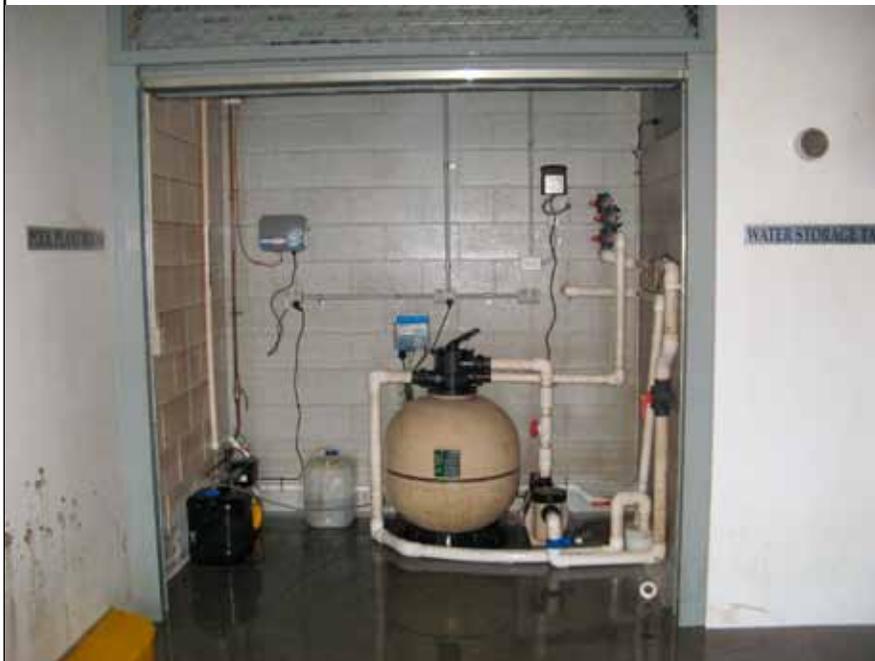
The Aura pool was inundated by flood waters, but the pool pumps and controls located under the pool in the B1 carpark were also damaged and repairs will cost around \$3000.

Close up of damaged pool controls in room with door raised on Basement 1

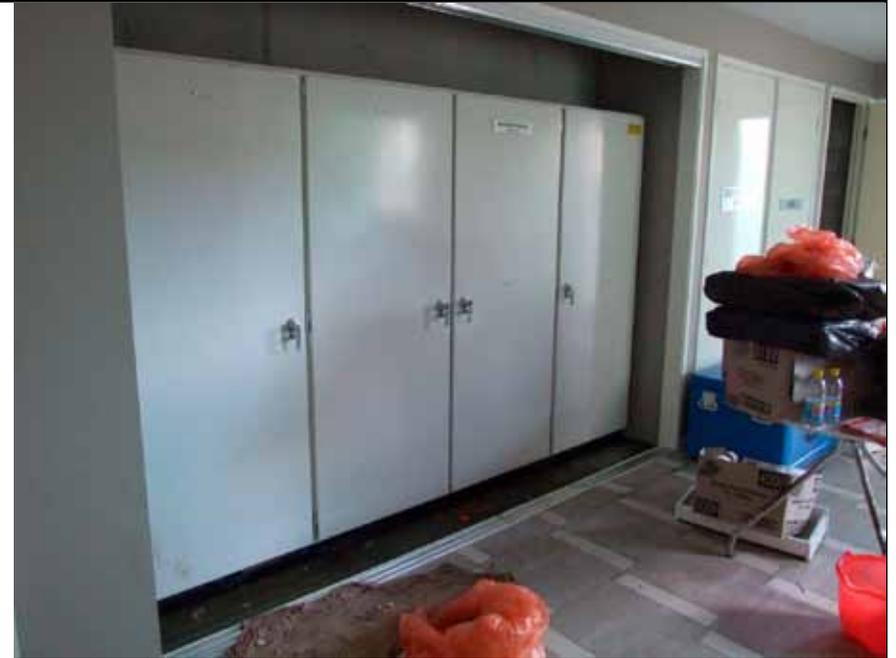
The power, fire alarm, video and telephone cabling control panels in Aura are on the ground floor so they were only partially affected by water, unlike other multi-storey buildings in the West End, which had more major damage because their control panels were located in basements. The control panels in flood-prone areas should be above any flood levels.

Power control panel inside Aura's foyer where partial damage occurred to the building power distribution.

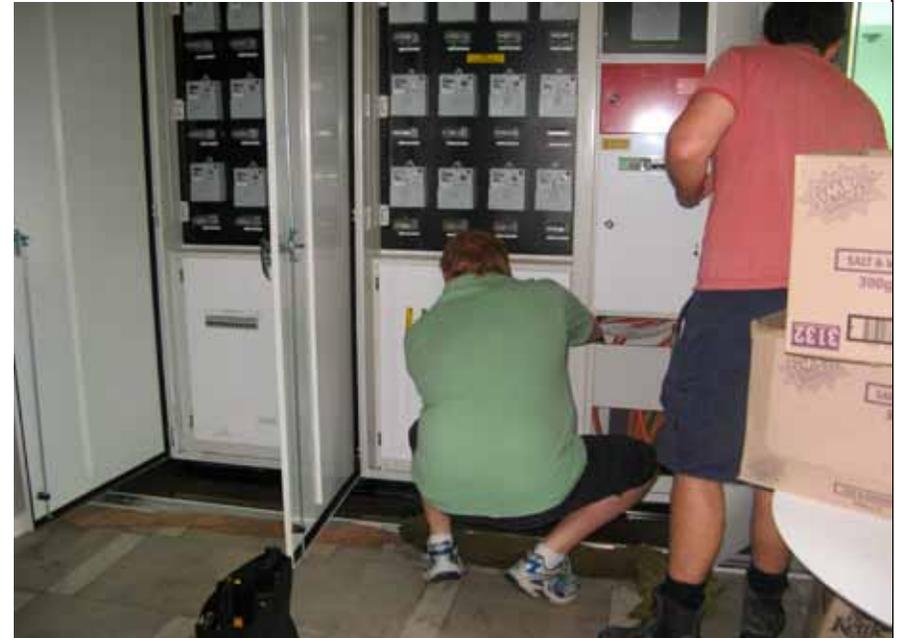
The main isolator switch on the power board was located at the lowest point on the panel and was the most expensive power component to replace

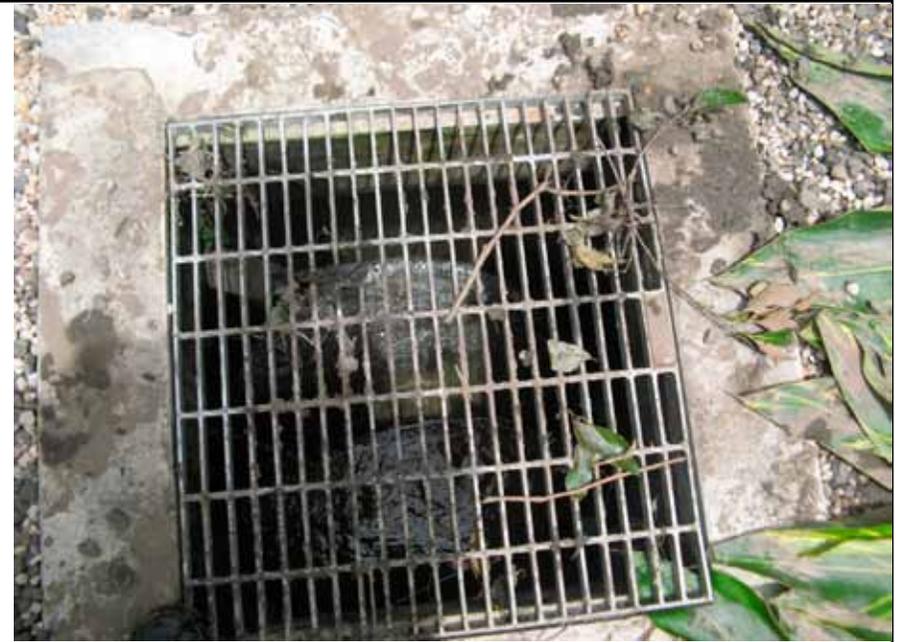
The stormwater drain around Aura could not cope with the volume of water and the first inundation occurred from stormwater, which bubbled up through the drain with such force it lifted one of the grates. One resident then fell down into the open hole, which was under water. The Council needs to better design for stormwater runoff in West End.

This stormwater grate is located on the main emergency exit pathway from the fire stairs. The pathway was flooded to knee level at the time the building was evacuated. This is an unsafe design that should not be allowed by the building code.

The large grate giving access to the stormwater drain at the side near the footpath gate on 14/01/11 at 1.04 pm, which can drown a person, if they fell in and could not get out

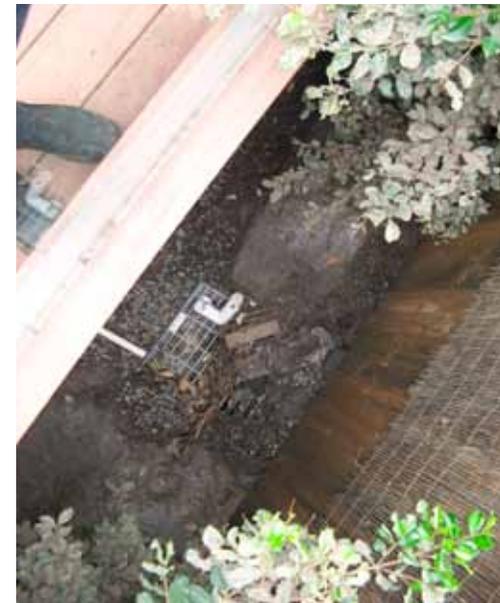
Aura stormwater drain on 14/01/11 at 2.53 pm showing where water bubbling up has not allowed any mud to settle around the grate

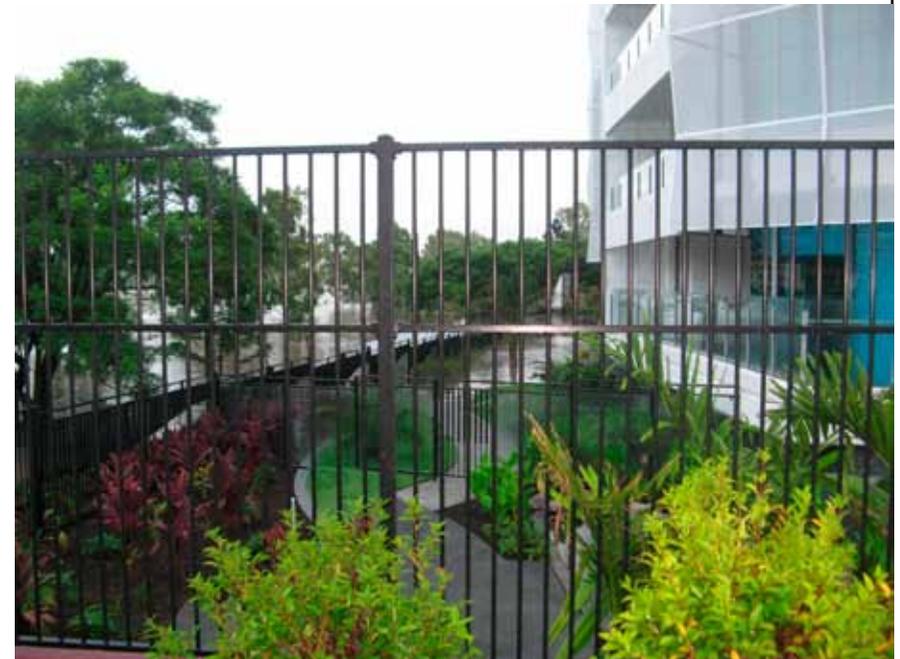
River water flowed over the bank in places along Riverside Drive and entered buildings and, possibly affected Aura. Instead of requiring developers building beside Riverside Drive to raise the bank, the Council allowed the developers of Waters Edge to lower the bank and this was one of the places where river water flowed over the bank.

View of water entering Waters Edge on 12/01/11 at 5.08 am
