Submission to Queensland Floods Commission of Inquiry Order (No. 1) 2011

Aura Apartments: A Case Study for Reviewing Planning in Flood-prone Areas in Brisbane

36 Units in Ferry Road, West End, Brisbane

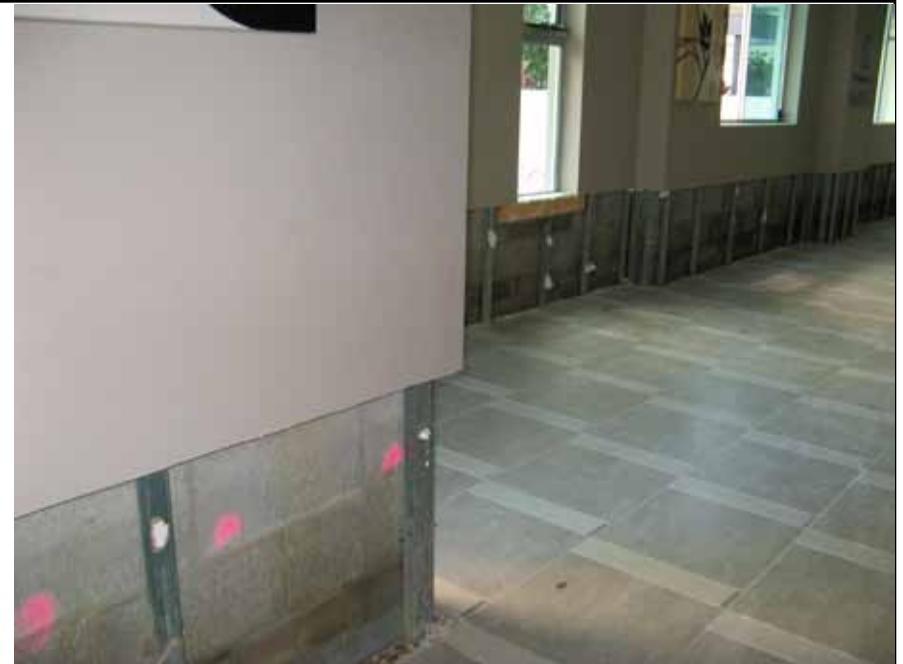
Aura Apartments were flooded in the January 2011 Brisbane floods up to approximately 0.5 metres above the ground floor level at RL5.9, badly damaging the building, furniture and contents of the common rooms, swimming pool, and four ground floor apartments.

Damaged walls in the Aura foyer

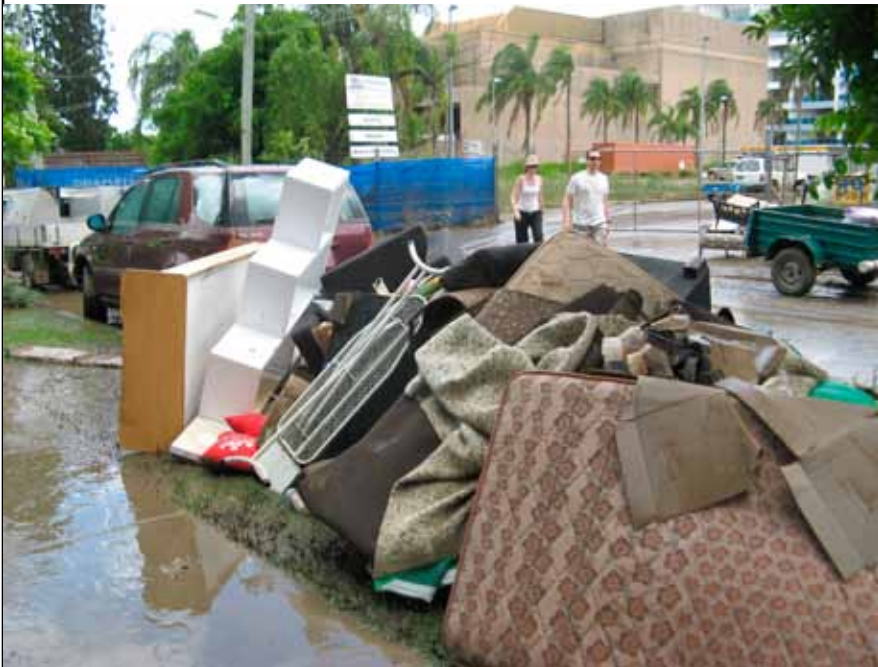
Pile of damaged contents from Aura

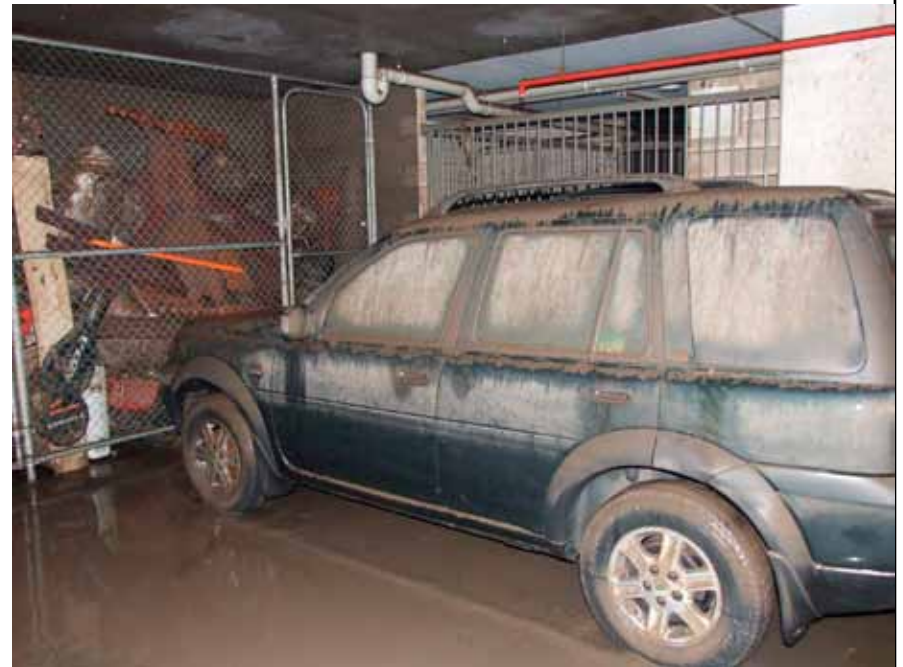
Car and contents submerged in Aura basement

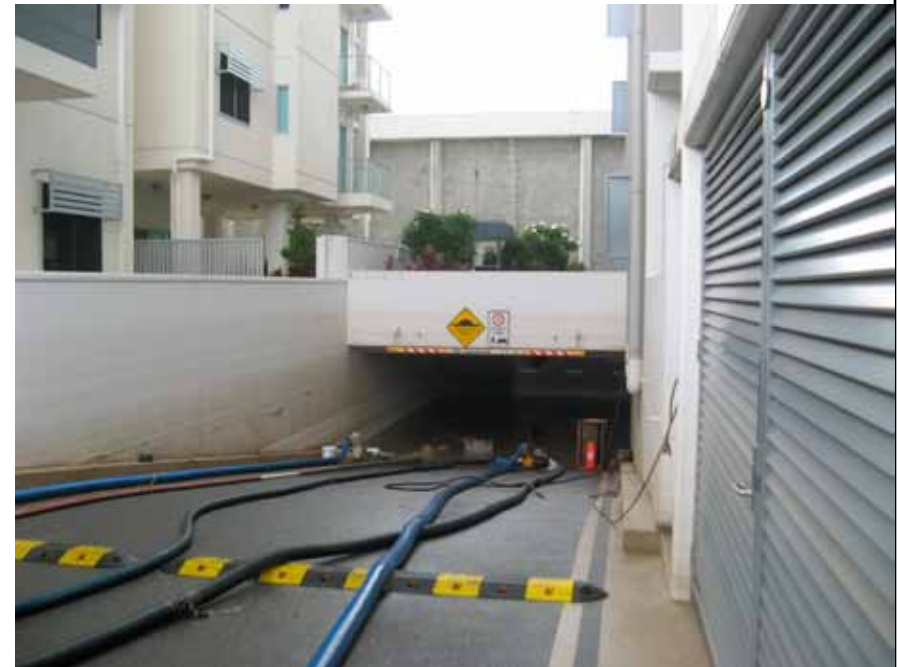
The ground floor was built at RL5.9, a level approved under the existing regulations. This was inadequate for Aura as water rose up to around 6.4 metres in our building and street in the January 2011 floods. This implies a design Q100 flood level of RL5.4. This level was far too low in Riverside South, West End and may even have been below the 1974 flood.

Carpark entrance with a mud line showing the height of the water

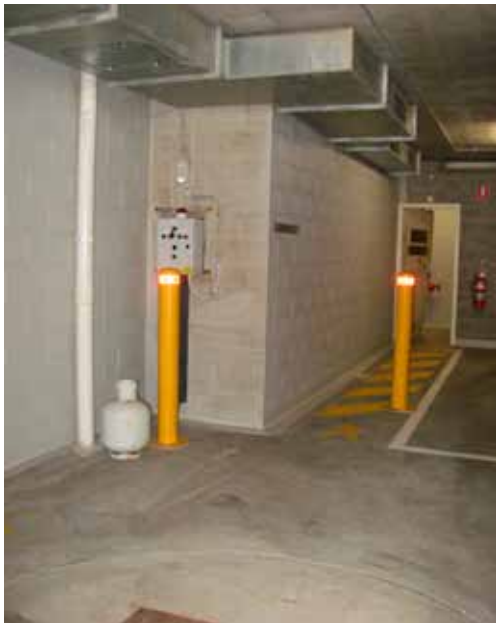
The building's normal de-watering system consists of a sump below the floor of Basement 2 with electric sump pumps under automatic level control. The power controls to the sump pumps are on the wall in Basement 2. Any basement de-watering fails when power is lost or when the control panel is flooded. Such control panels should be above the design flood level and buildings should have backup power in case of power outages.

De-watering pump controls in Basement 2

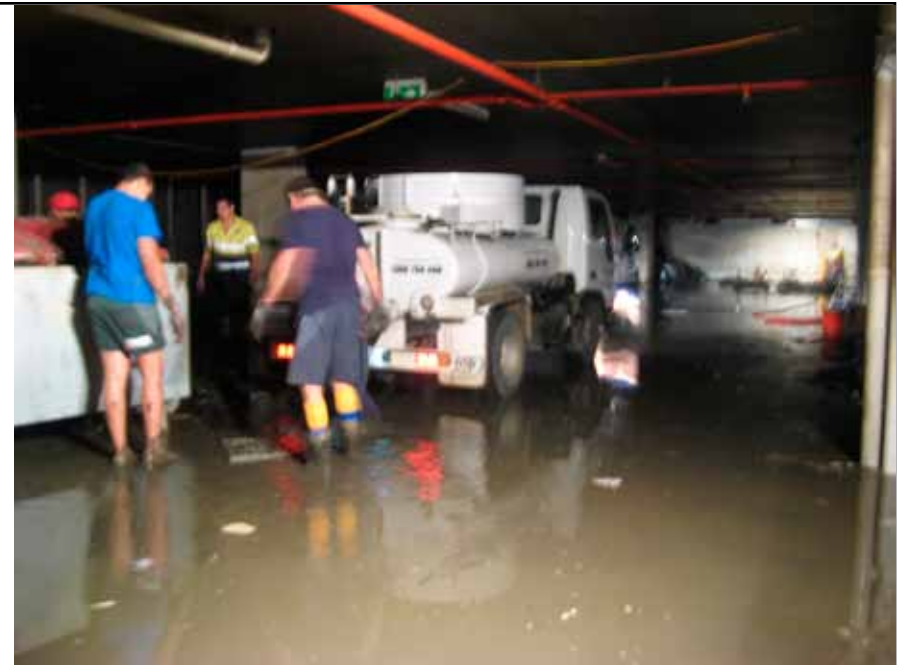
Pumping out the mud from the sump pumps on 29/01/11

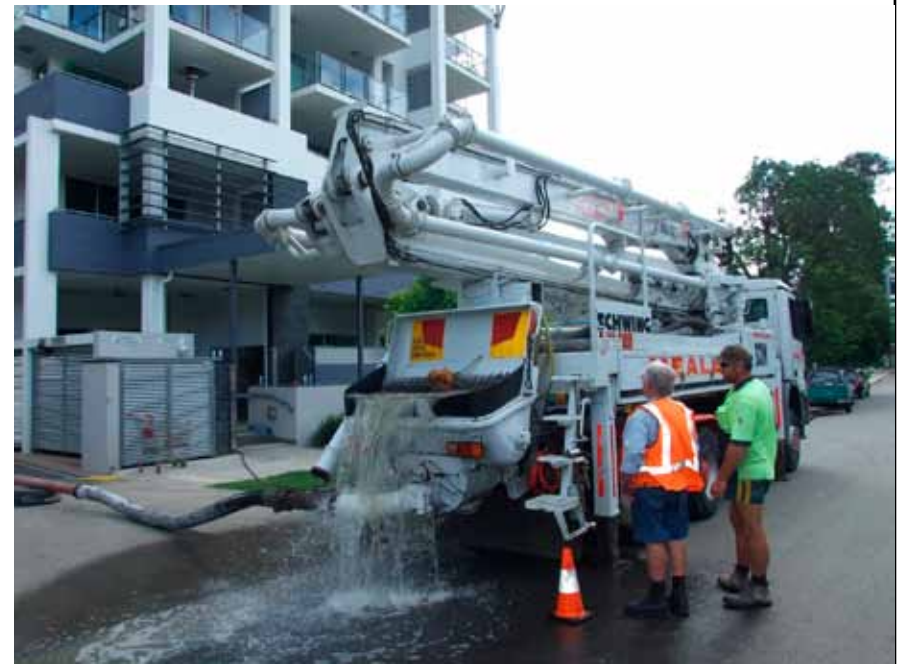
The building has two basement carpark levels. It took 2 days to remove water from the first level, but another 7 days to empty the second level. Regulations need to stipulate building designs with access holes that make it easier to pump water out of second or lower level basements.

Pump truck needed to pump out Basement 2

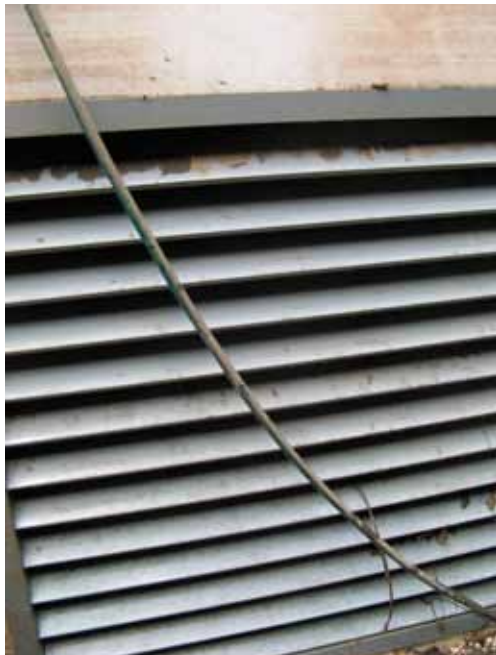
The Council approved building plans for grills for ventilation into the B1 carpark. These grills are well below the ground floor level of the building, and below the design Q100 flood level.

Close up of vents where water spilled into the B1 carpark basement

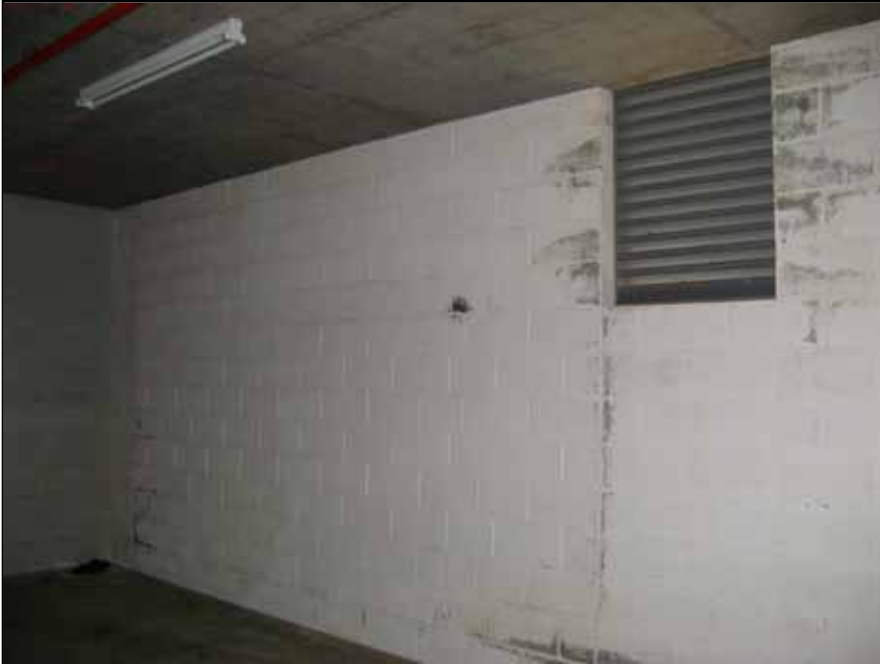
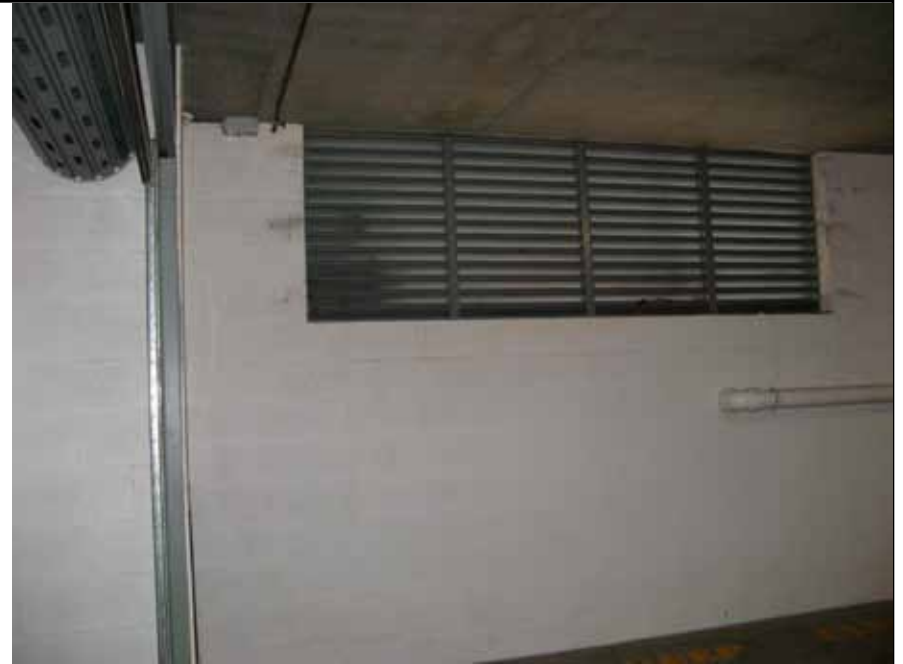
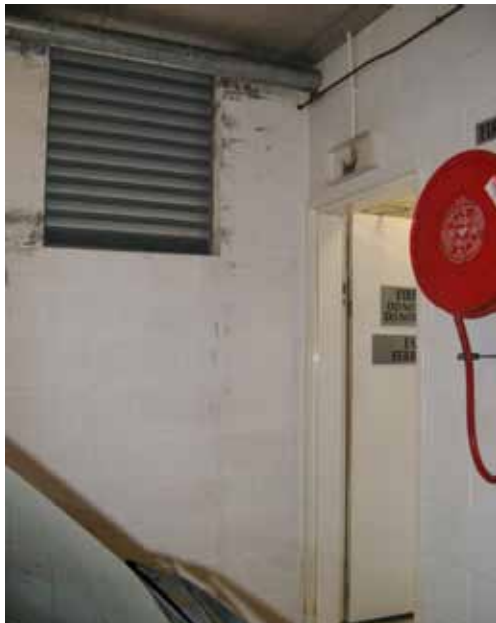
Basement 1 vents where water entered carpark

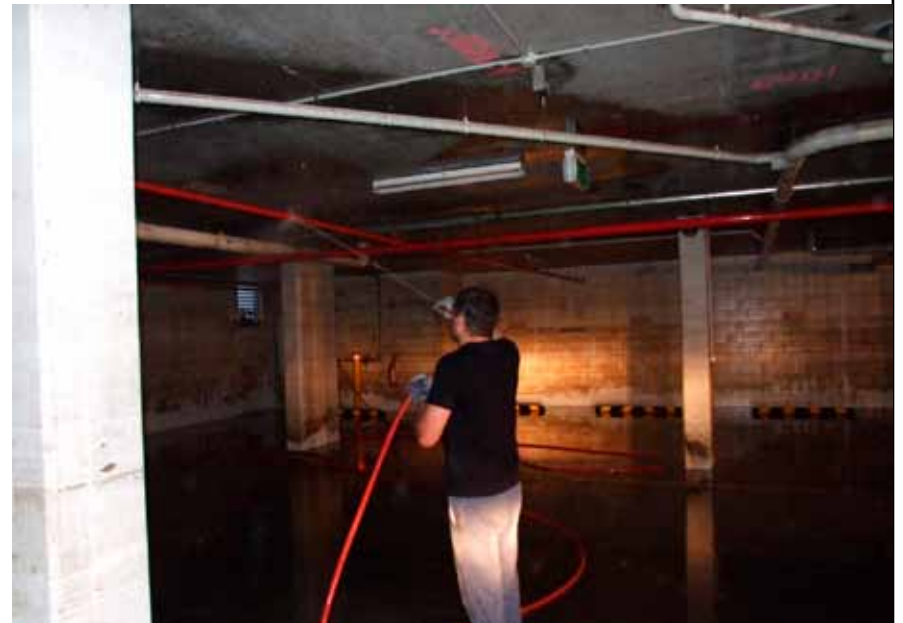
Inside view of one set of vents where water entered Basement 1 carpark

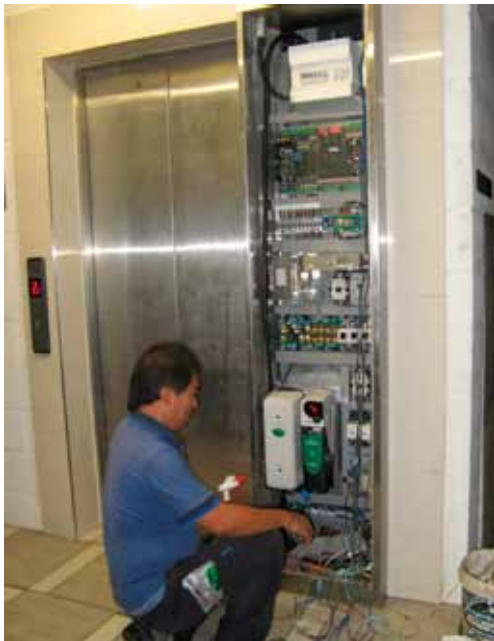
The lift motors and controls are located in the Basement 2, so they were badly affected by flood water and they are very expensive to replace, costing over \$40,000. In Aura there is room for the lift to be placed at the top of the lift shaft, but relocating the motor and controls is very expensive at over \$250,000. Regulations requiring lift motors and controls to be put above flood water levels would have saved residents in Aura many thousands of dollars.

Aura lift control panel beside the lift in Basement 2 positioned at the lowest point in the building

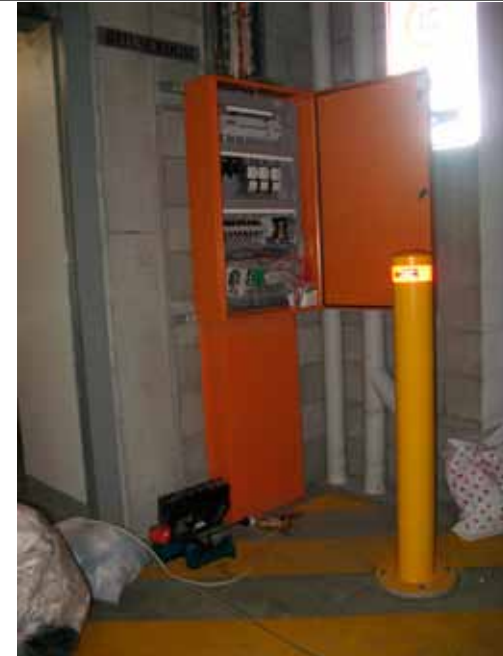
The control panel for the CO₂ ventilation system is located in Basement 1, so this was another expensive service to replace. Repairs will cost over \$20,000. Not all parts of this system can be relocated, but the control panel could be. However, retrofitting this panel is expensive. In flood-prone areas buildings should have the control panel above flood levels.

CO₂ Panel controls in Basement 1 beside the lift shaft

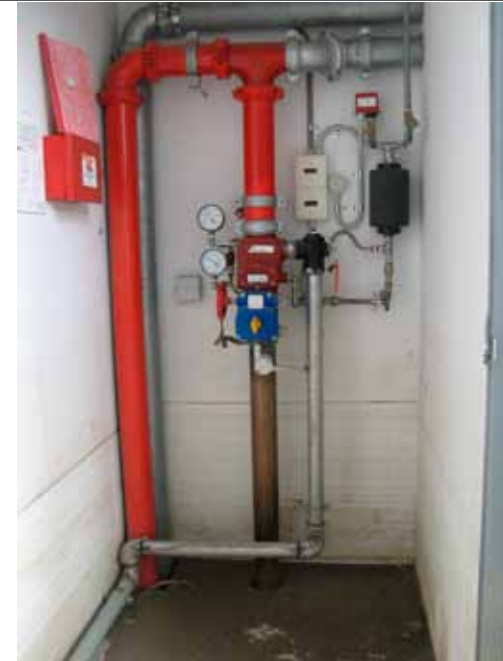
The fire services in Aura were located below the RL5.9 level required for the ground floor. (The roof of the carpark seen in the photo below indicates the ground floor level.) As a result, the sprinkler system, the booster pumps and control board were badly affected by the flood waters and these cost over \$27,000 to replace.

Inside the fire sprinkler system that was damaged by water

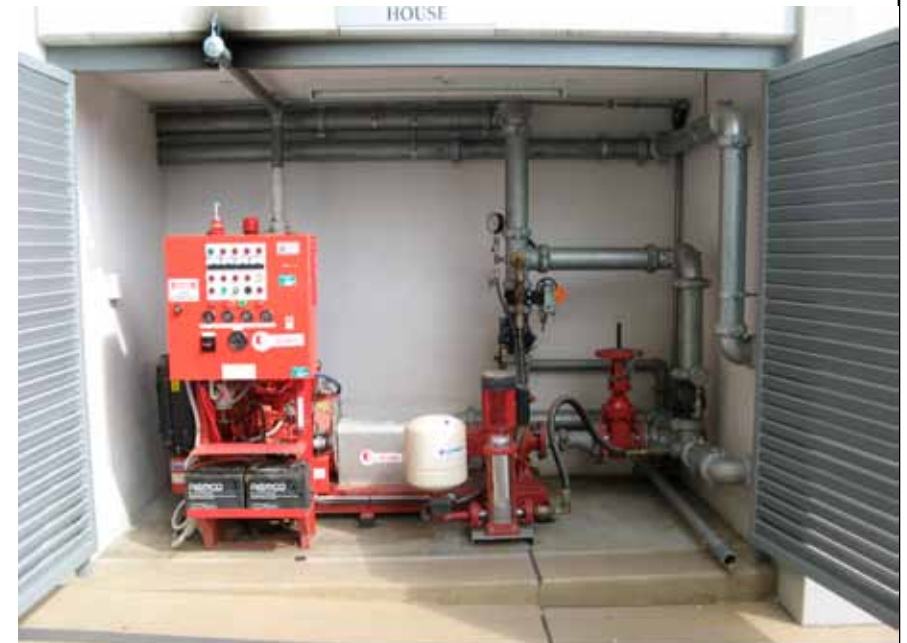
Main fire sprinkler and pump damaged by water

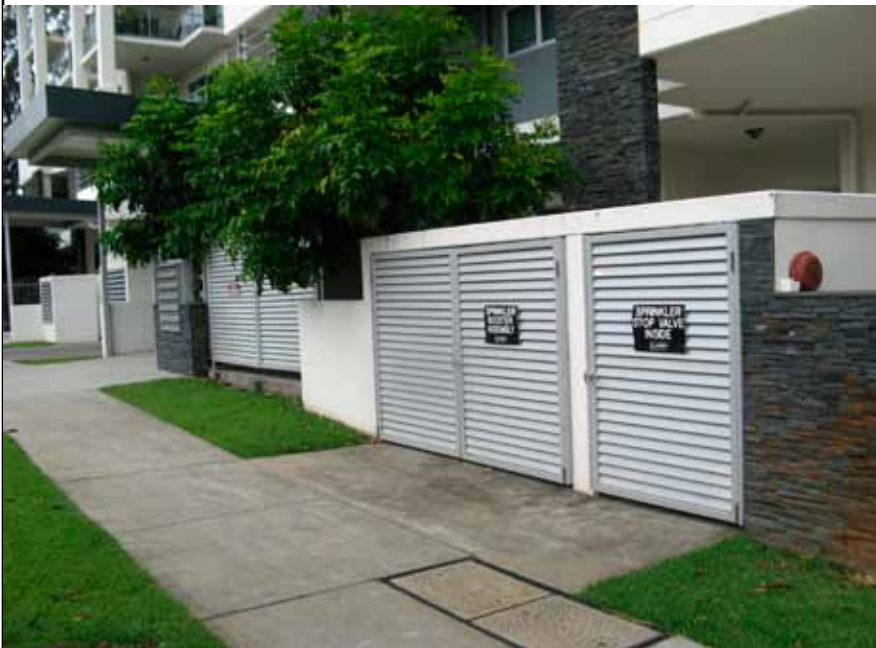
The Energex transformers for the Aura and Arriva Apartments are located in front of Aura's sister building next door and sit at ground floor level, so the transformers were affected by water inundation and had to be turned off when flood waters began rising. That meant that the pumps in the basements stopped working and residents could no longer live in the buildings, even if they were not directly affected by water. The regulations need to stipulate that vital services, such as energy supplies, should be well above any flood levels.

Room on left under tree housing Energex transformer for Arriva & Aura Apartments where water entered

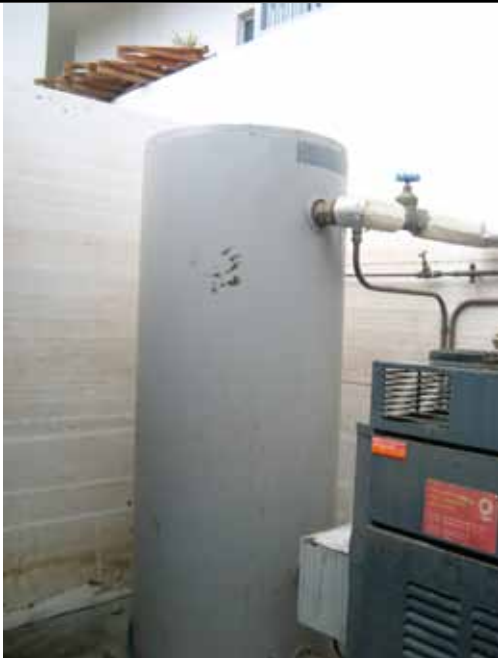
The gas-fired water heaters and electric pumps were completely submerged and needed to be replaced. Residents did not have hot water for some time and then a limited service until units could be replaced. Located in the sunken garden, these heaters are well below the ground floor level of RL5.9.

Water heaters that were completely submerged and damaged beyond repair

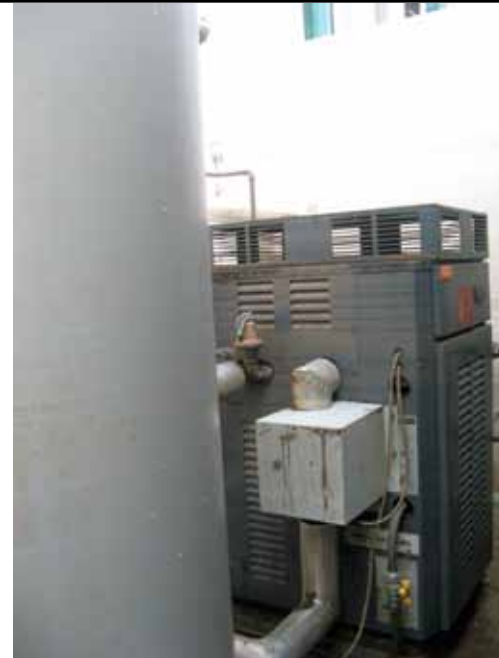
Water heater controls that were completely submerged and damaged by water

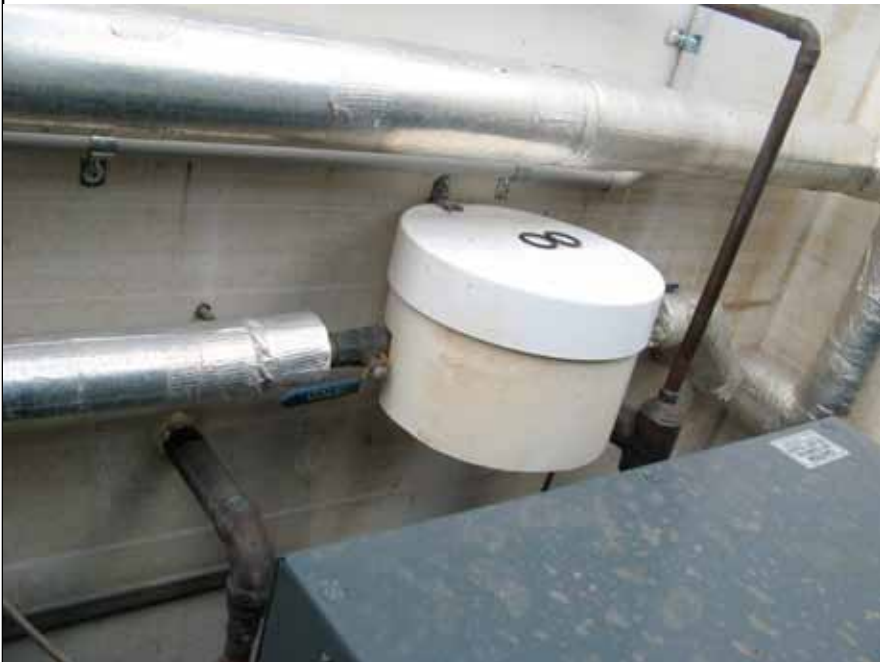
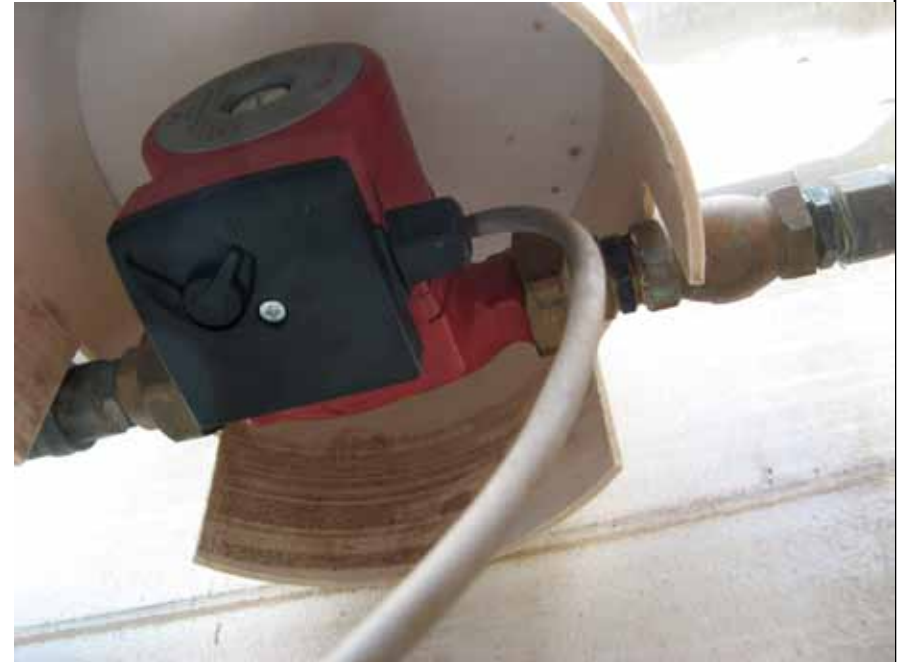
Hot water recirculation pump that cost Aura \$450 to replace

Close up of hot water recirculation pump that needed to be replaced

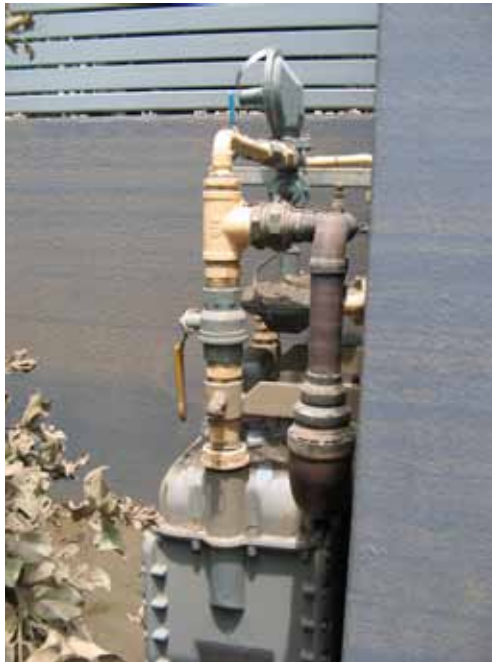
The gas valves in Aura are located in the sunken garden below ground floor level and were completely submerged by water.

Main gas valve

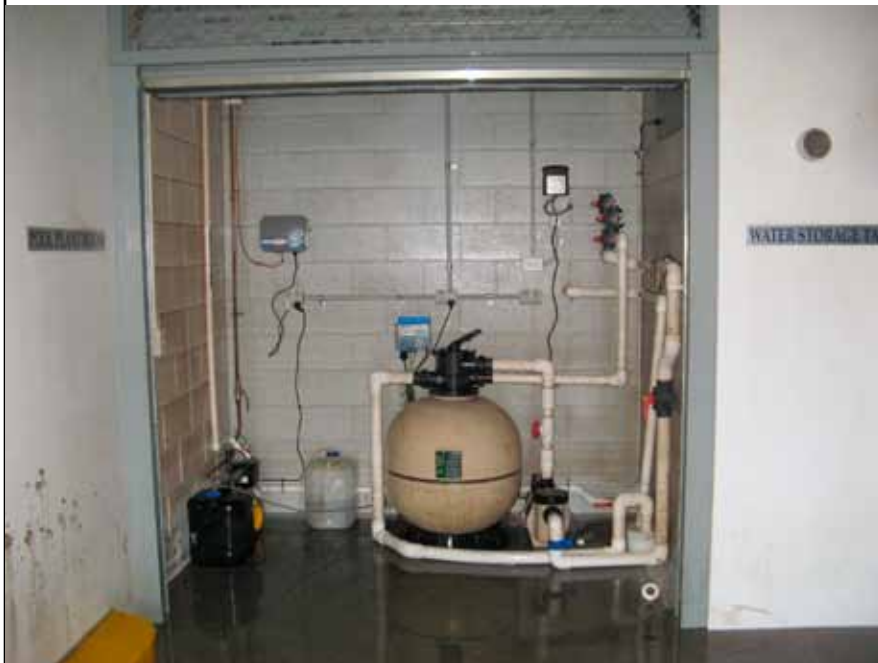
The Aura pool was inundated by flood waters, but the pool pumps and controls located under the pool in the B1 carpark were also damaged and repairs will cost around \$3000.

Close up of damaged pool controls in room with door raised on Basement 1

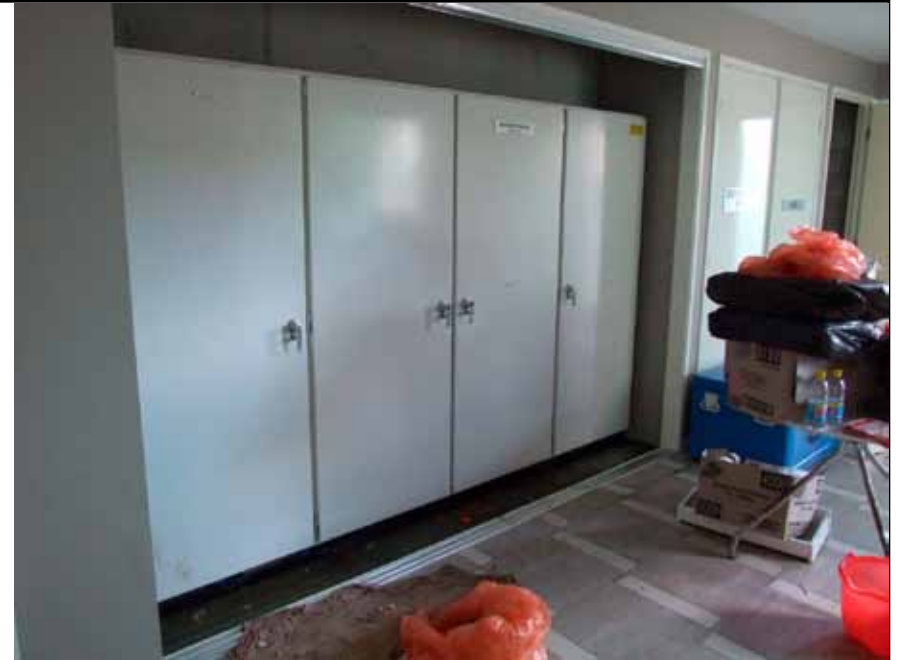
The power, fire alarm, video and telephone cabling control panels in Aura are on the ground floor so they were only partially affected by water, unlike other multi-storey buildings in the West End, which had more major damage because their control panels were located in basements. The control panels in flood-prone areas should be above any flood levels.

Power control panel inside Aura's foyer where partial damage occurred to the building power distribution.

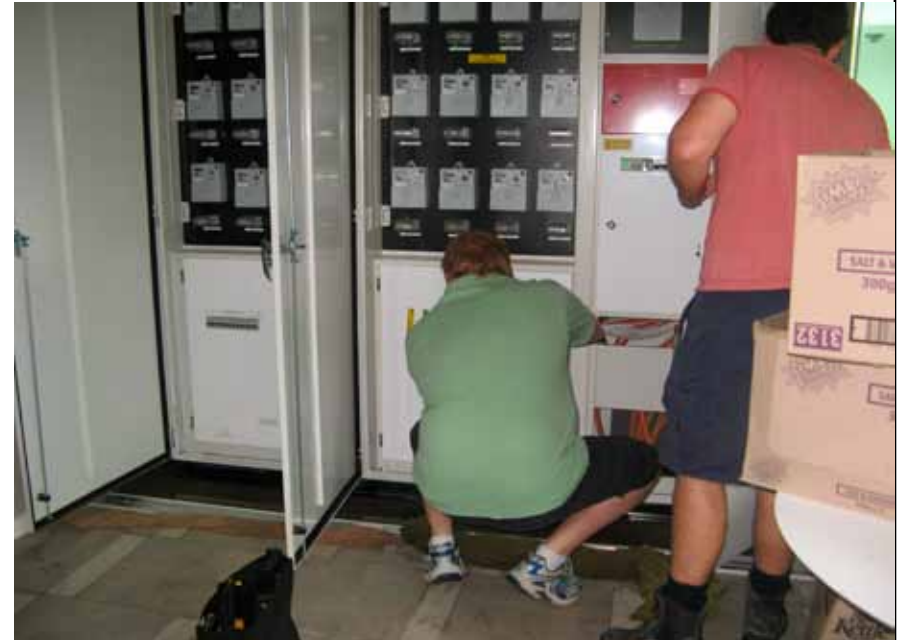
The main isolator switch on the power board was located at the lowest point on the panel and was the most expensive power component to replace

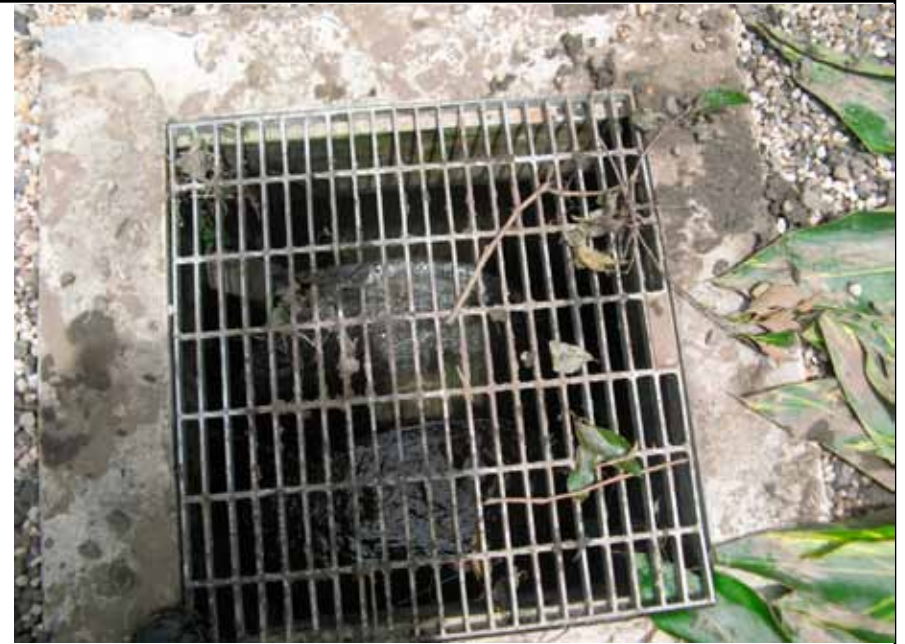
The stormwater drain around Aura could not cope with the volume of water and the first inundation occurred from stormwater, which bubbled up through the drain with such force it lifted one of the grates. One resident then fell down into the open hole, which was under water. The Council needs to better design for stormwater runoff in West End.

This stormwater grate is located on the main emergency exit pathway from the fire stairs. The pathway was flooded to knee level at the time the building was evacuated. This is an unsafe design that should not be allowed by the building code.

The large grate giving access to the stormwater drain at the side near the footpath gate on 14/01/11 at 1.04 pm, which can drown a person, if they fell in and could not get out

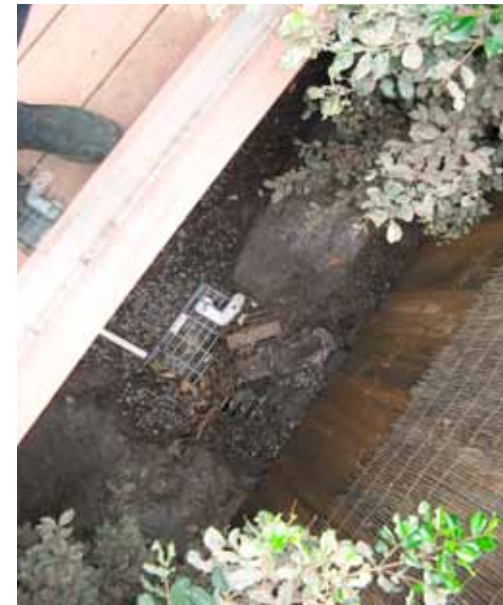
Aura stormwater drain on 14/01/11 at 2.53 pm showing where water bubbling up has not allowed any mud to settle around the grate

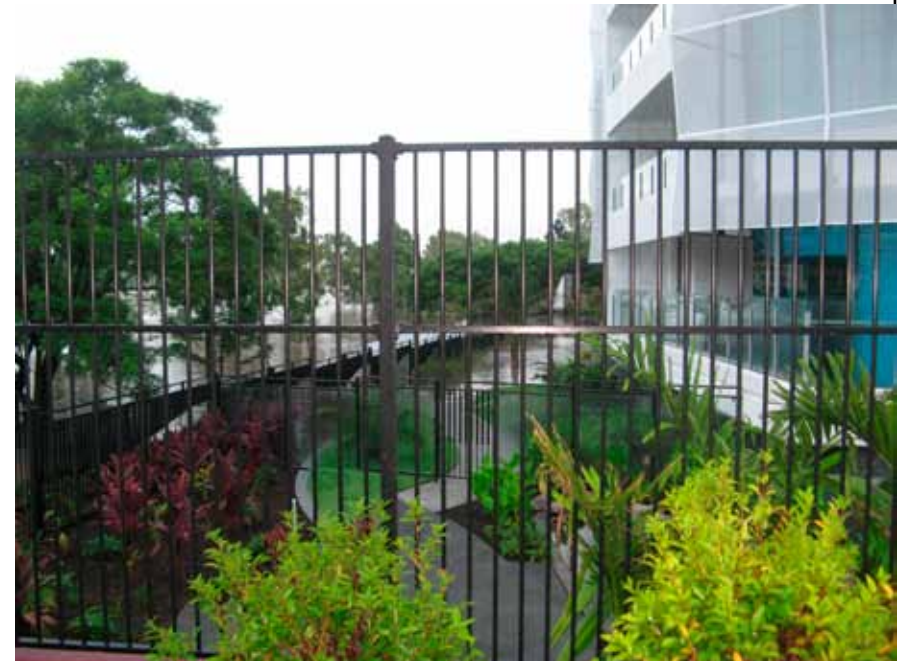
River water flowed over the bank in places along Riverside Drive and entered buildings and, possibly affected Aura. Instead of requiring developers building beside Riverside Drive to raise the bank, the Council allowed the developers of Waters Edge to lower the bank and this was one of the places where river water flowed over the bank.

View of water entering Waters Edge on 12/01/11 at 5.08 am
