Lynn de Lange

[REDACTED] Basement Water Inundation

This letter confirms the outcomes of our investigations into the source of water inundation into the basement levels of your building located at the corner of [REDACTED] Streets in Brisbane City. The water inundation event occurred over the period 12<sup>th</sup> to 14<sup>th</sup> January 2011.

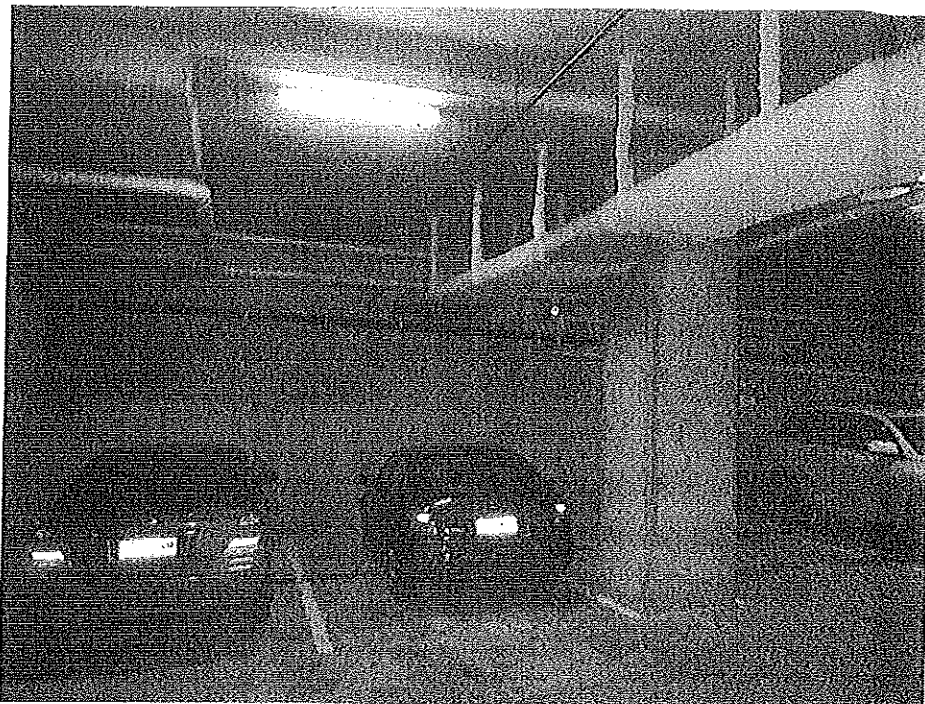
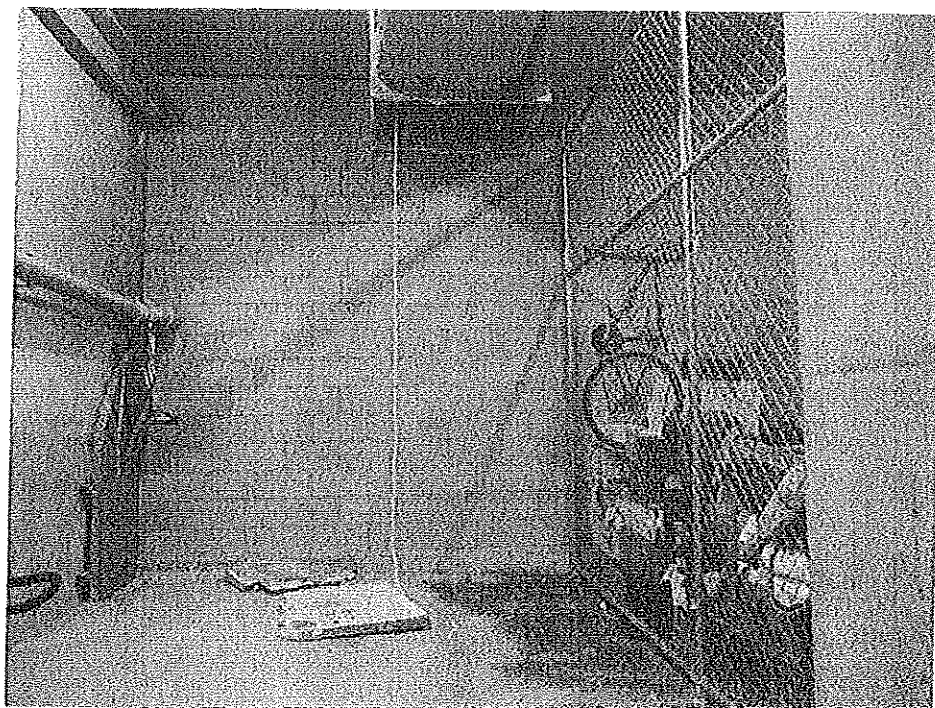
This report advises us that the water entered via the conduit in which the Energex underground power cables enter the building from the Energex pits in the footpath outside which are very deep. These would have had considerable water in the bottom coming up from the river. Apparently, Energex does not seal around the cables where they enter the conduit that takes the underground cables to our site.

The source of the water inundation is believed to be at the incoming electricity mains to the building on the [REDACTED] Street Frontage. Marked up drawings are attached and photographs follow for identification of this primary water inundation source. A "waterfall" from this location was observed by staff on site during the event. The water staining on the vermiculite encasing of the incoming conduits and failed fire proofing of the entry location boxing soffit also confirm the likelihood of this location being the main source of water entry into the basement.

I understand that this happened in other buildings also. To avoid this happening again I am of the view that Energex should be required to seal the conduit around the cables or have valves in their footpath pits to prevent the water backing up the pits from the river.
