Name of Witness	Thomas Paul FISCHER
Date of Birth	[REDACTED]
Address and contact details	[REDACTED]
Occupation	Travel Agent
Officer taking statement	Det/Sgt Anthony VLISMAS
Date taken	7 September 2011

FIRST REPORT – FLOOD DAMAGE CLAIM

Water Technology has been commissioned to inspect the property and undertake a study of the area to determine the source and cause of the inundation and specifically to provide an opinion on whether the inundation would be classified as Stormwater or Flooding.

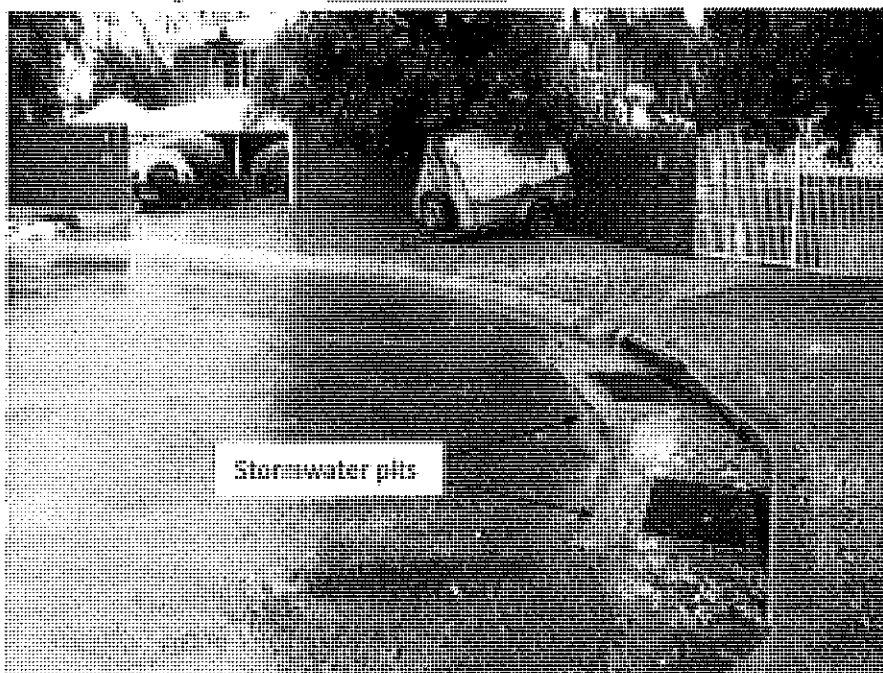
Figure 3-2 [REDACTED] stormwater pits (taken: 18 April 2011)

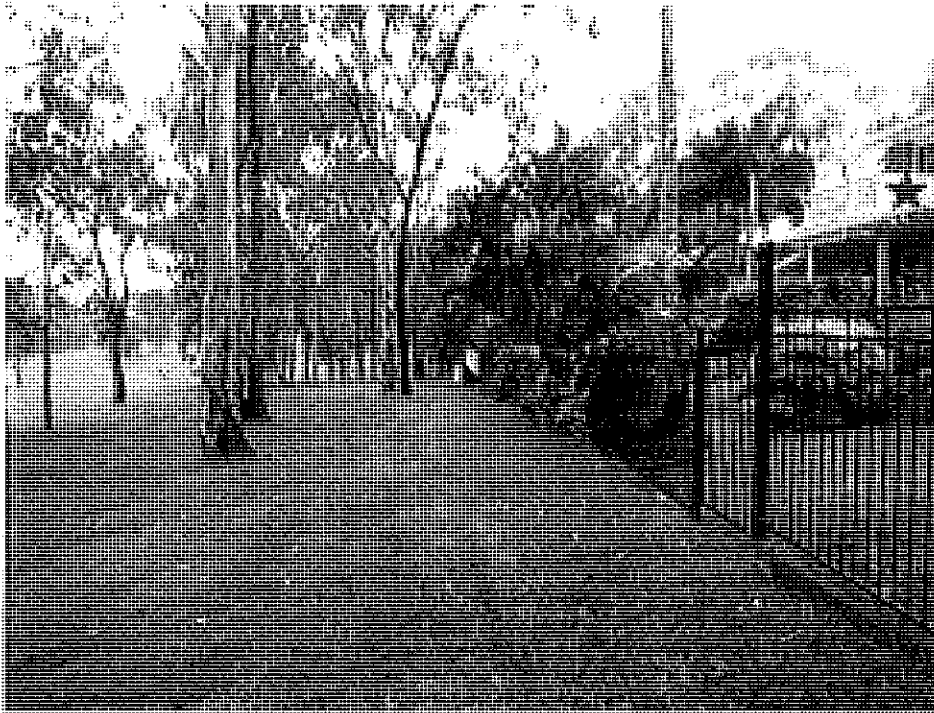
Figure 3-3 Golf course at the back of the property (taken: 18 April 2011)

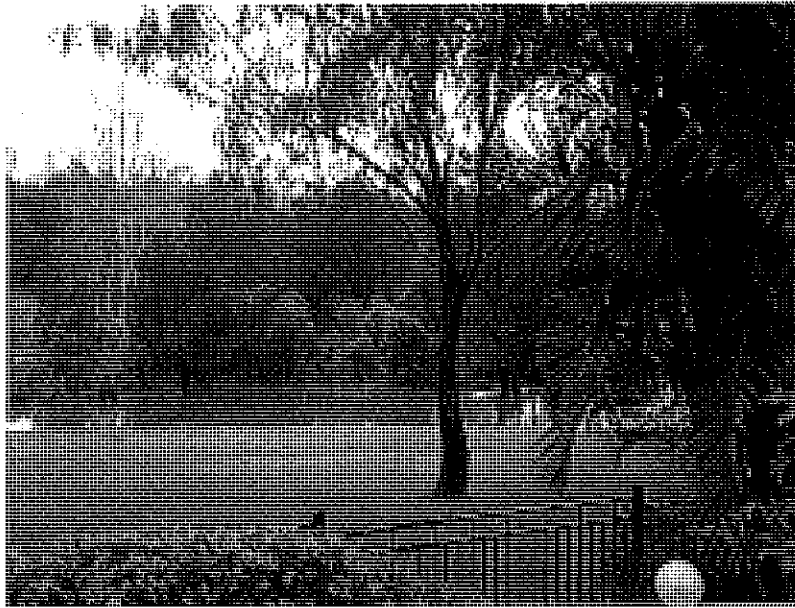
Below are photographs supplied by Mr Fischer and photographs that were taken during the site inspection. Inundation in the golf course late Tuesday afternoon is shown in Figure 3-4. Figure 3-5 shows an indicative flood depth at the rear of the house on Thursday afternoon. Figure 3-6 shows the golf course is still inundated late Thursday afternoon and Figure 3-7 indicates the flood depth reached at the rear of the property.

Figure 3-4 Inundation on Golf course at the rear of the property (taken by owner: 4:47pm on Tuesday 11 January 2011)

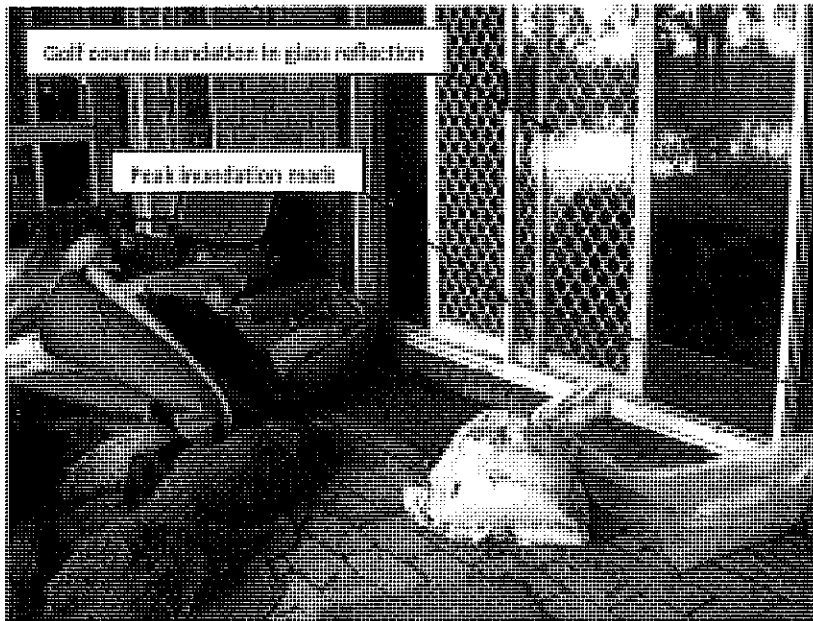
Figure 3-5 Rear of house (taken by owner: 1:55pm on Thursday 13 January 2011)

During the site inspection Mr Fischer pointed to a spot where he believed the peak water level was. This was measured to be approximately 300mm above the slab floor level and matches well with Figure 3-5 provided by Mr Fischer. It was noted that the highest point on the property is at the south-western corner near the driveway. The driveway was estimated to be 100mm lower than this

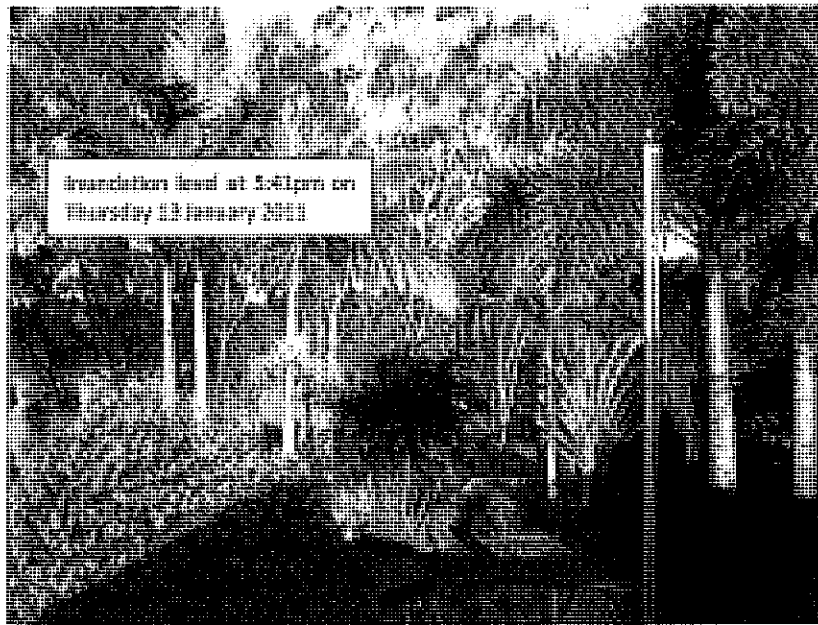
Figure 3-6 Inundation on Golf course at the rear of the property (taken by owner: 5:41pm on Thursday 13 January 2011)

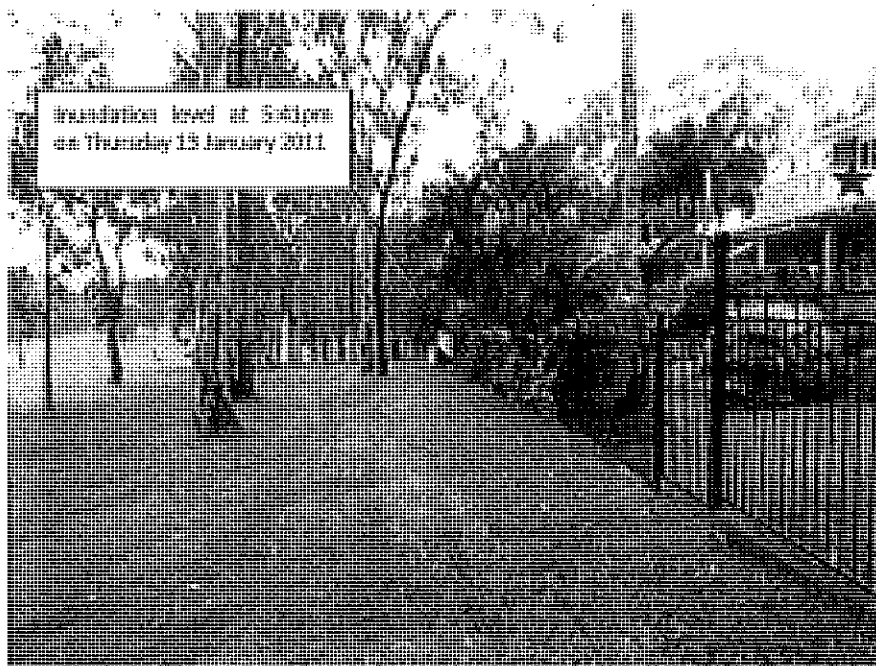
Figure 3-7 Indicative inundation level at the rear of the property (taken 18 April 2011)

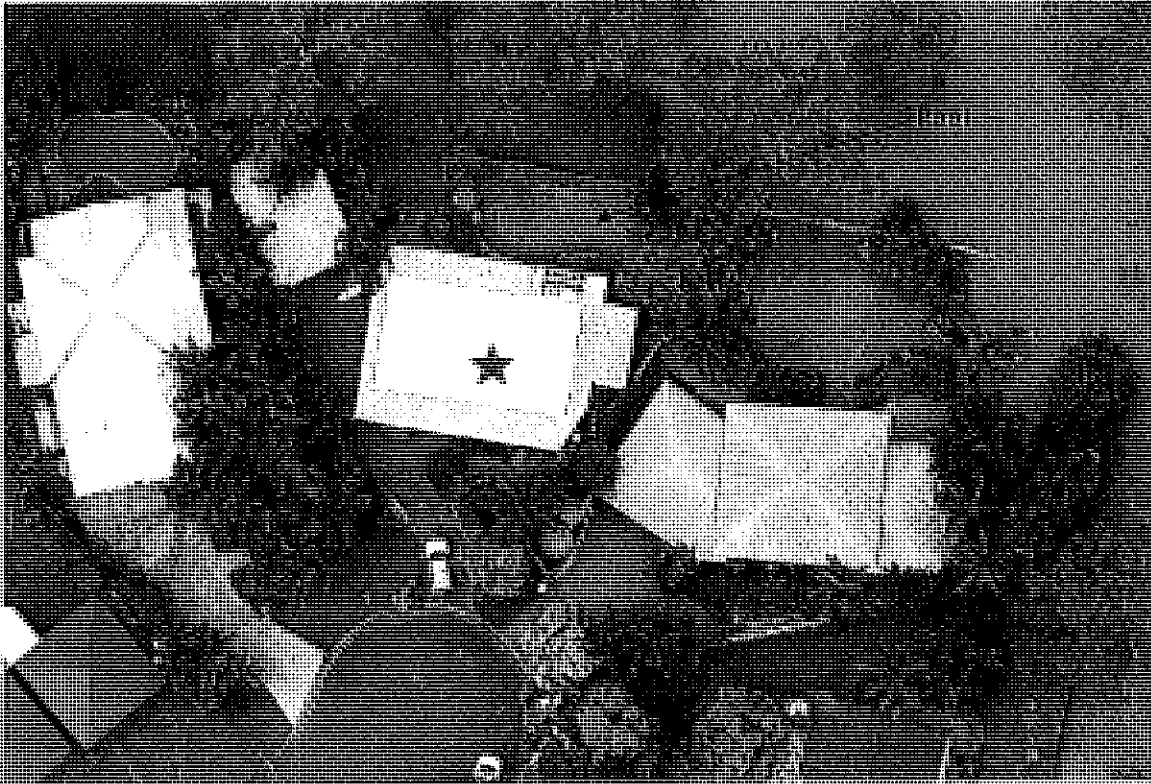
Figure 6-7 is an aerial photo from the Nearthmap website taken on Thursday 13 January 2011 after the peak inundation level had occurred. The remains of dirty water are seen in the pool. The cul-de-sac, grassed footpath beside the property driveway and the area immediately next to the stormwater pits do not show signs of inundation. Figure 6-8 is the Nearthmap image with Insurance Council of Australia (ICA) supplied inundation extent overlaid. This shows the property was within the inundation extent provided by the ICA.

Figure 6-7 Aerial Image of Inundation showing Site on 13/1/2011 (Nearthmap 2011)

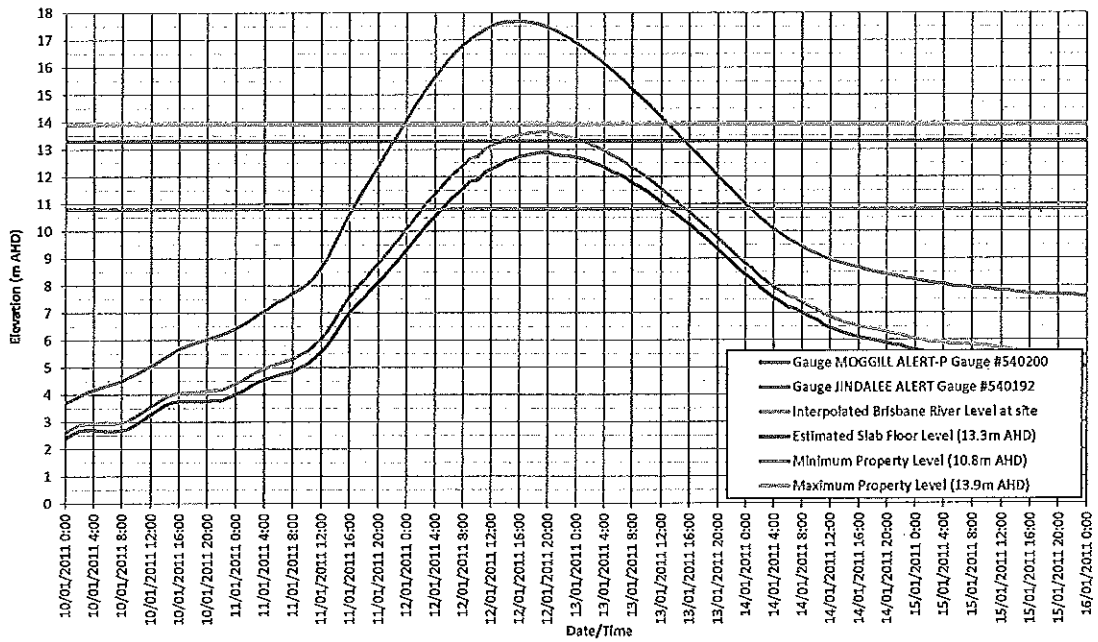
- There were no surveyed levels available for the site. We estimate the ground level of the property at [REDACTED] to be between 10.8 and 13.9 m AHD based on Brisbane City Council's Floodwise Website. Based on the floodwise reports, observations of the site and course contour data, we estimate the concrete slab floor level of the property at 13.1m AHD. These levels are estimates only and would require confirmation from survey but are suitable for the purposes of estimating the timing and depths of inundation. The site is located approximately 3km upstream of the Jindalee Alert gauge (#540192) and 16km downstream from the Moggill Alert gauge (#S40200). Using these levels we can plot an interpolation of Brisbane River levels against levels of the property and approximate estimated slab floor level as shown in Figure 7-1.

Figure 7-1 Interpolated Brisbane River levels and timing for 6 Erill Close, Middle Park

- Figure 7-1 shows the inundation at the property would have commenced at approximately 2:00am on Wednesday 12 January and inundated the slab floor level at approximately 1:00pm on Wednesday 12 January before peaking at a maximum level of approximately 13.6m AHD at around 7pm on Wednesday 12 January and receded below the slab floor level at approximately 2:00am on Thursday 13 January 2011. This agrees well with observed peak inundation depths in the house and correlates well with the owner’s recollection of water starting to inundate the bathroom and laundry at lunchtime/afternoon on Wednesday, and no inundation in the house at 6:00am Thursday 13 January.

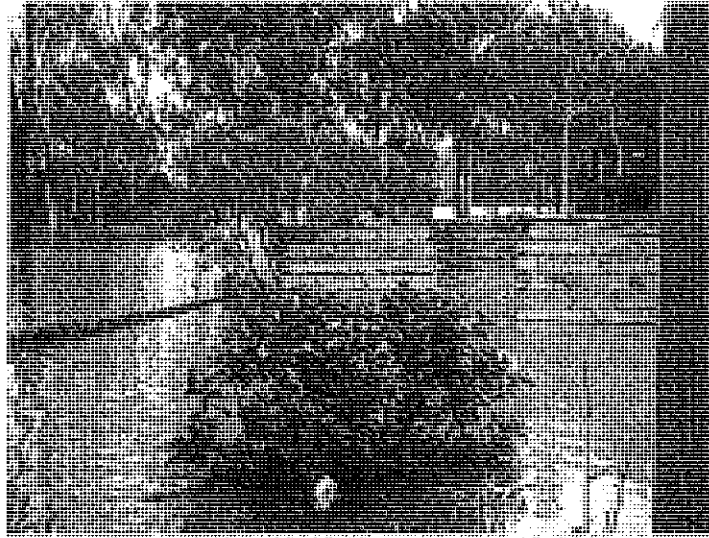
- a) Unit 13 had approximately 330mm of water through the ground floor at the highest point at approximately 10pm January 12th. This would place the water level at approximately 13.1m AHD in this area at that time.
- b) Unit 5 had approximately 700mm of water through the ground floor, at the highest point at approximately 10pm January 12th. Confirming water level at 13.1m AHD. Water started entering units 1 to 5 around 6am January 12th, 2011.
- c) Photographs taken at the site on January 13th suggest the water levels receding from a January 12th peak, though BOM advised that the Brisbane River was yet to peak. This peak information was confirmed in the image published by the Courier Mail (13th January 2011) shown below.

FIGURE 4. UNIT 13, 12:43PM, JANUARY 12, 2011

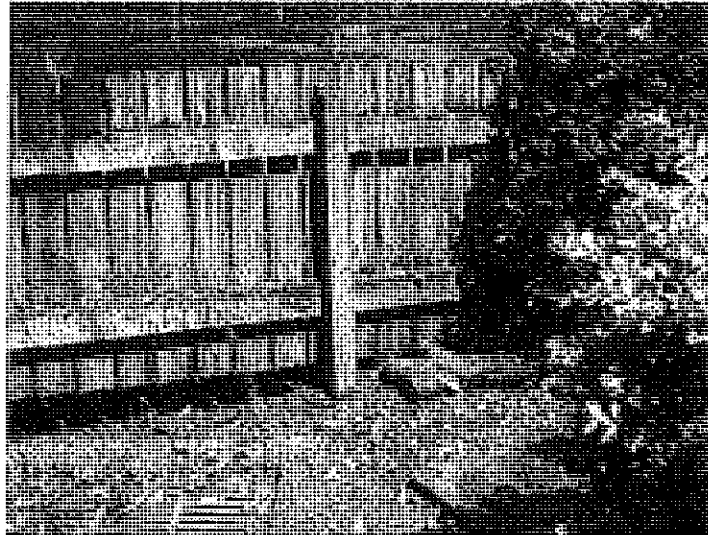
FIGURE 5. UNIT 13, 7:45AM, JANUARY 13, 2011

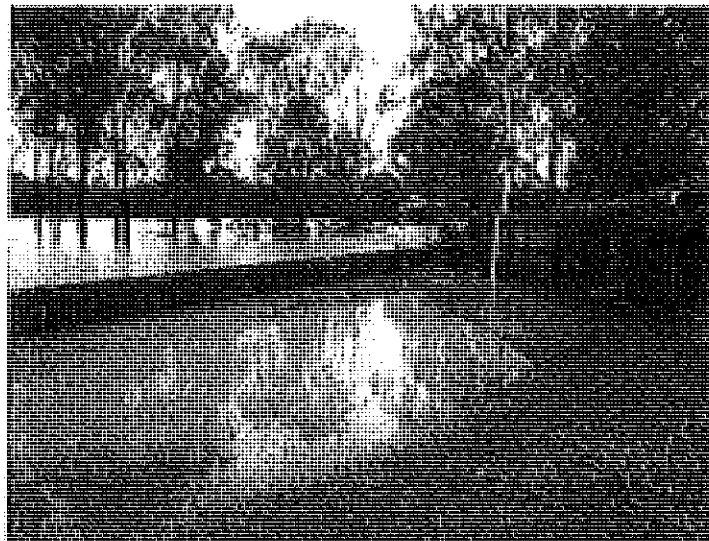
FIGURE 6. UNIT 5, 10:55AM, JANUARY 13, 2011

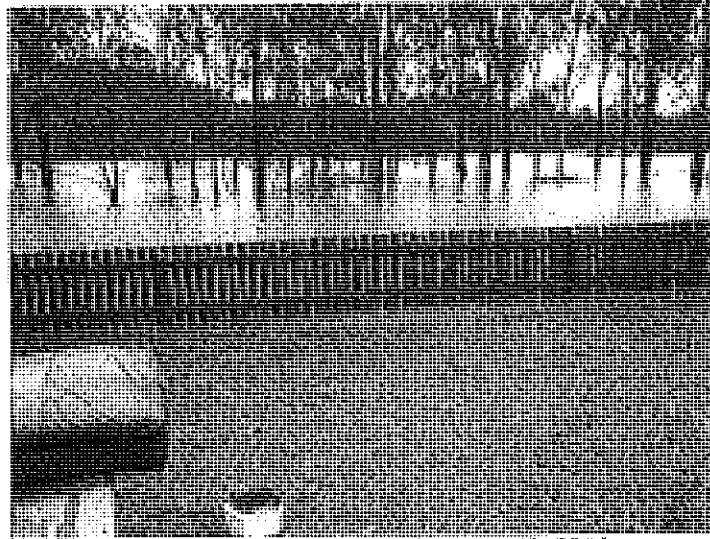
FIGURE 7. UNIT 5, 11:07AM, JANUARY 13, 2011

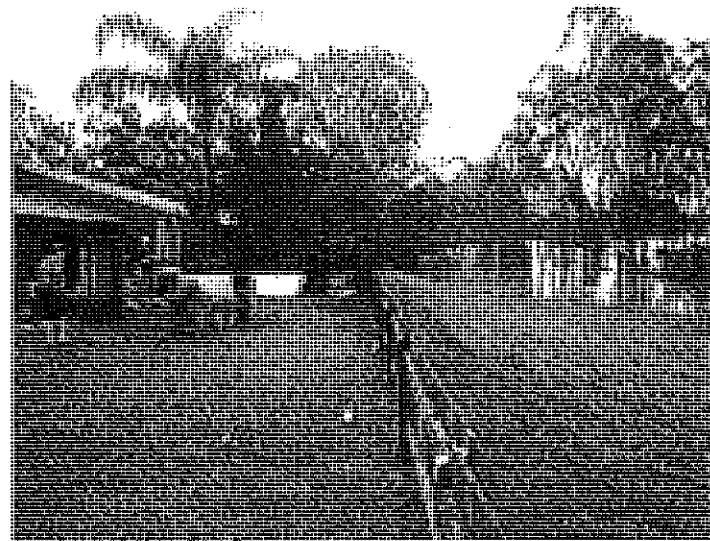
FIGURE 8. UNIT 5, 4:10PM, JANUARY 13, 2011

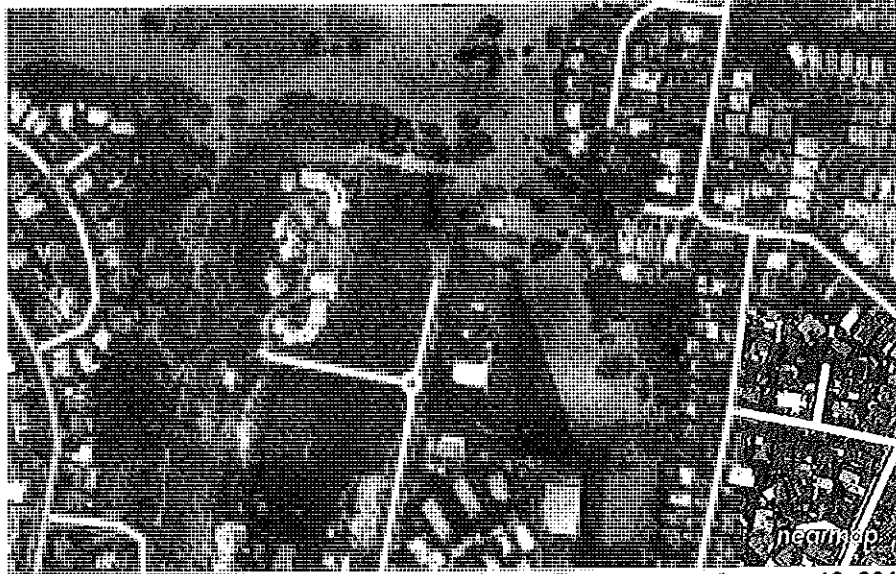
FIGURE 5. RECEDED WATER, MIDDLE PARK AERIAL PHOTOGRAPH, JANUARY 13, 2011
(SOURCE: NEARMAP)

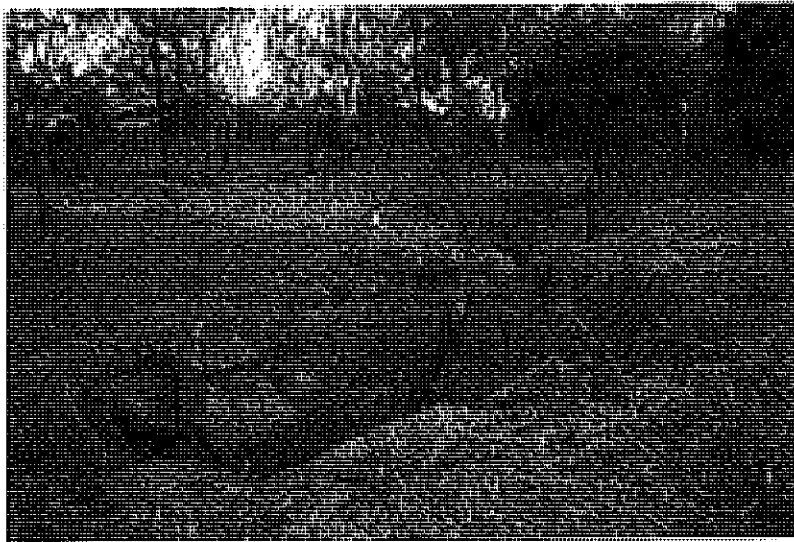
- d) An inspection of the drainage system in the waterway along the western site boundary conducted by a DEC representative at 1:30pm on 11th January 2011 confirmed flows were continuing to be received down the drainage network from the upper Middle Park catchment. These flows were occurring in both the drainage pipes and overland flowpaths. This flow was engulfed by the tailwater conditions present in the MacLeod Golf Course. A photograph of the waterway after the water had receded is below, showing the vegetation has been compressed in the direction of flow downstream.
