Flood Operations of Wivenhoe and Somerset Dams

Notes on the Analysis of the Late December 2010 Flood Event

WIVENHOE DAM

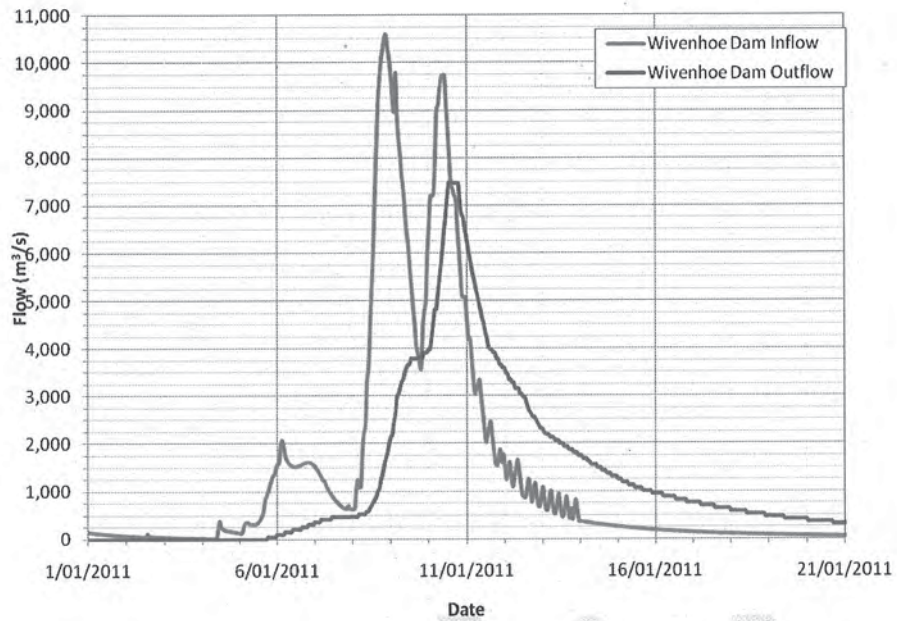
Figure 1 - Inflow and Outflow Hydrographs at Wivenhoe Dam for January 2011 Floods

Following the peak discharges from the dam, the dam operators reported to the flood operations centre an increase in the observed tail water levels and the turbulent flow as discharges passed over the rock pile at the end of the chute.

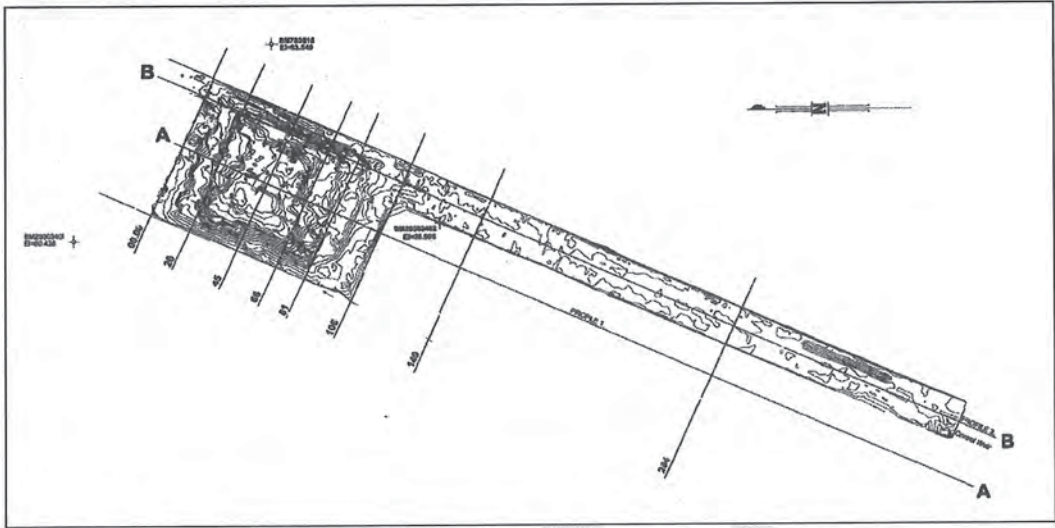
Figure 3 - Survey of Wivenhoe Outlet Channel and Spillway Post January 2011 Flood

It can be seen from cross section A-A in Figure 4 (left to right represents upstream to downstream) that the majority of material removed from the base of the plunge pool was located at the downstream side of the excavation. The plunge pool depth was decreased to a depth of EL14m and up to 10m of rock was removed from areas of the spillway structure. However, it should be noted that there was minimal head cutting of the upstream side of the plunge pool.

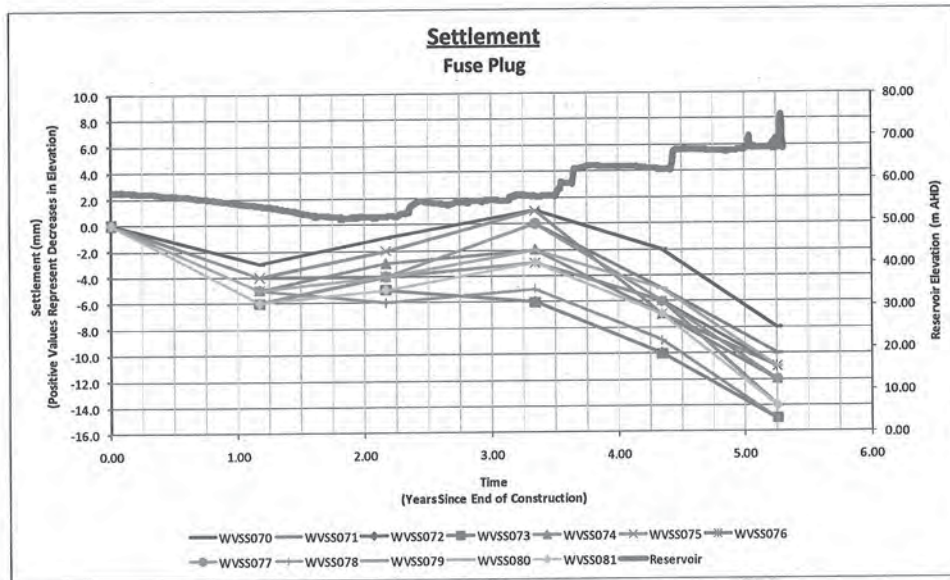
Figure 15 - Settlement of Monuments Analysed for Fuse Plug

Figure 15 presents the post construction deformation settlement versus time for the fuse plugs. The maximum value of settlement is 15 mm, with an average settlement of 5.8 mm. There is an issue to be investigated for the settlement of all the monuments, WVSS070 through WVSS081, that are located on or around the fuse plug. Within the last two plus years, there is a clear trend that the entire structure is gaining in elevation. It can be seen in the following Figure 15 that all the monuments are settling (or rising) at similar rates. A cross-section of the fuse plug design can be found in Appendix A.

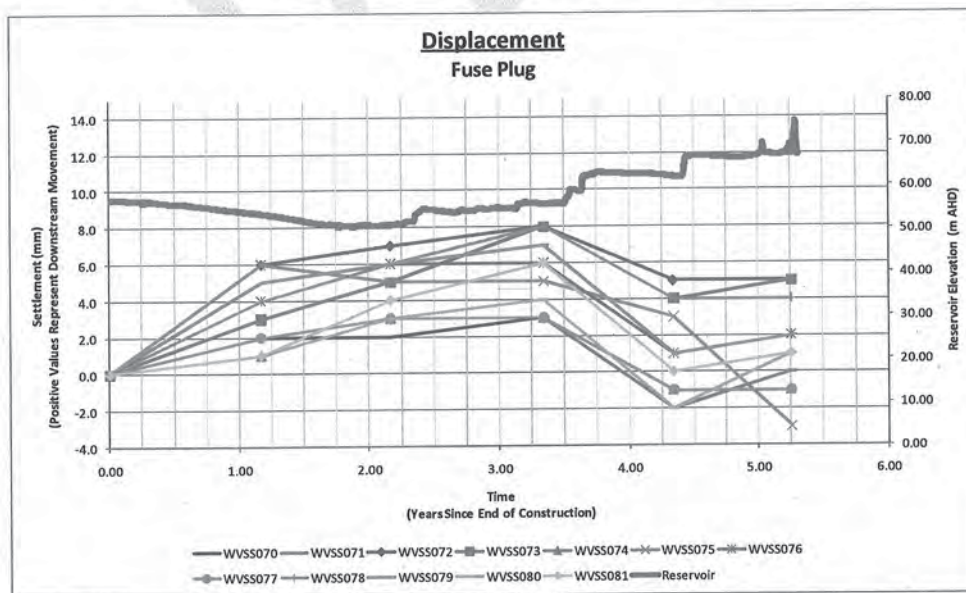
Figure 16 - Displacement of Monuments Analysed for Fuse Plug

Figure 16 presents the post construction deformation displacement versus time for the fuse plugs. The maximum value of displacement is 8 mm, with an average of 3.1 mm. With the exception of monument WVSS075, all the monuments are operating as expected. Monument WVSS075 is located in the embankment portion of the middle fuse plug and it should be noted that it has not been trending in line with the other monuments for the last year plus.

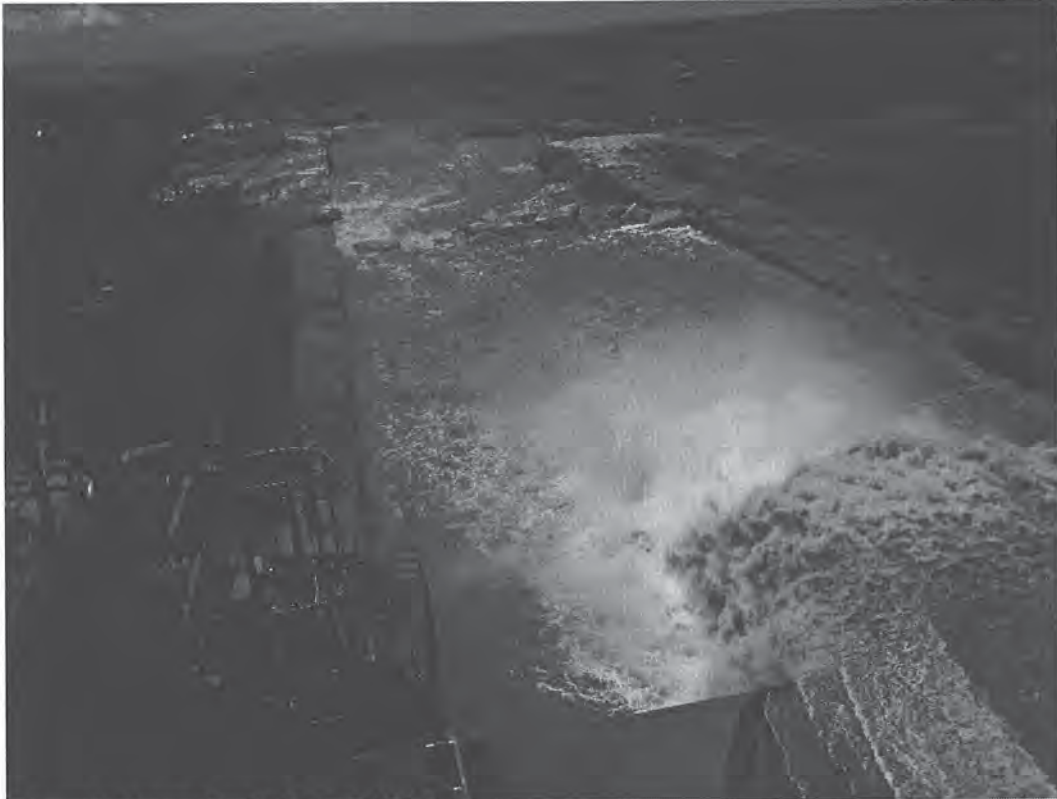
Figure 1 Plunge Pool 10 am 19/1/2011

As the tail water receded, a bank (Figure 1) of large blocks of sandstone rock emerged just downstream of the plunge pool. The bank was causing an afflux of about 4 meters.
