KROOMBIT DAM

EMERGENCY EVENT REPORT

20TH DEC 2010 to MARCH 2011

KROOMBIT DAM - EMERGENCY EVENT REPORT

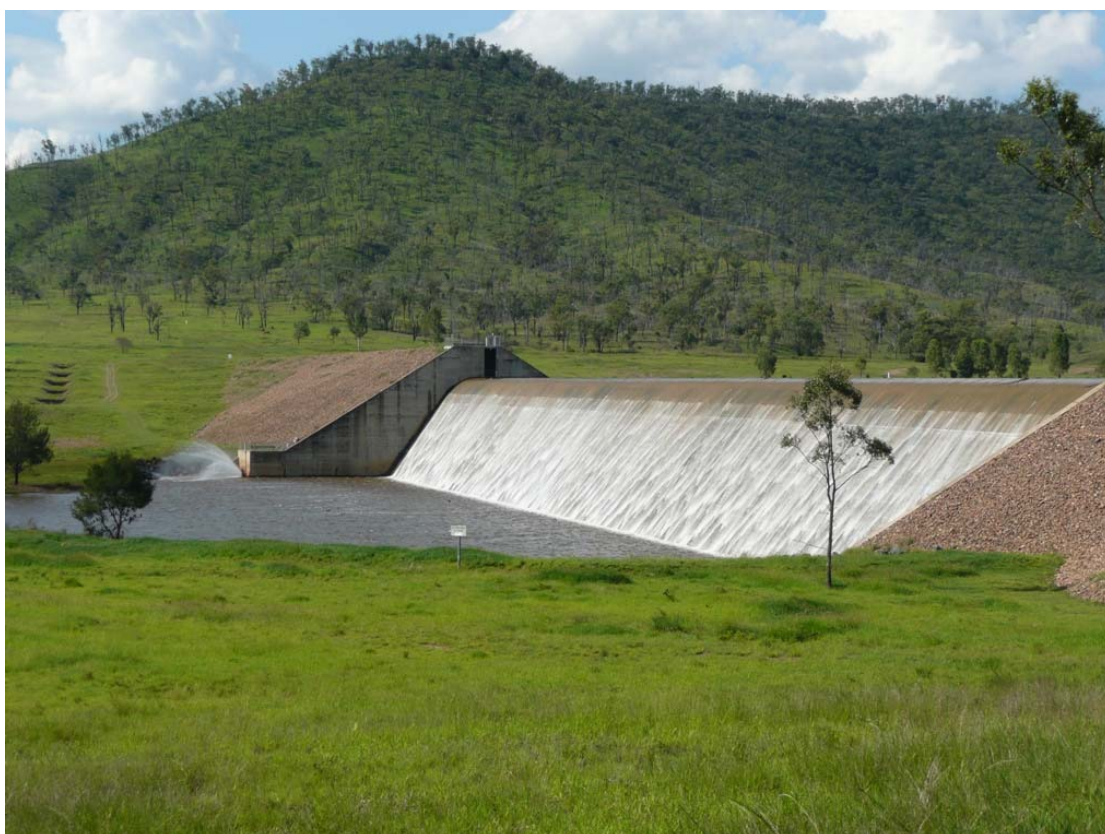
11/1/2011

Nil Damage recorded
