QUEENSLAND FLOODS COMMISSION OF INQUIRY

STATEMENT OF ANDREW KROTEWICZ

ATK2-1 Wivenhoe Power Station Geological Inspection Report by SunWater 19 January 2011

Project: P-AEXP-1900-AC-12-03 **File No:** 05-013001/009

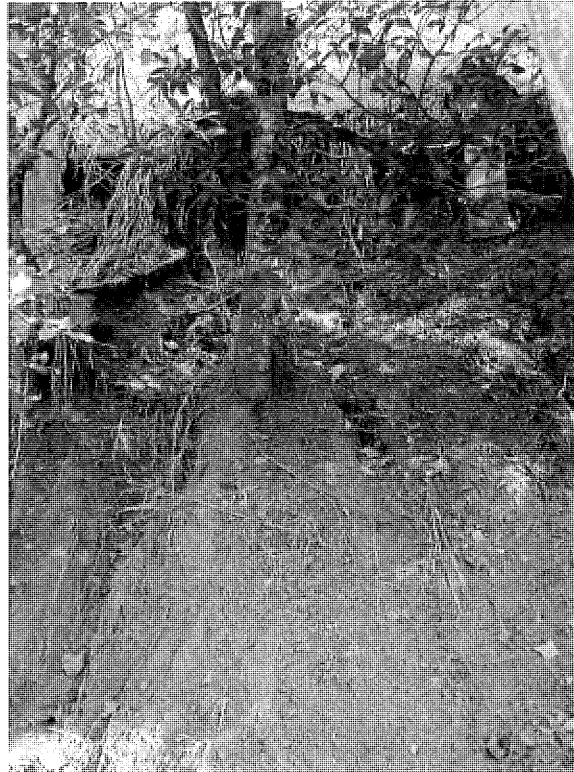
An over slip was observed up-slope of the sewerage pipe near the evaporation trench (Figure 2). It is recommended that the affected area be benched to increase slope stability, with a drain possibly installed at the crest of the slip, in addition to formed drainage on each bench to prevent ponding.

Figure 2: Slump above and below sewer line (upper centre of image).

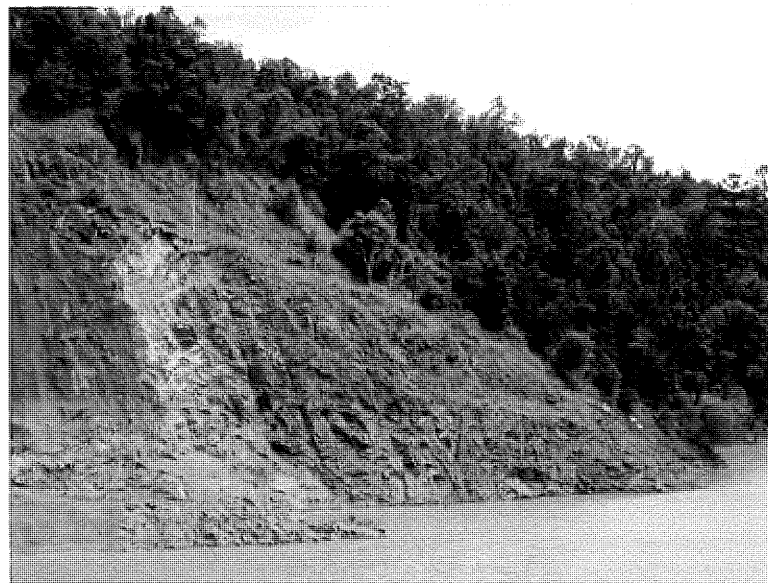
Figure 3 shows a rock fall which occurred on the southern slopes, immediately adjacent to the boat ramp launch area. This site was inspected from both below and above.

Figure 3: Rockfall (pale yellow-brown area) in southern wall of inlet area.

Weathered rock material, failed from the area immediately below the bench along which the sewer line runs and adjacent to a shotcreted section of the wall, was deposited on and above the boat ramp. No damage was noted to have occurred to the boat ramp, however a large amount of sediment had accumulated [in a delta like feature] along a section of the ramp interpreted to be coincident with the water level in the reservoir at the time of the rain event.

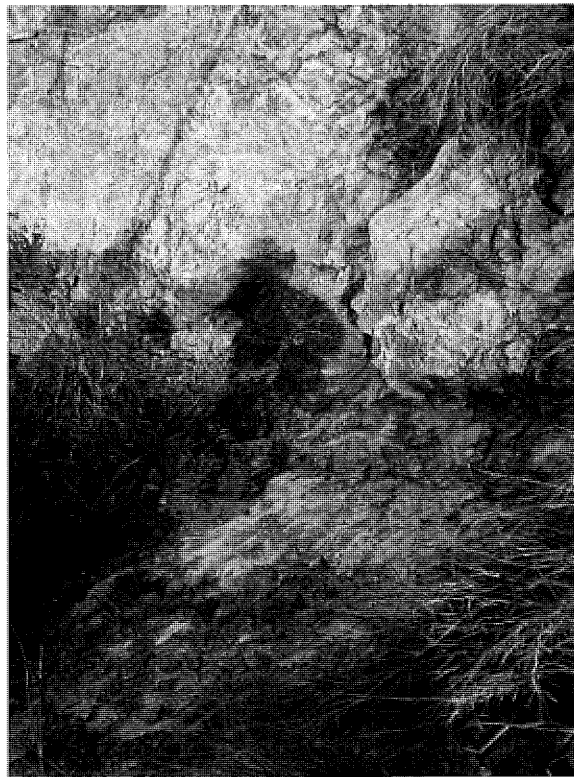
The material was observed to have released along a clay filled joint plane (Figure 4), which was likely weakened to the point of failure due to over-saturation during the rain event. Material remaining in-situ was also observed to have dilated and initiation of toppling and sliding failure was observed (Figure 5), and as such it was recommended that the at risk material be removed (barred down), and that the site should be monitored using an extensometer.

Figure 4: View of clay coated jointed (shaded area at base of image) and weathered rock.

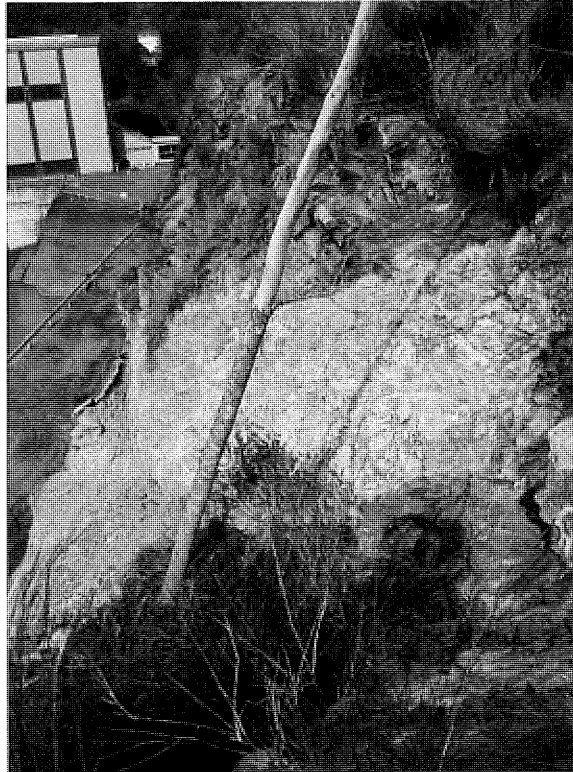
Figure 5: Weathered rock toppling from slope below sewer-line bench.

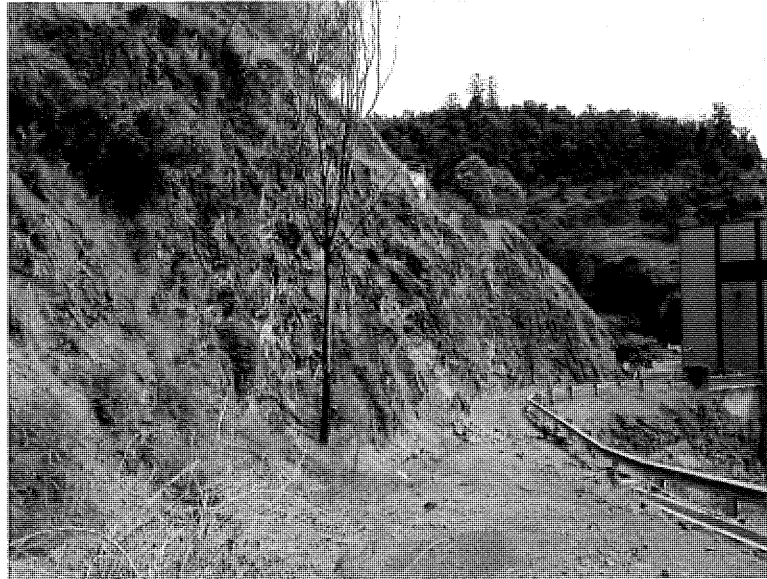
Material (rock and soil) was observed on the access track below the south-eastern slopes (Figure 6). Several rock falls and slips were observed above (see Figures 7 and 8). No damage to the road was observed and the slope below the road was observed to be intact.

Figure 6: Access track to south-eastern slopes (looking towards power station).

At those locations where there is a high likelihood of further rock fall (i.e. loose or overhanging rock), it is recommended that such material be removed via barring down as soon as practicable to safely do so.

Where benches or berms exist, it is recommended that these features are cleared of displaced material as soon as possible to allow these structures to accommodate future failures. It is suggested that a crest drain is installed to divert water away from the slopes.

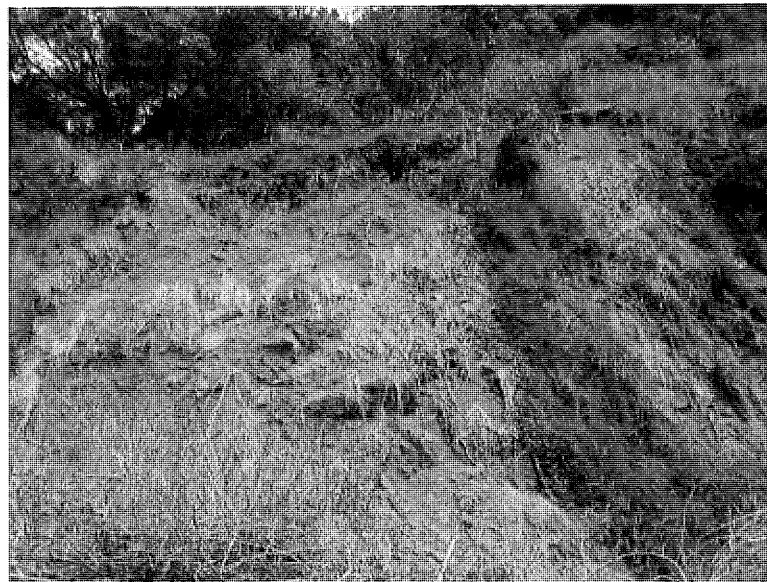
Figure 7: Over slip in soil in access track area.

It is noted that in those areas where the failures have occurred within the soil profile, the failure appears to be limited to the vegetated horizon, with the base of the vegetated mat approximating the release surface.

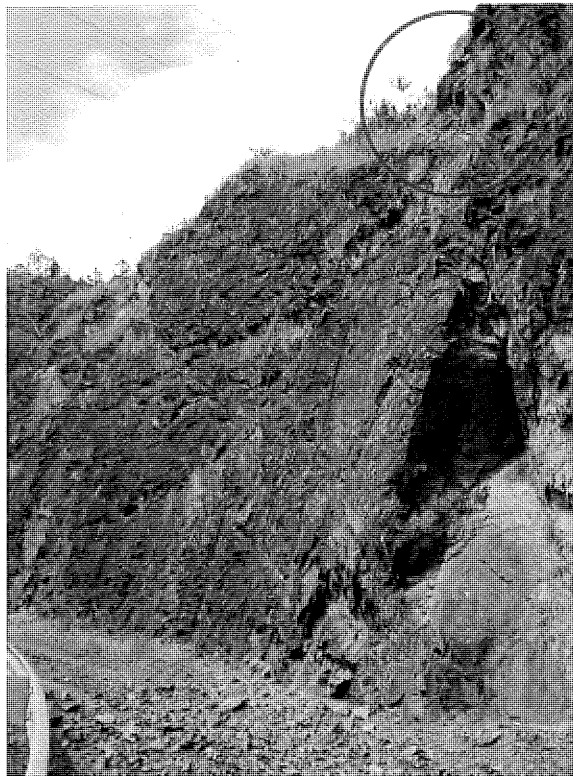
Figure 8: Minor rock fall associated with unfavourable jointing, south-eastern access track area. Note that wedge failure in foreground occurred some years ago.

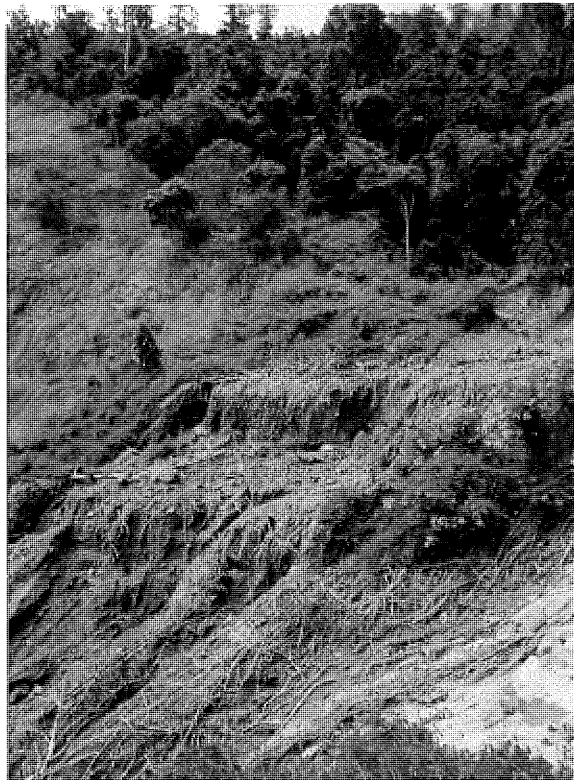
The slope directly behind the power station was observed to have suffered major degradation, and wasting as shown in Figure 9. The damage to this area was enhanced by a large quantity of additional material from multiple significant upper slope failures and erosion moving down gradient along existing gullies and communication and power service corridors. Several concrete pipes were exposed along the southern edge of the corridor. Where erosion had occurred in the existing gullies, the soil profile was estimated to range between 2 to 4 m (Figure 10).

Figure 9: Benched slope behind the power station illustrating degradation and wasting due to overland flow.

To improve slope stability it is recommended the areas that were denuded during the rainfall event are revegetated as soon as practicable to assist in stabilising the slope, reducing overland flow velocities, ultimately reducing the potential for further erosion. This may be achieved by planting a series of parallel rows of vetiver grass orientated normal to the flow direction, at regular intervals along the gullies.

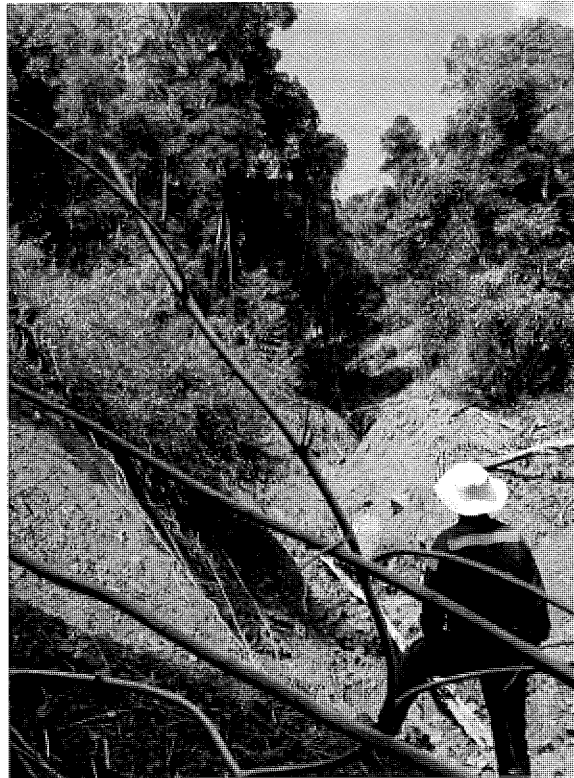
Figure 10: Eroded gully illustrating thickness of soil profile.

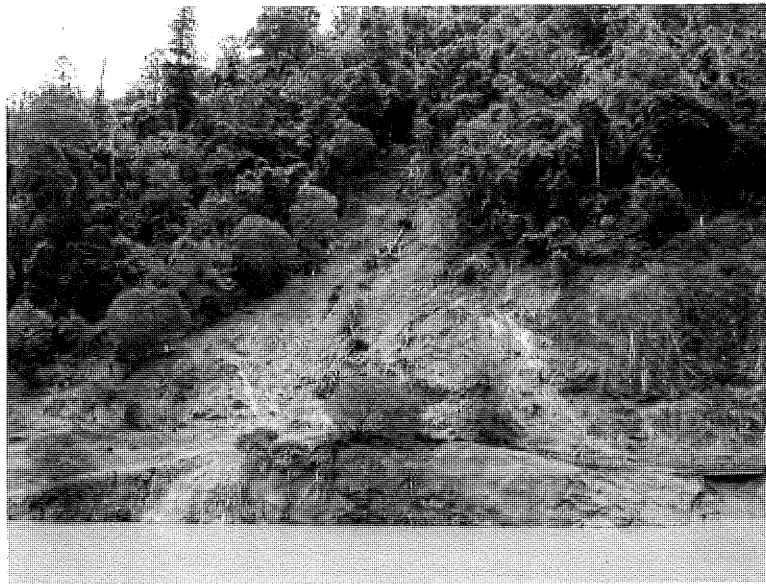
A land slip was observed on the north-western slopes, with the release surface interpreted to approximate the base of the vegetated root mat. This interpretation is based on the limited escarpment adjacent to the slip and the observed root mat thickness below the vegetated areas (Figure 11). Generally, some of the soil profile appears to remain intact within the failure area, with rock exposed along the base of the slope in the area where engineered works appear to have been completed as part of the construction of the inlet pool.

Figure 11: Slip located to the north of the pump intake area.

It was suggested that to prevent fouling of the inlets as a result of future failures in this area, that an appropriate barrier fence/wall be constructed along the toe of the slope. Ideally the slope should be benched and drained, and re-vegetated with vetiver grass or a similar deep rooting species.

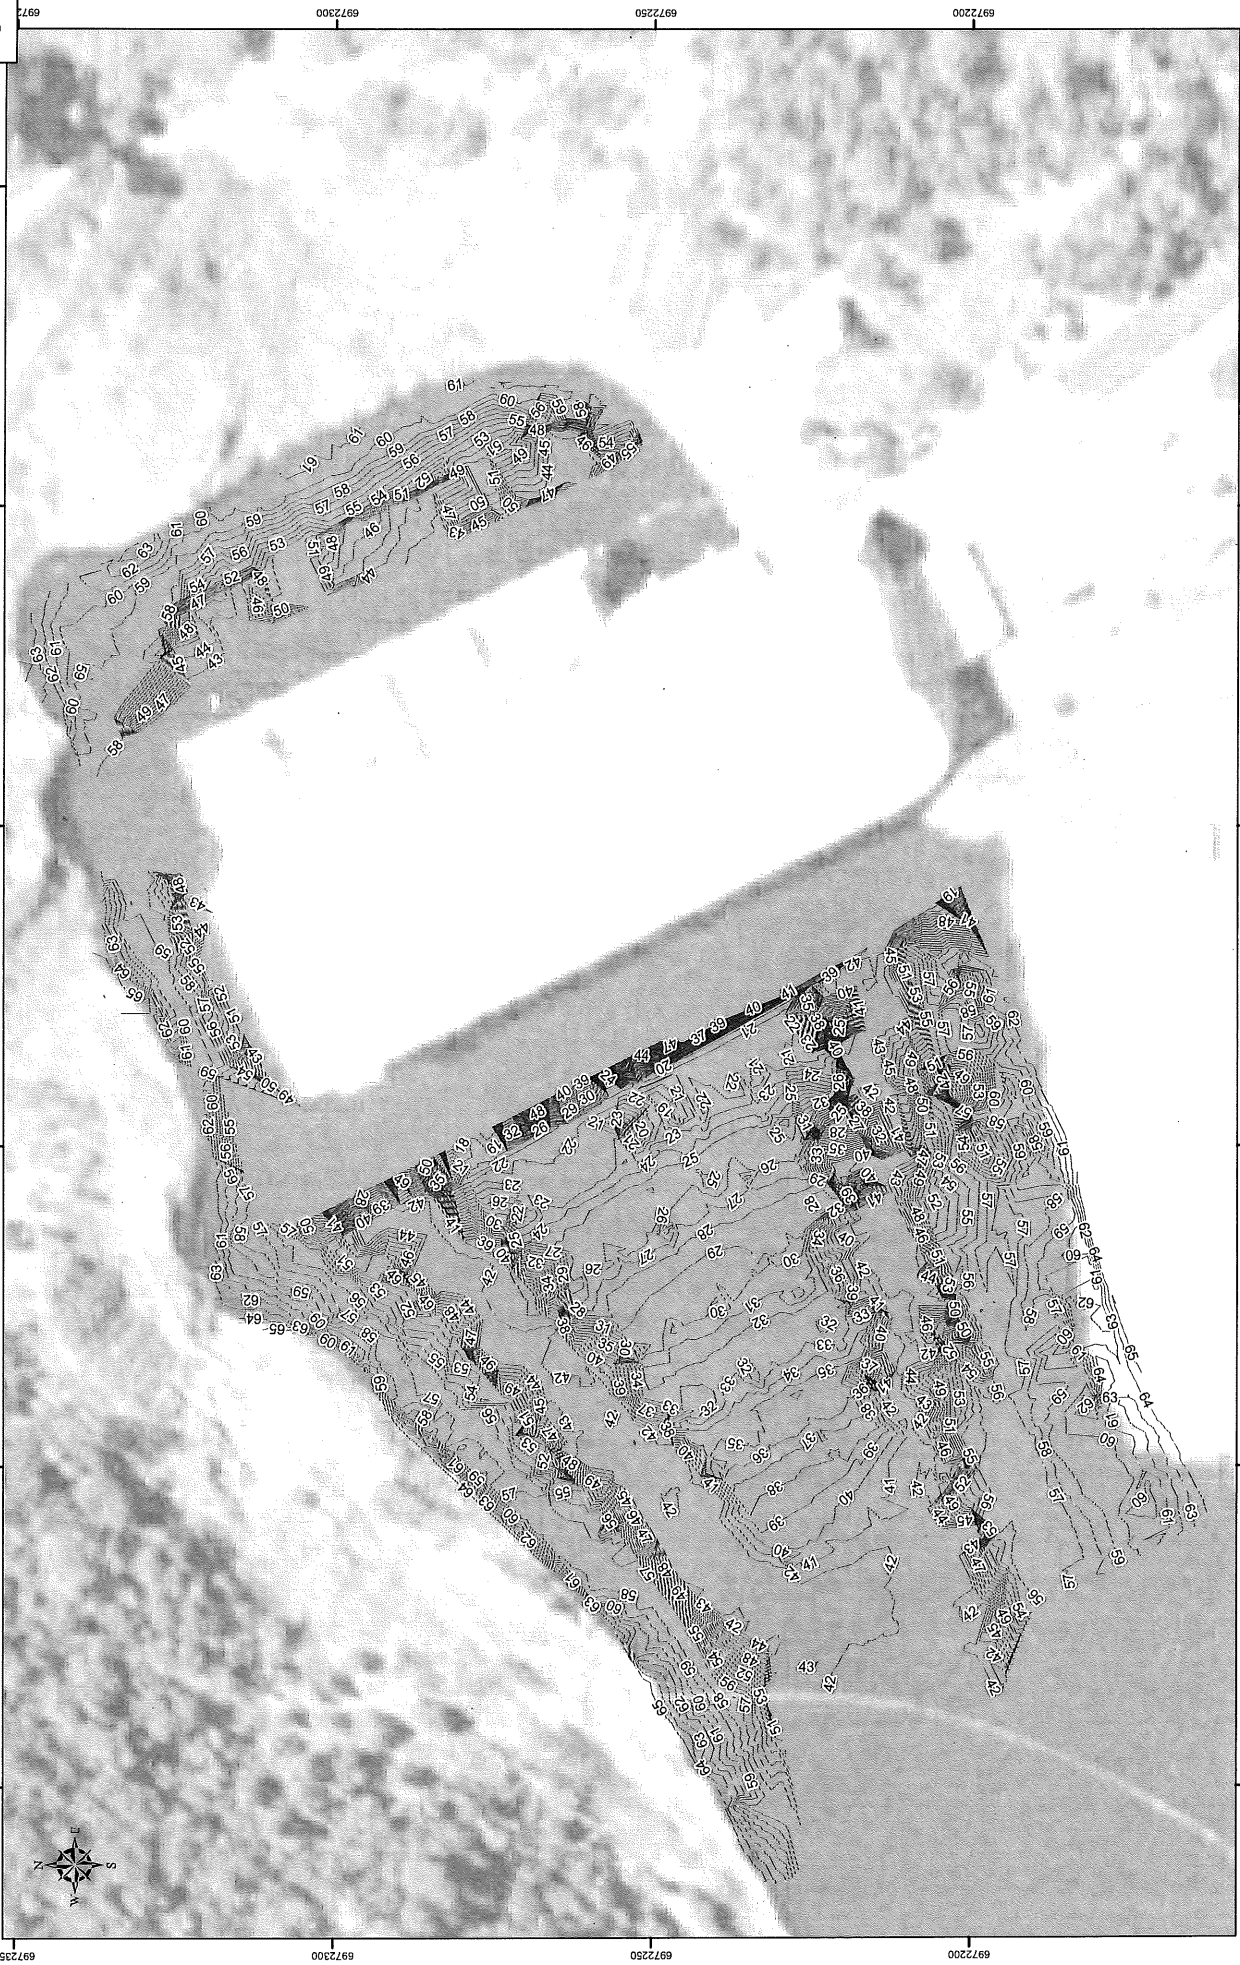
Fig 12

Engineering surveying of the inlet pool was carried out by [REDACTED] (SunWater) 20 to 21 January 2011. Depth contours are shown on Figure 12. From the survey, it is interpreted that no significant quantity of land slip debris was introduced to the inlet pool as a result of the failure. Therefore, the topography and pre-existing structures at the base of the slope appear to have assisted in dissipating much of the wasted material, diverting it to the right and left of the failure plane.

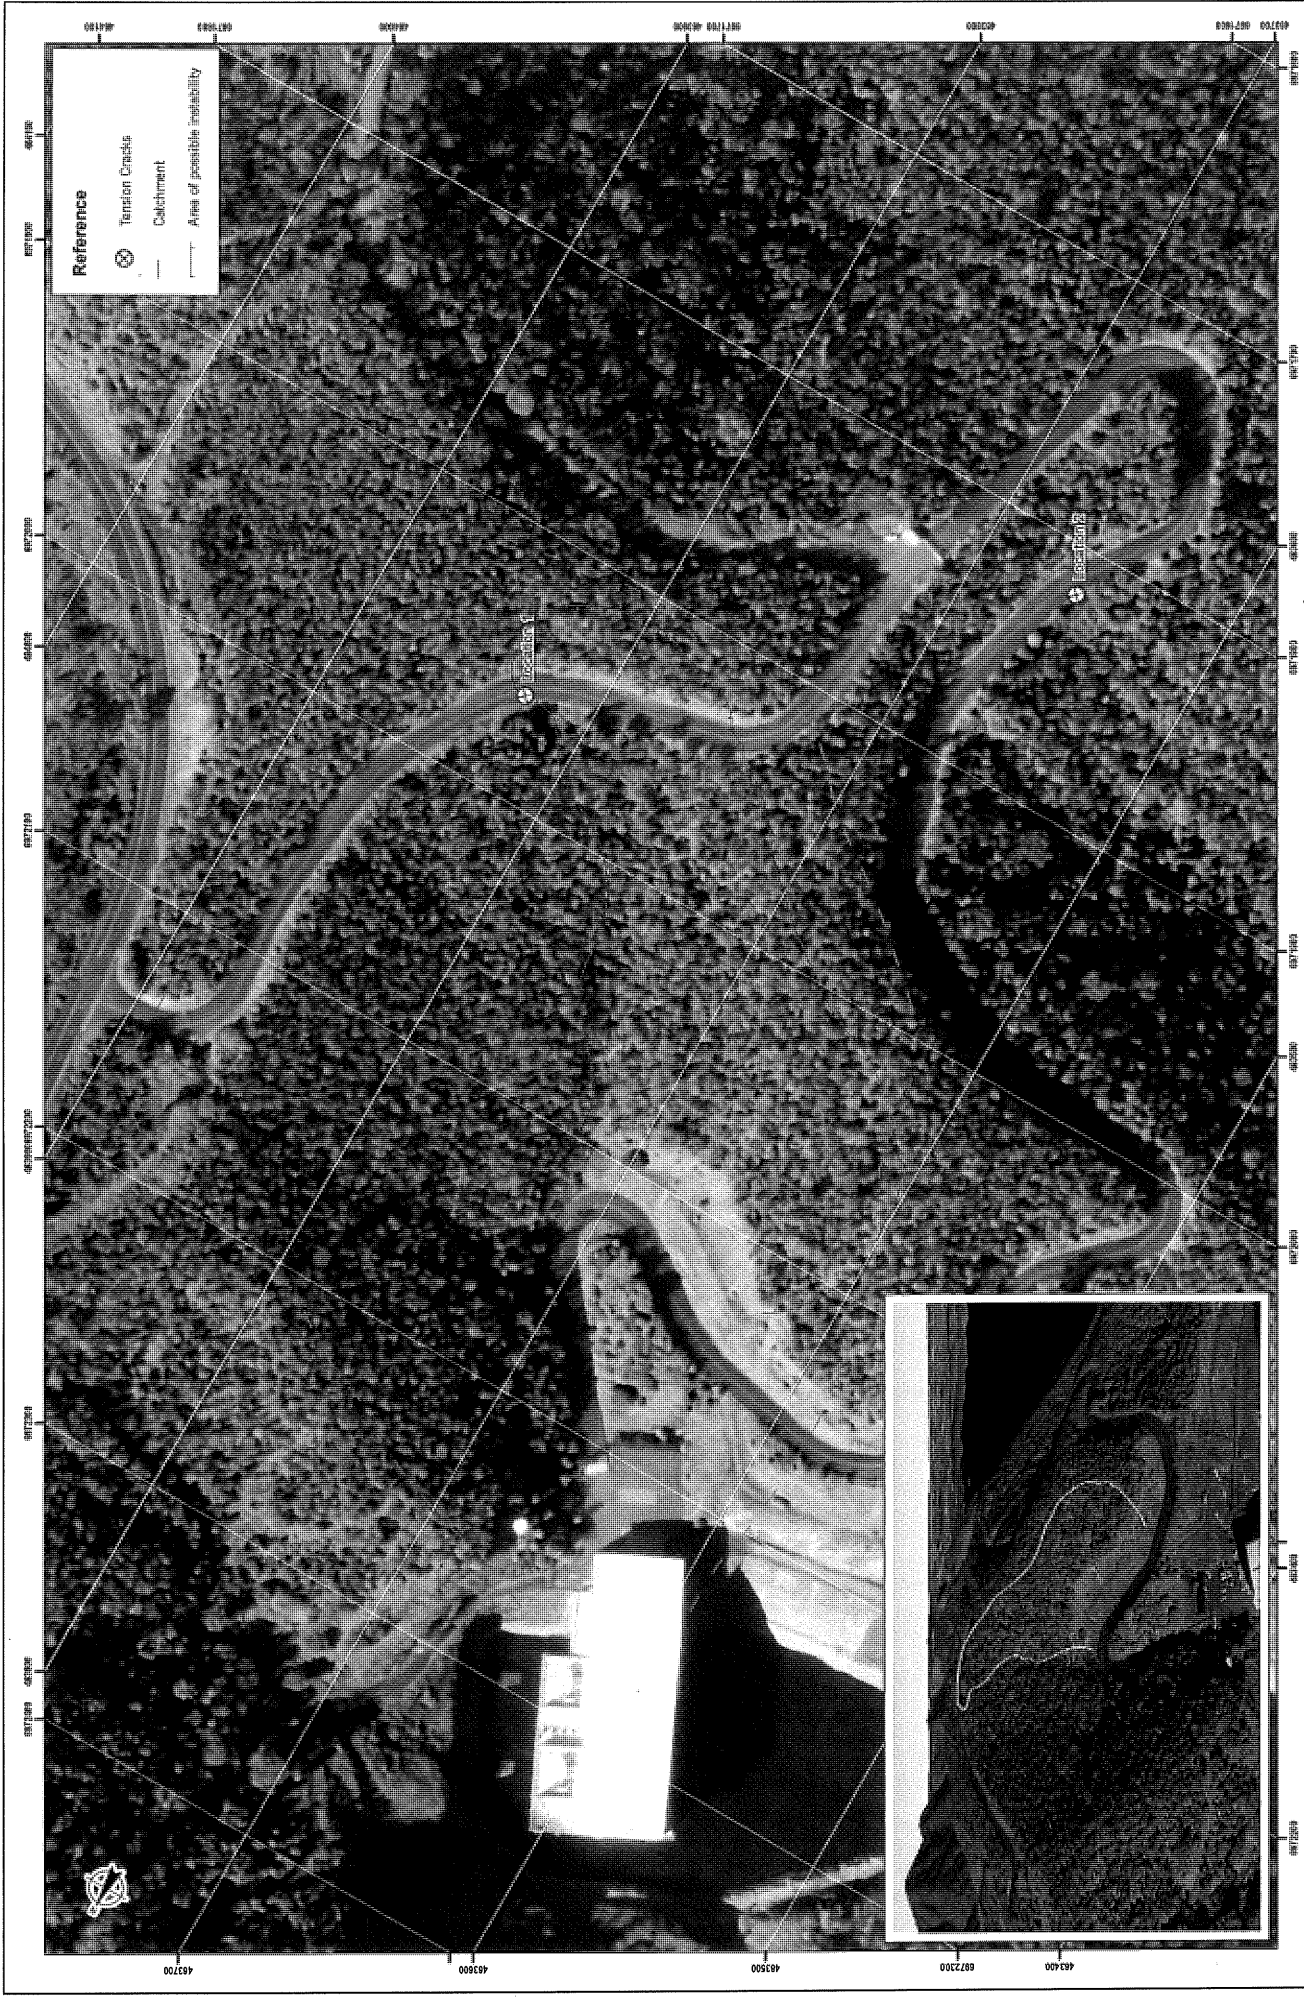
CONTRACT NUMBER DRAWING NUMBER 238170 DATE 03 Feb 2011	
WIVENHOE POWER STATION GEOLOGICAL INSPECTION Figure 13 Location of possible unstable area & tension cracks.

Interpretation of an oblique aerial photograph identified a large section of the catchment may be mobile, with a distinctive change in vegetation about a feature with geometry similar to that of a landslide. This area has an area of approximately 22,000 m². The head scarp of this feature appears to coincide with tension cracks present within the roadway, approximately 200 m north of the security hut (Figure 13).

This is, however, an interpretation only, based on aerial imagery only and requires investigation and mapping to confirm if this area does, in fact, present a risk.

Longitudinal tension cracks, in excess of 2 m in length, were observed along the outer side of the access road at two locations, as marked on Figure 13.

Tension cracks indicate the likelihood of failure in a particular area is elevated and it is recommended that an exclusion zone be immediately established around the cracked area to reduce loading which may lead to failure. To reinstate these areas, the affected area will require engineered stabilisation solutions.

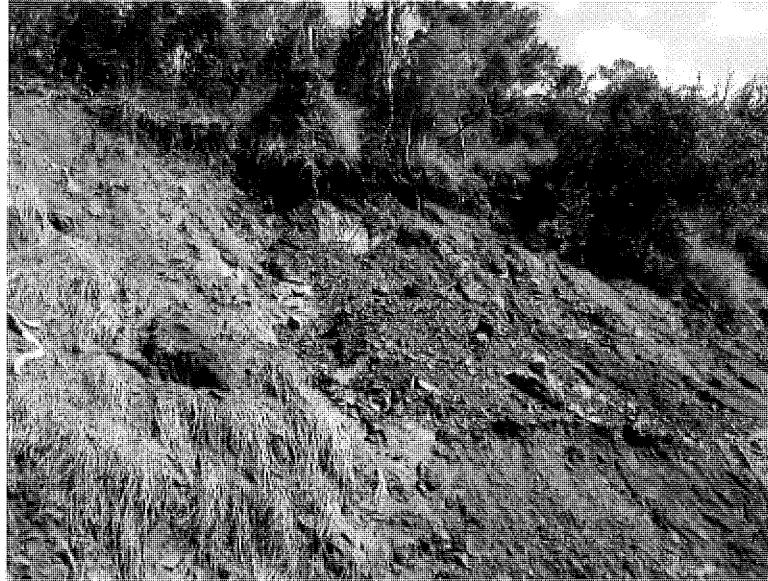
Both rock falls and slips (typically over slips) were observed along the length of the access road. The majority of the failures are interpreted to be due to a combination of intensive overland flow, soil saturation and a lack of support at the base of slopes (slope over steepening resulting from construction of the roadway). A well defined escarpment (approximate height 400 mm) was consistently observed at the top of failure slopes (Figure 14). Therefore, the slips are interpreted to have a minimum depth of 400 mm. Soil creep was also observed on slopes.

Figure 14: Over slip present in the upper section of the access road.

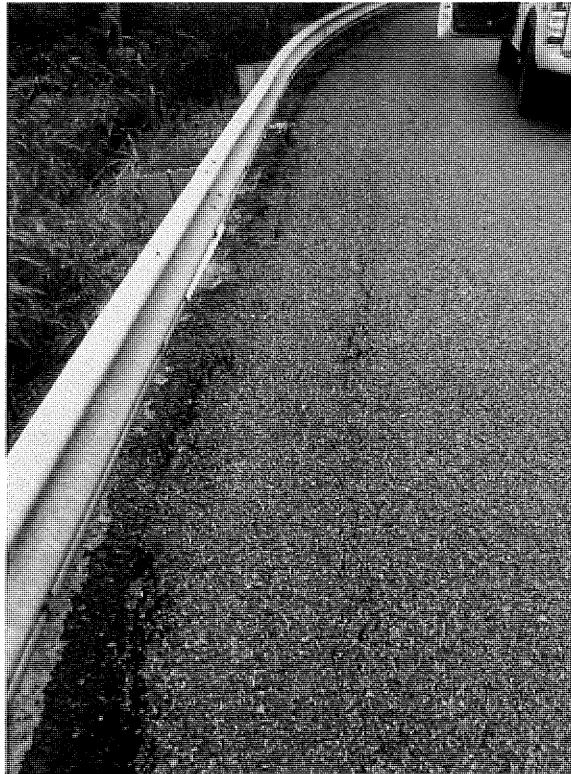
Figure 15: Tension crack and tilted guard rail located approximately 100 m north of the security building (Location 1).

Cracks at Location 1 appeared to be recently dilated, and it is recommended that they are sealed with tar or grout slurry (with care) to prevent water penetration and hydraulic jacking along the crack (Figure 15).

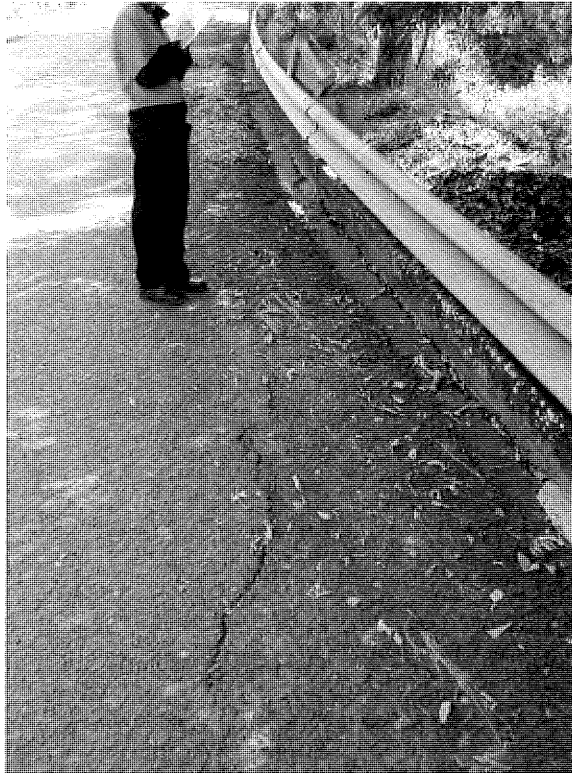
Cracks at Location 2 were dilated approximately 10 mm and as they were filled with soil and debris it was difficult to determine their age (Figure 16).

Figure 16: In filled tension crack at Location 2

All tension cracks should be monitored using crack indicators such as paint. An elongate rectangular stencil is recommended.

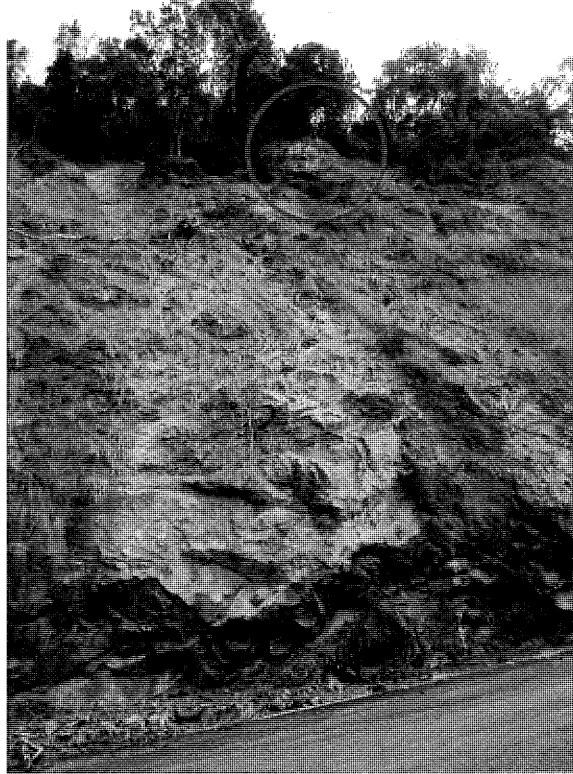
A number of large boulders (2.0 x 1.5 x 1.0 m and 0.5 x 1.0 x 1.5 m) were observed to have fallen onto the access road and at least one other large boulder (inaccessible during the site inspection) appeared to be at risk of future failure (Figure 17). Mitigation options to remove this threat are limited and the best solution may be to remove the boulder using a controlled blast, possibly using detonation cord to first reduce the size of the boulder so it can then be barred down or removed. A licensed blasting contractor should be consulted to discuss removal options.

Figure 17: Large boulder located upslope of the access road.

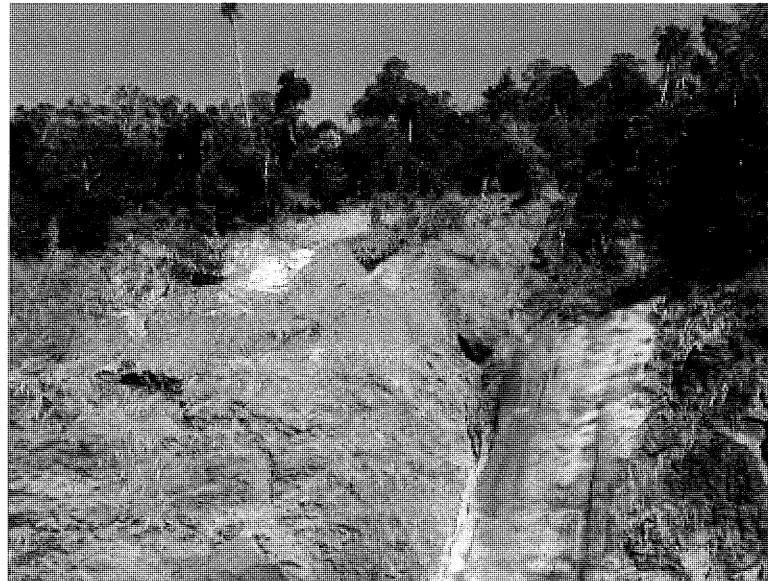
Figure 18: Accumulated material present on bench.

Along the access road it is generally recommended to re-instate pre-existing benches and berms as soon as possible as these features mitigate some of the impacts of upslope failures by acting as catch benches. It is possible, however, that accumulated material, deposited during the last extreme weather event, will be transported to the roadway during subsequent weather events unless removed (Figure 18). The accumulated material also loads the slope below, affecting stability.

A cement/concrete lined crest drain should be constructed along the crest of the slope to divert surface flow around the excavated area.

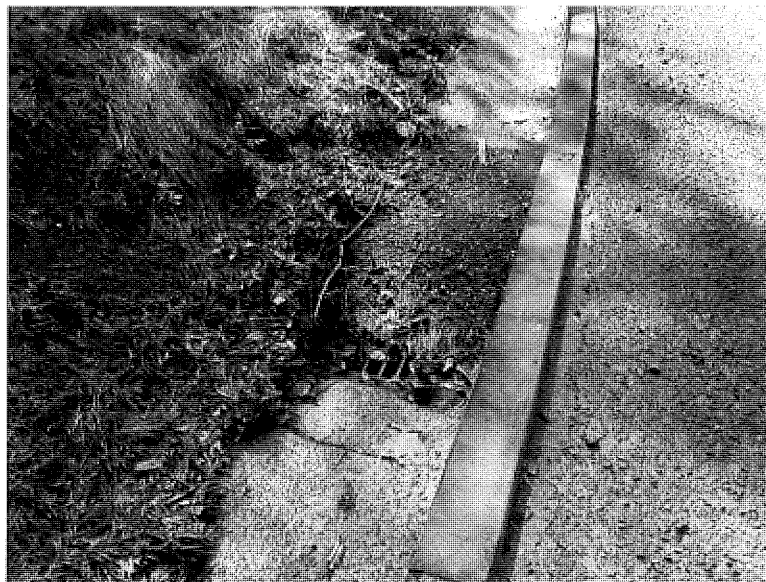
Figure 19: Partially blocked cross drain, located along access road.

Culverts and blocked drains should be cleared (Figure 19).

It is recommended that large drains cross-cutting the access road be considered at key points. Such drains would reduce the flow that would otherwise be discharged in the area of the power station car park.

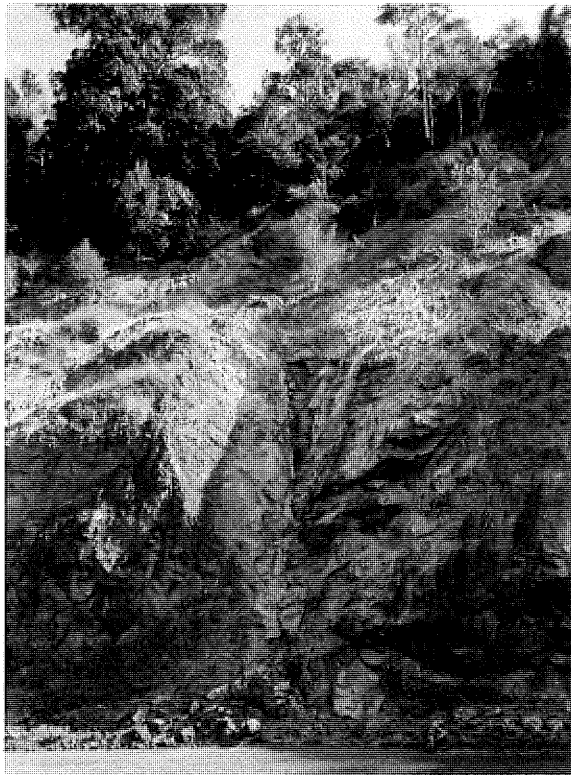
Figure 20: Preferred discharge zone, eroding weak rock along intersecting joints.

Shotcrete or conventional reinforced concrete should be considered to protect susceptible erosion areas such as those shown in Figure 20.
