Statement of Ian WHITEHEAD

QUEENSLAND FLOODS COMMISSION OF INQUIRY

STATEMENT OF IAN WHITEHEAD

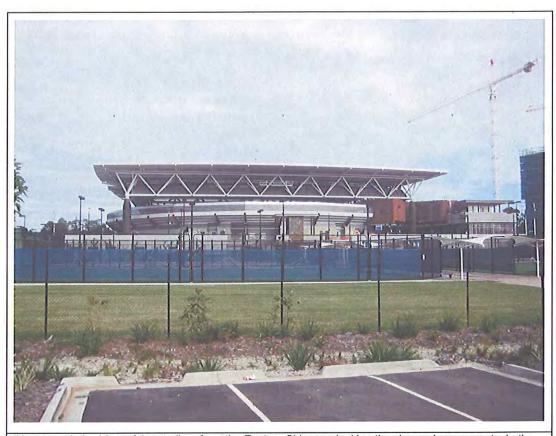
Photograph 1. View of the stadium from the Eastern Side over looking the clay and grass courts. In the back ground are residential construction works

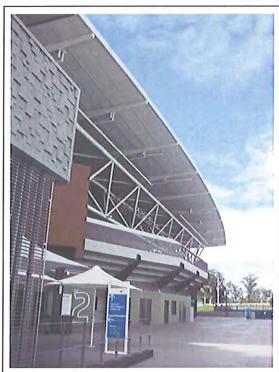
Photograph 2. Western End of the main grandstand

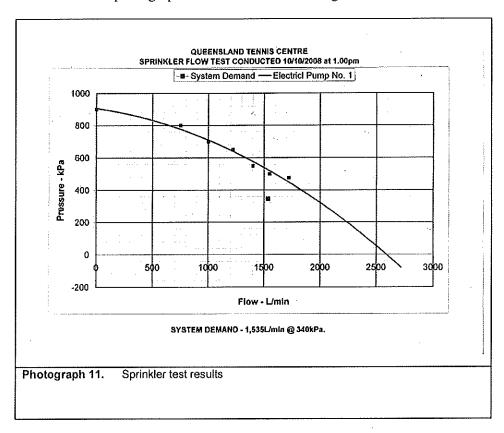
The static pressure in the line was noted as being 560kPa at the time of the survey.

Please refer to photograph 11 for the commissioning flow test results.

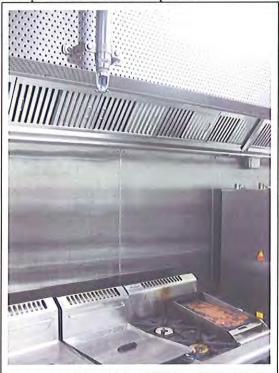
Photograph 12. Kitchen area on level three

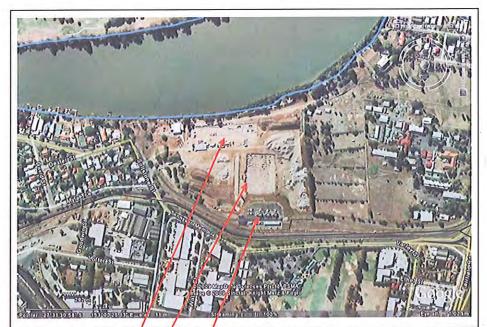
Photograph 20. Google Earth image of property prior to construction of venue

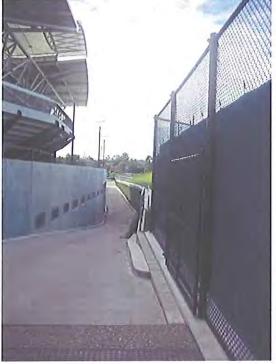
Photograph 21. South East corner driveway from an Eastern orientation

Photograph 22. Driveway view from the Western orientation
