IN THE MATTER OF
THE QUEENSLAND FLOODS COMMISSION OF INQUIRY

STATEMENT OF PETER WILLIAM CARE

The Dam Raising Project

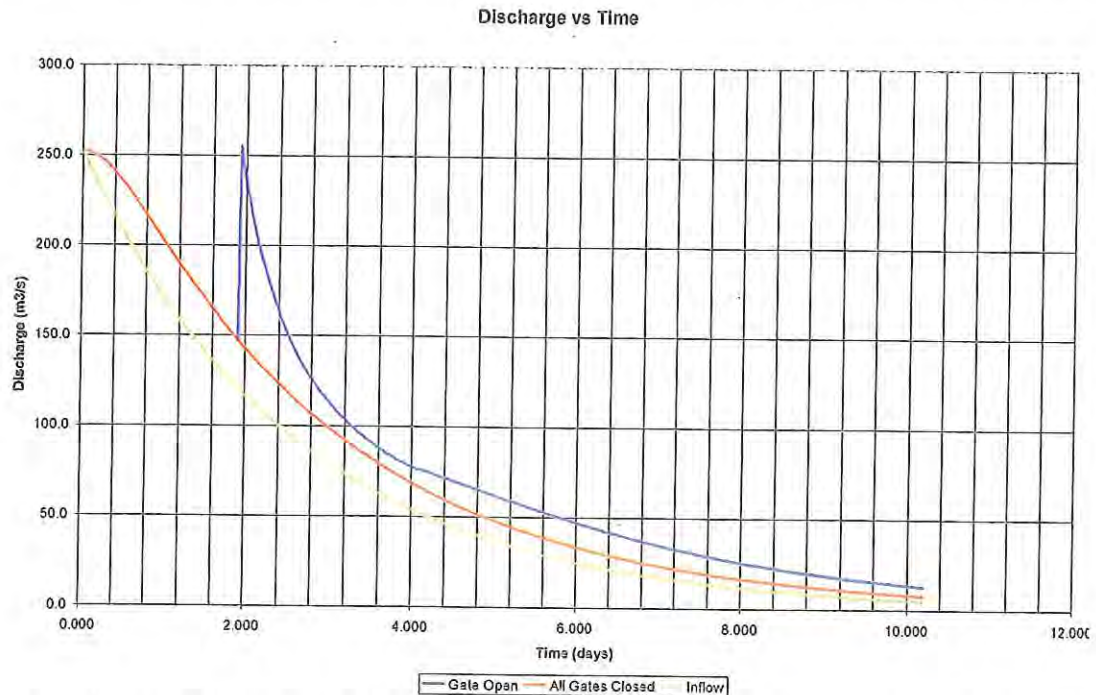
The need to open a single gate is driven by the urgency in getting the dam level back to or below the FSL of 26.0 RL, which alleviates the inundation upstream, and increases the ability of the reservoir to absorb new rainfall events and minimises the potential for increased downstream inundation in the event that the gates operate at a higher water level. Furthermore this will provide the opportunity for additional commissioning tests of the gates, particularly the measurement of the lintel seal compression directly through the downstream lintel cover plates.
