IN THE MATTER OF
THE QUEENSLAND FLOODS COMMISSION OF INQUIRY 2011

SECOND SUPPLEMENTARY STATEMENT OF BARTON JEFFERAY MAHER

Brief description of the nature of cracking at Somerset Dam

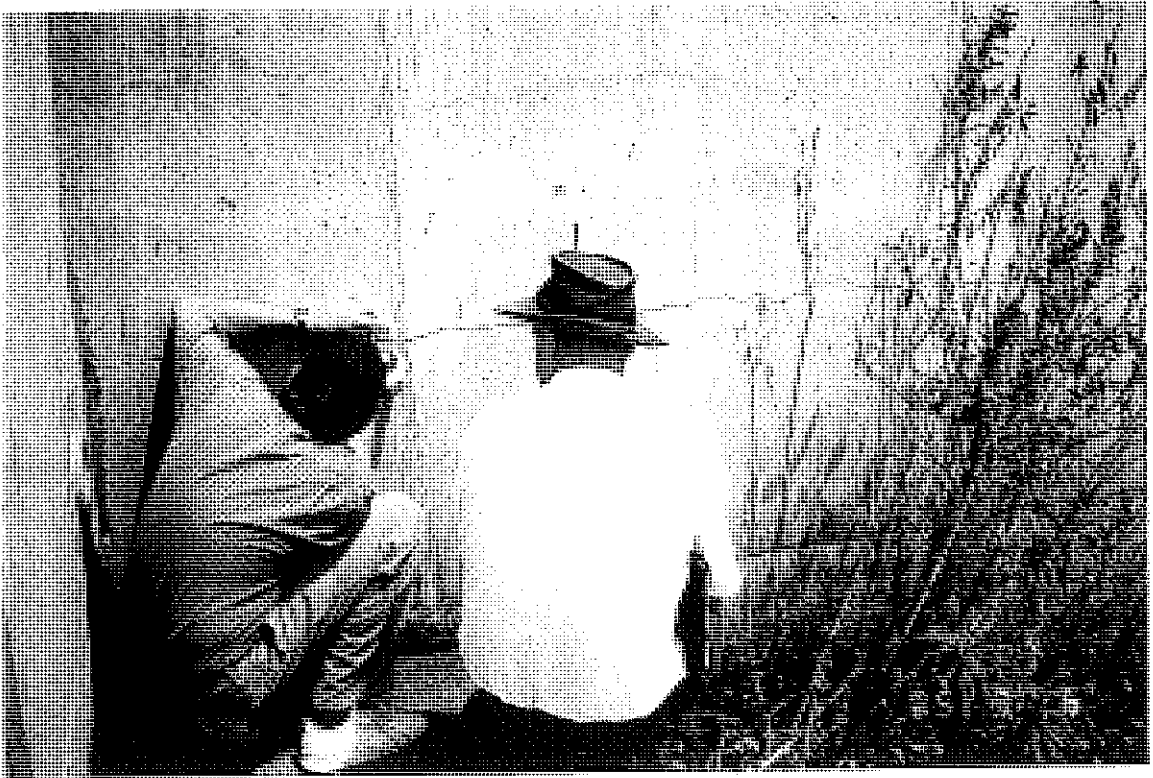
Upstream Face of Dam on Left Abutment - crack about 0.5 m above FSL - approximately 0.5 mm to 1 mm wide.

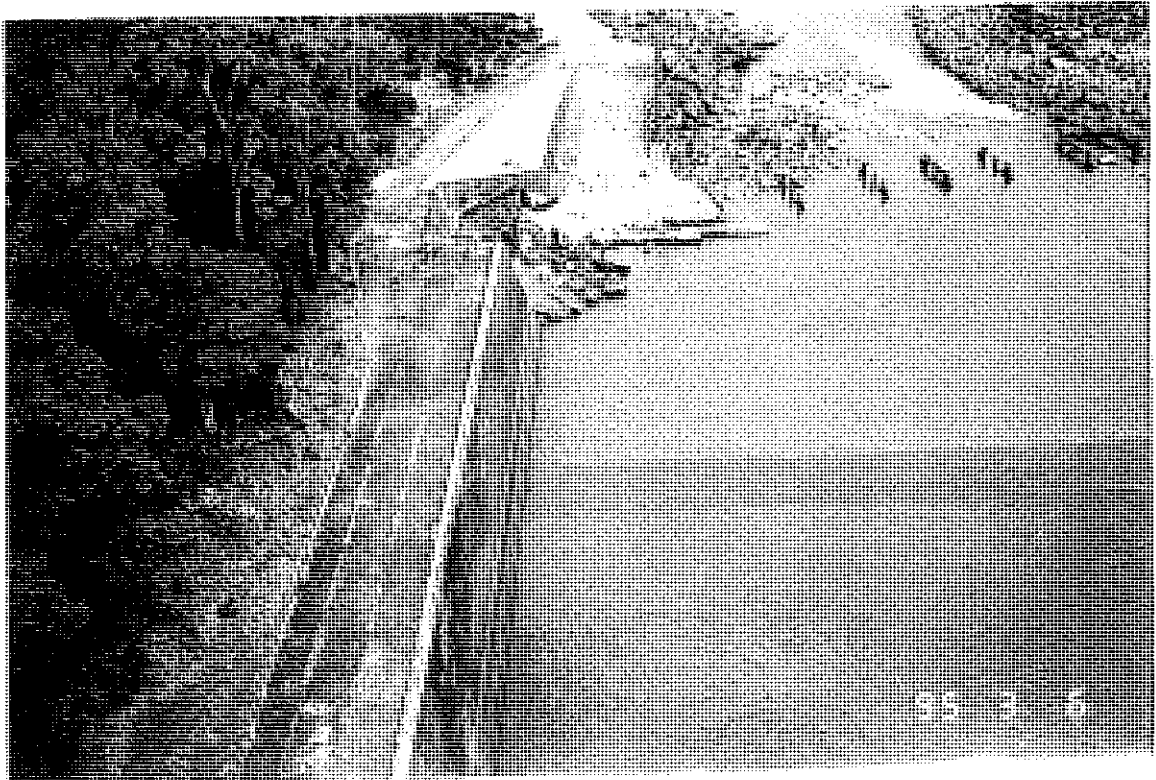
Left Abutment Stilling Basin Wall - Note backfill to full height, no weep holes, grass growing in joints on top sealing slab.

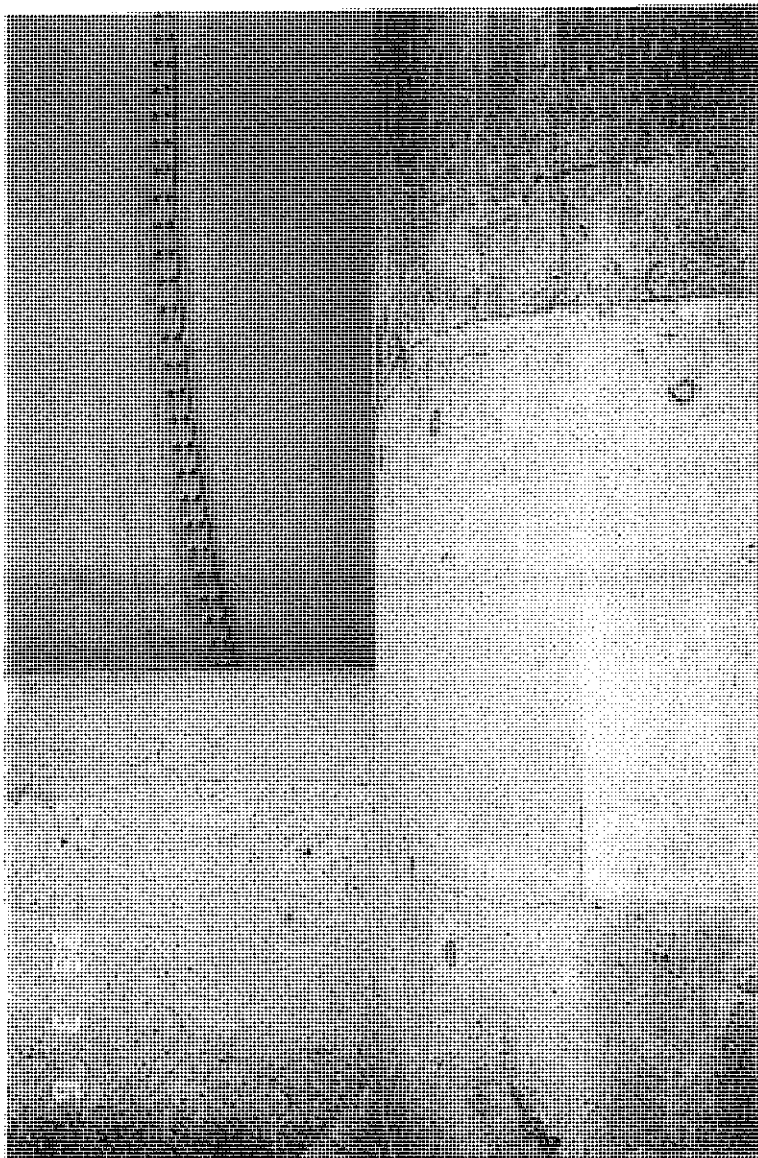
Right Hand Side of Spillway, Note cracking in joint between pours.

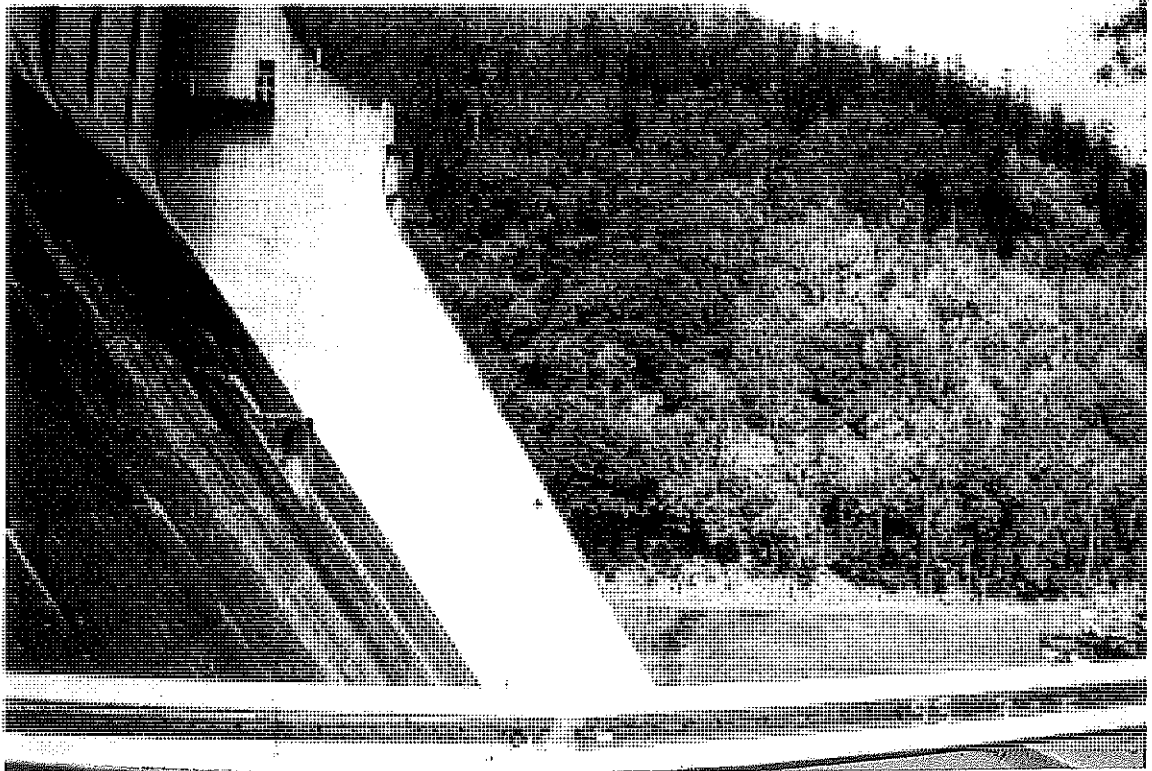
Downstream Face of Dam - Note calcite staining along construction joints.

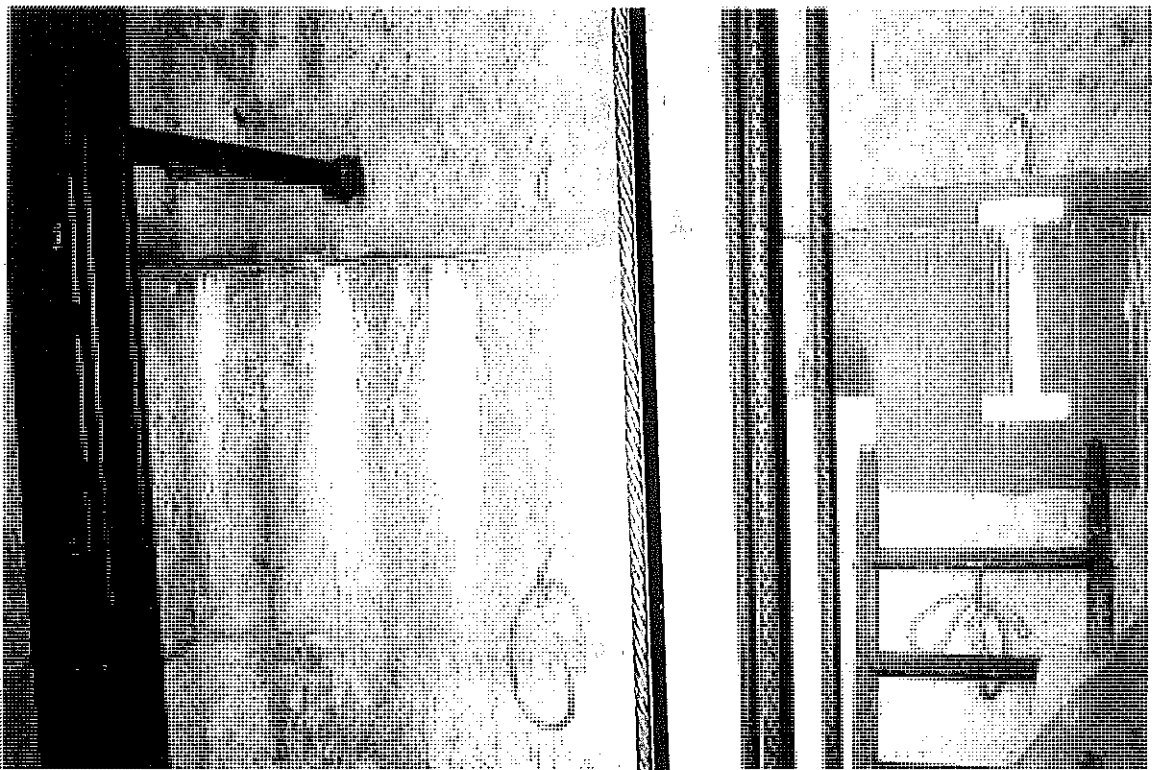
Sluice Shaft Construction Joint in Monolith I about 3 m above upper gallery level (approximately RL 91.5). A crack in the upstream face of the dam was noted at RL 95.3 in Monoliths F, S and R.

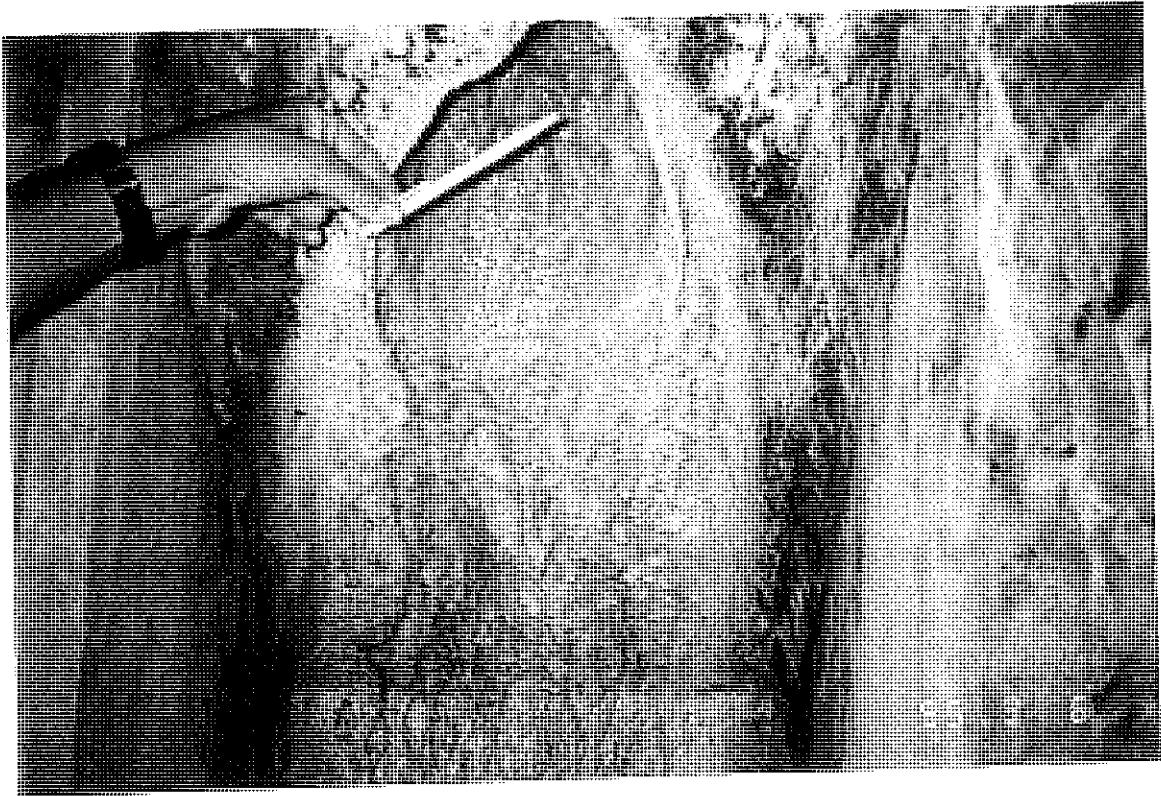
Contraction Joint Drain in Monolith S lower gallery - Note that in 1977 a horizontal crack was found in the upstream face of the dam at about RL 97.2.

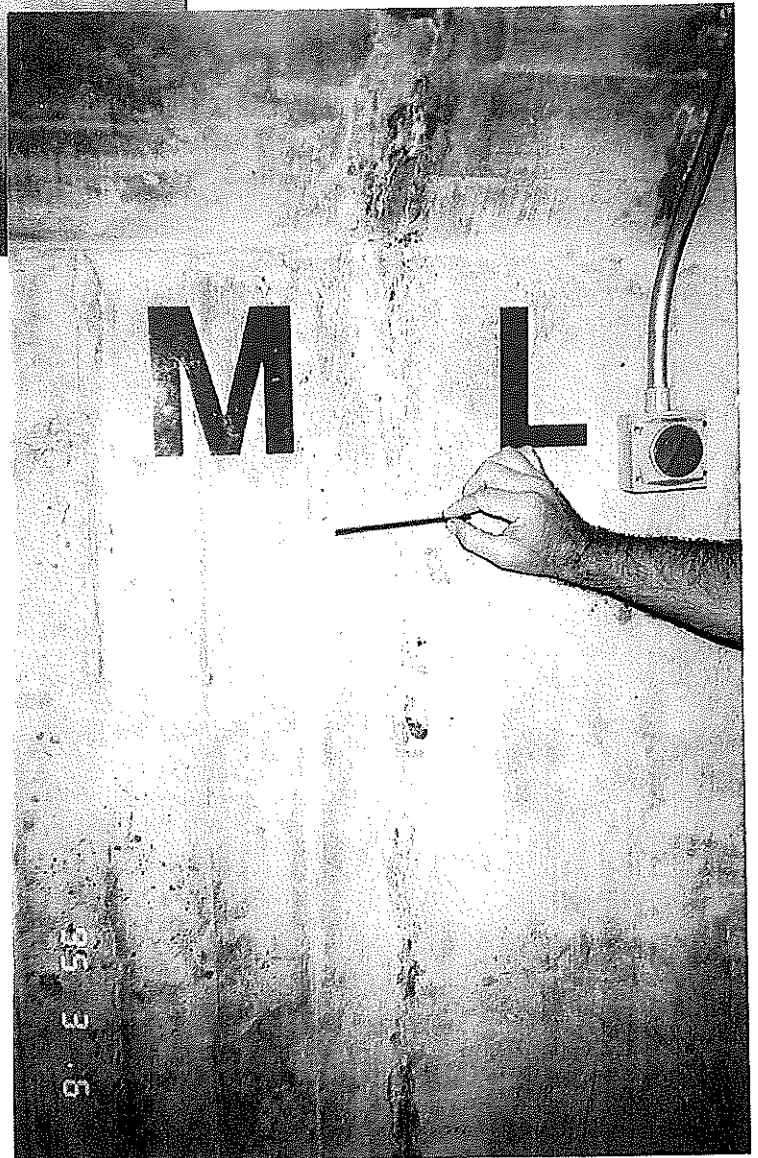
Downstream face of joint between Monoliths I and J in lower gallery. Seepage from downstream face indicates drains not acting to completely stop seepage.

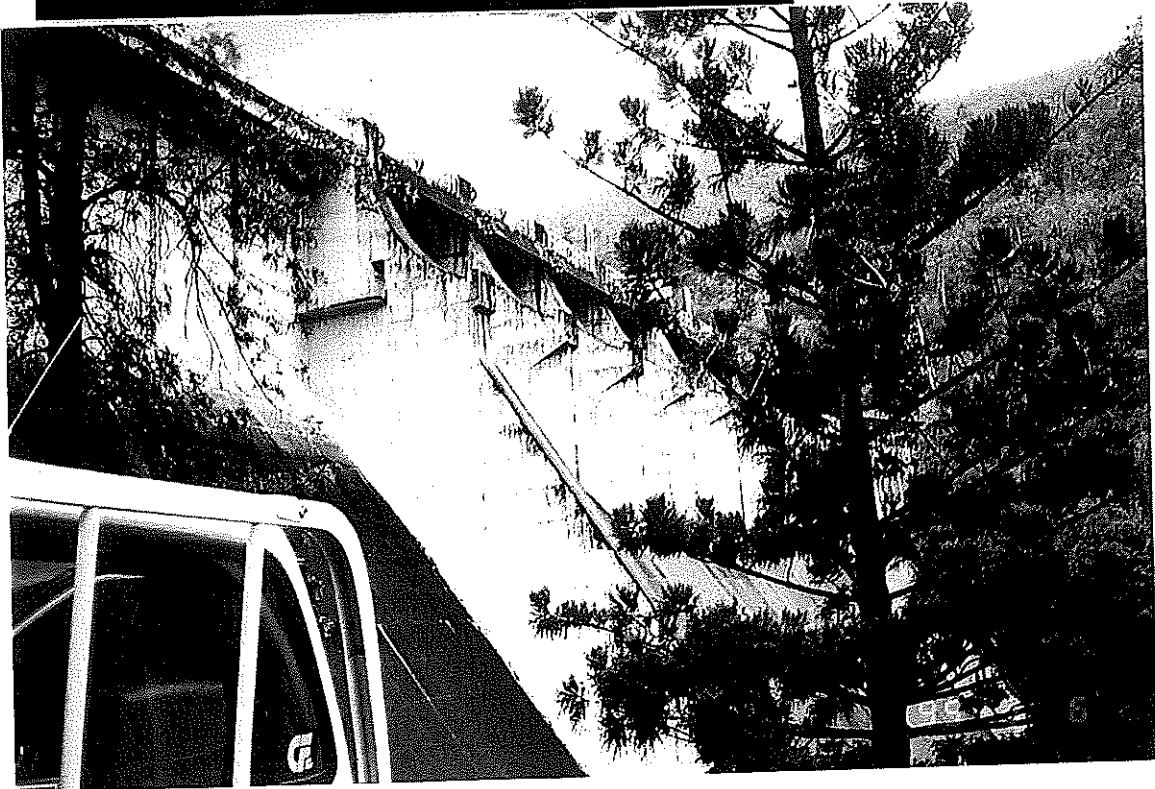
Downstream Face at Dam - Note staining on gate piers.

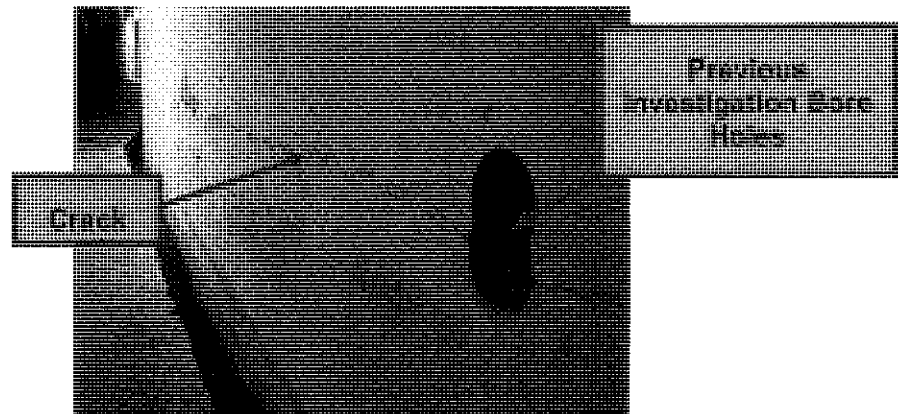
Figure 2. Crack in Upper Gallery – Somerset Dam

Previous investigation saw a limited number of cores being taken from within the gallery along the line of the cracks. These cores were drilled horizontally from within the gallery and limited to a depth of approximately 1 to 2 metres and provided a limited degree of information in respect to the cracking.

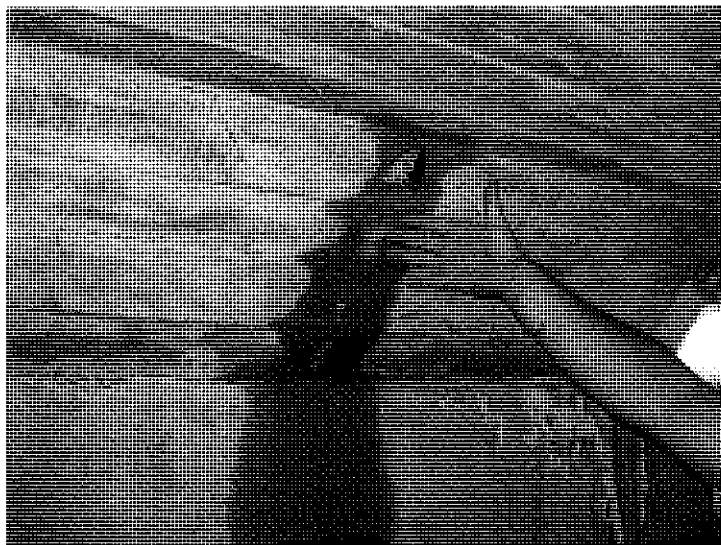
Photo 3. Photo showing CHEA1 intercepting upper observation gallery

Holes CHTA1 and CHEA2 both intercepted the upper observation gallery at identical positions (top corner of the downstream gallery wall). Drilling was ceased immediately and gallery inspected for any damage and drill cuttings.

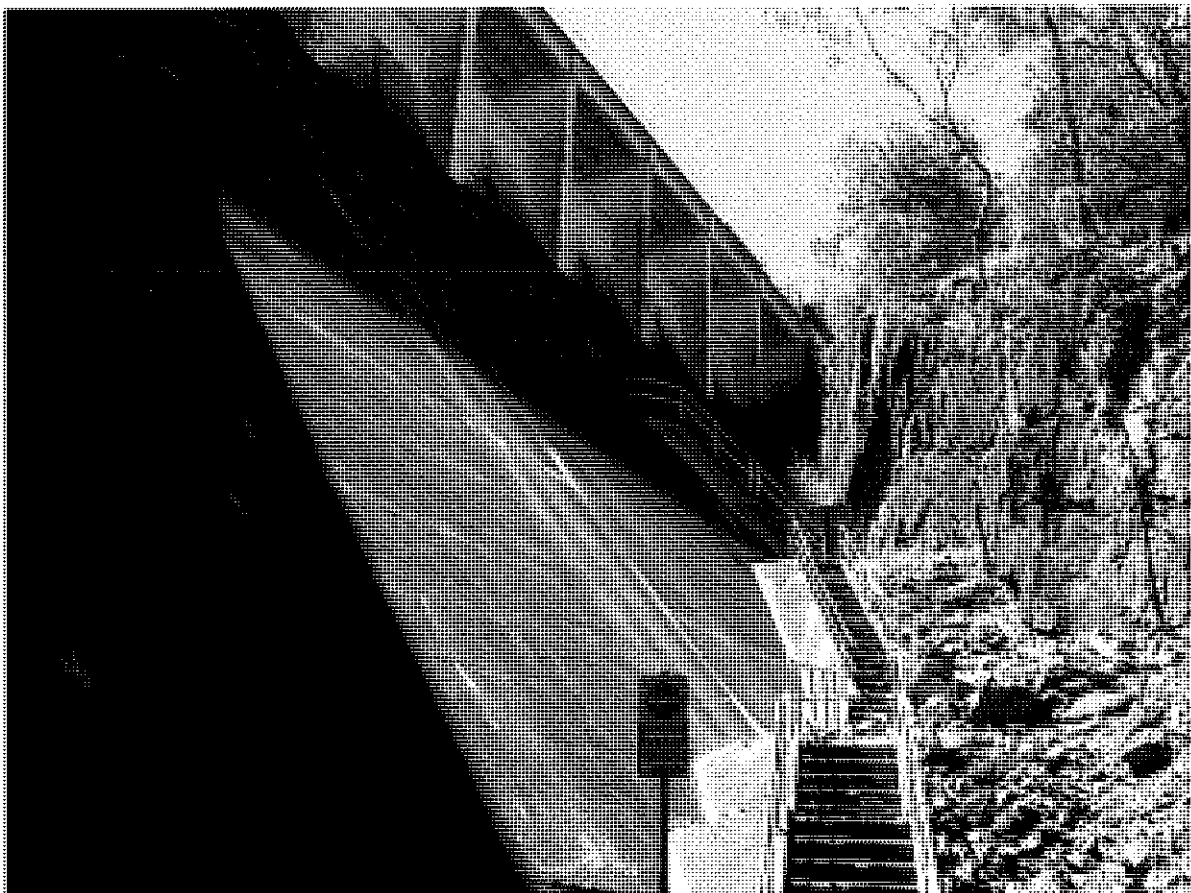
The concrete embankment was inspected and was found generally to be in good condition. Some vegetation was observed growing on the embankment and within five metres of the embankment abutments that should be removed. This aspect of the embankment is certainly improved since the 2008 inspection, with several large trees removed from the right bank.

Trees and Vegetation to be removed beside embankment abutments

- ***Vegetation growing on the embankment is to be removed and/or sprayed with a suitable herbicide. This includes the trees growing within five metres of the abutments.***

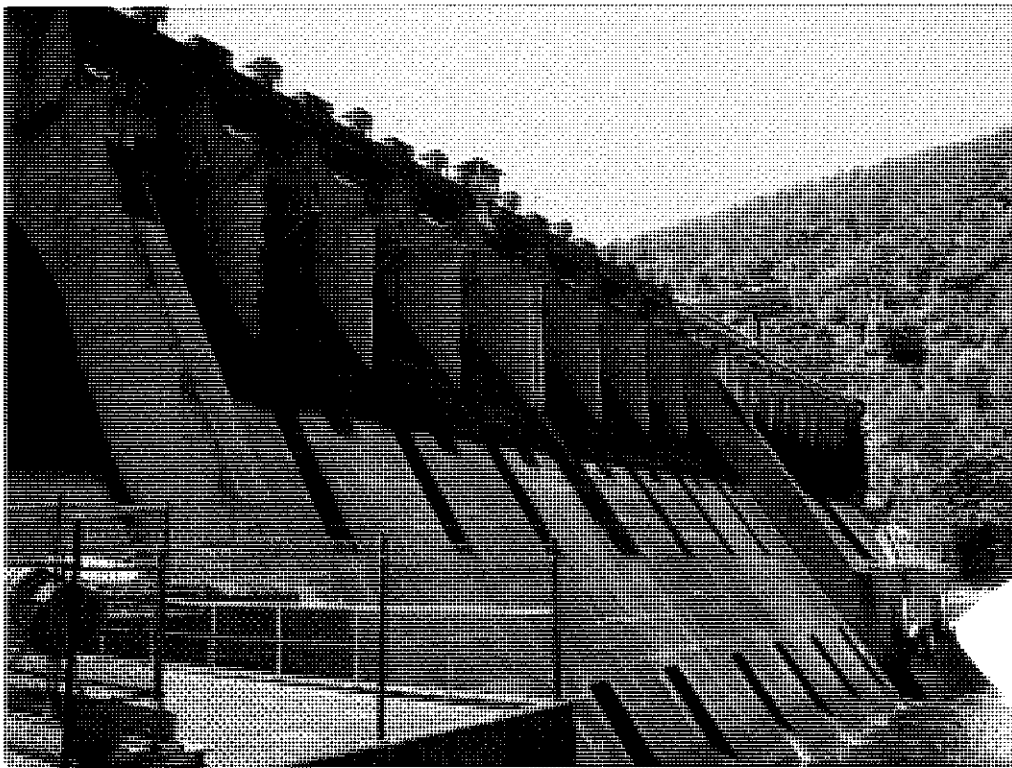
Spillway

The spillway and associated gates, hoisting gear and emergency coaster gate looked to be in good condition, with only some minor issues identified. Undertaking regular routine maintenance in accordance with the dam Operation and Maintenance Manuals appears to be producing good results and it is important that this program is continued. However, it was noted that the electrical condition monitoring program seems to have been discontinued and this is of concern. Replacement of the Radial gate counter weight buffers remains outstanding from the 2008 inspection.
