Lenthalls Dam (QLD), Dam Gate Failure to Operate as Designed Increased Flood Risk, gates faulty since 2007 inaction by State Government / Local Government and Wide Bay Water Corporation (WBWC).

LENTHALS DAM GATES FAILURE 2008 – A CASE STUDY IN GATE RELIABILITY AND HUMAN FACTORS, FAILURE TO IMPLEMENT RISK MANAGEMENT PROCEDURE.

PROJECT
ALLAN FARM HOUSE
 ASSESSMENT OF INCREASED FLOOD HAZARDS AND RISKS
 LENTHALLS DAM, DOONGUL CREEK
 CROSS SECTION OF FLOOD HEIGHTS

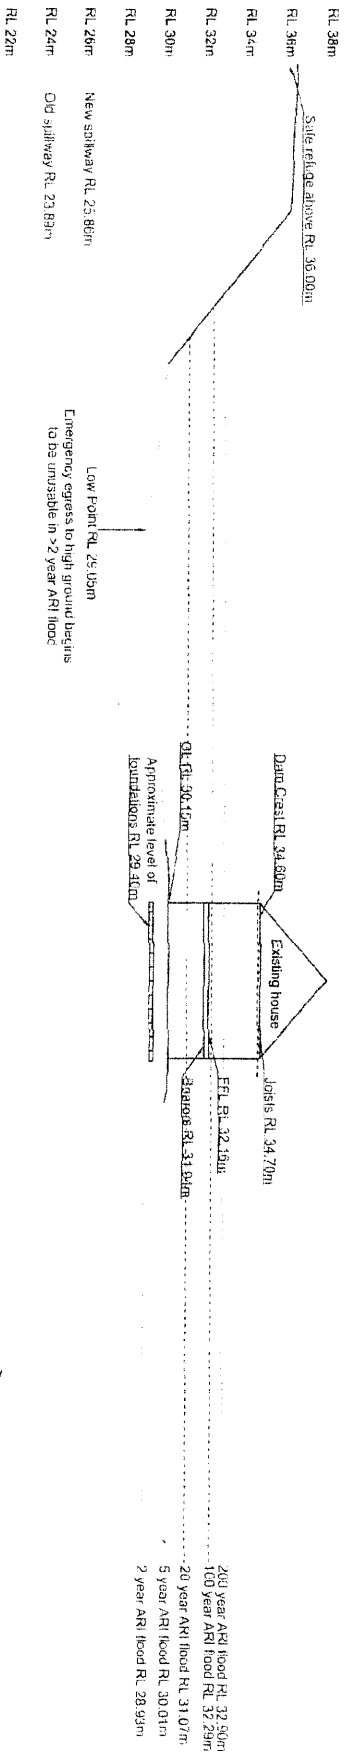
Case 4 - Post dam, spillway at RL 26.00m*, all spillway gates fail

The affect of the Lenthals Dam Gate failure was upstream flooding (to higher levels than recorded at the impoundment wall), roads were cut off and water rose around the residence where 3 individuals were stranded. The flood level 1.4m over the seized gates was higher than modelling for previous incidents recorded in the EAP but not much lower than publicly documented historical flood incidents.

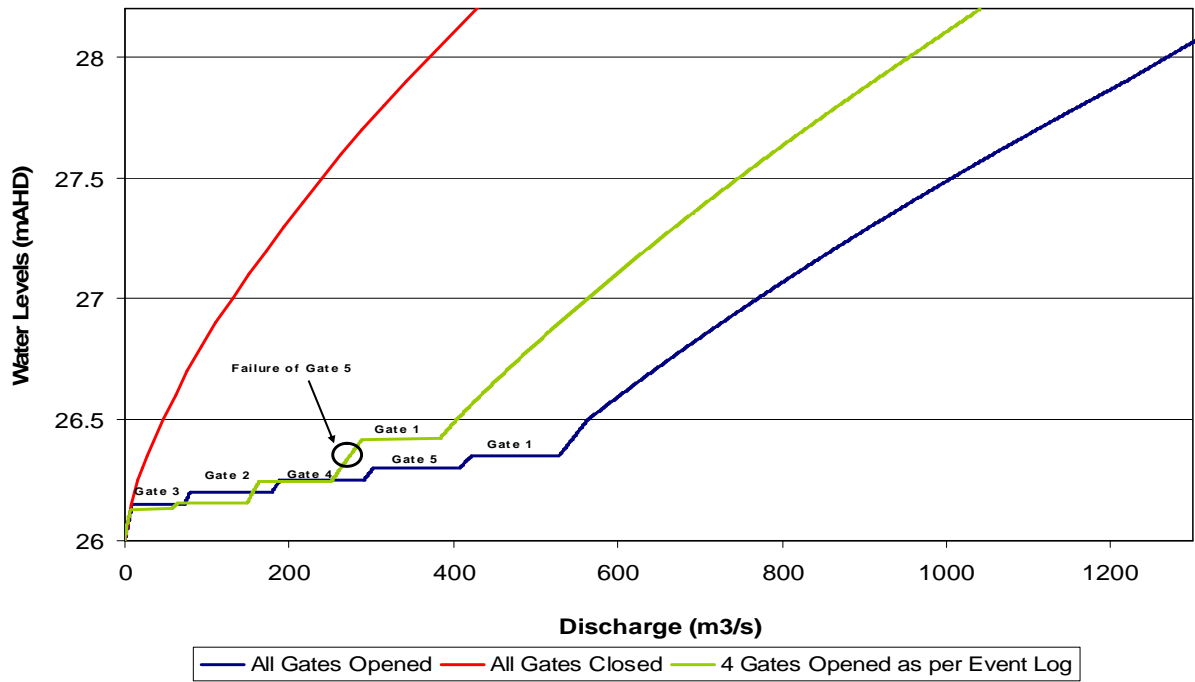
Figure 3-4: Discharge Curves for Lenthalls Dam with 5 Crest Gates Fully Opened, 5 Gates Fully Closed, and 4 of 5 Gates Opened

Figure 3-4 effectively shows a new discharge curve with only four of the five gates working (Gate 5 reportedly did not function). As expected, the new discharge curve lies between that for all five of the gates closed and all five of the gates opened.

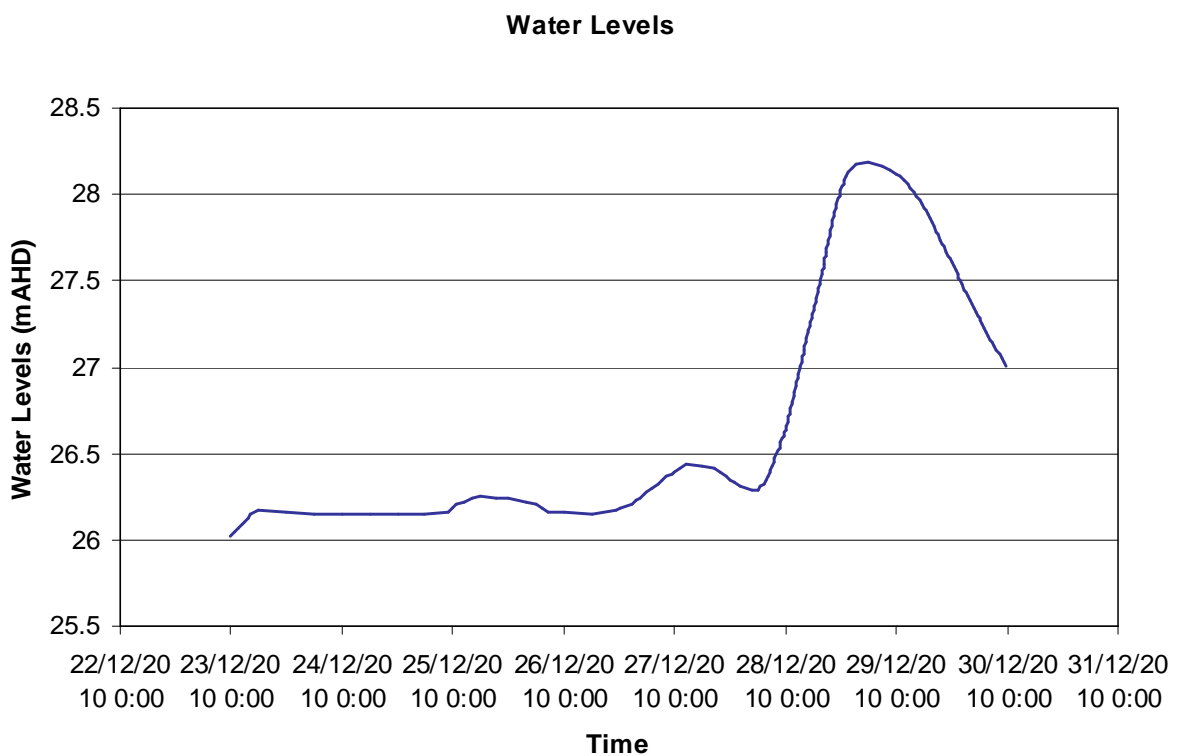
Figure 3-5: Water Level Data Recorded at Lenthalls Dam for December 2010 Storm Event

Based on Figures 3-5 and 3-6, the recorded peak water level at Lenthalls Dam was 28.183 m AHD (6 pm, 28 December), while that at Howard Alert was 7.42 m AHD (2 pm, 28 December).

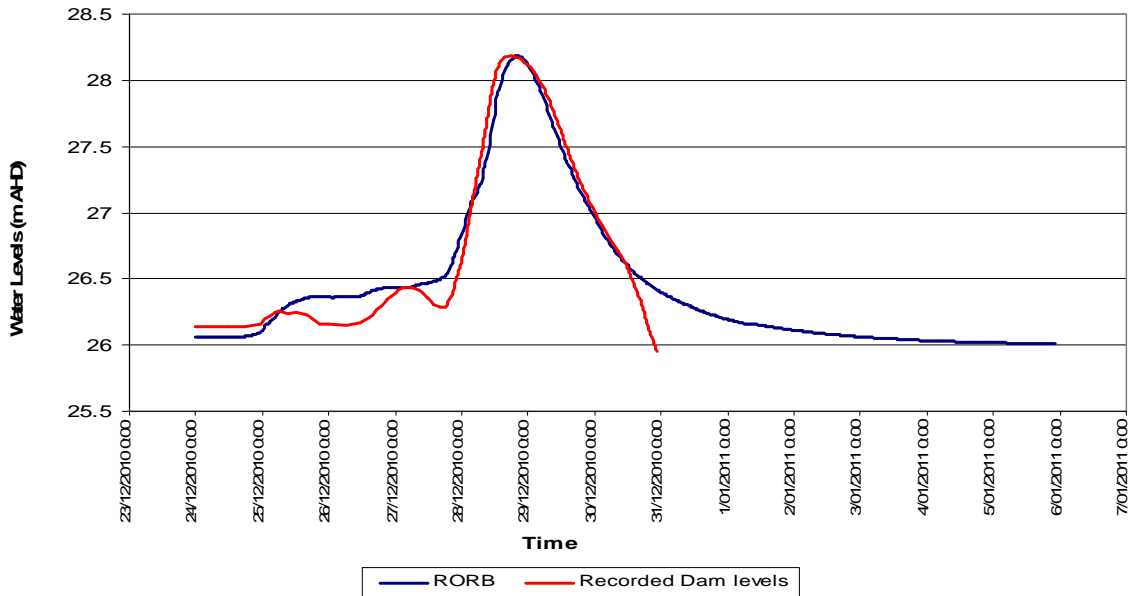
Figure 4-4: Scenario 2D (All Gates Closed) Dam Outflow Hydrographs

The results, presented in Table 4-1, are rather surprising. Essentially, they showed that the recorded peak water level in the dam of 28.18 m AHD could not possibly be reached using the Event Log. This was the case for the full range of model parameters tested, including the use of impractical parameters. Example plots for RUN 3A and RUN 3E are shown in Figure 4-5 and Figure 4-6. In these two runs, the peak RORB model levels are between 0.6 to 1.2m lower than the recorded peak dam level.

This raises the possibility that all the gates had somehow failed to open during the peak of the storm, which would be consistent with the results for Scenario 2.

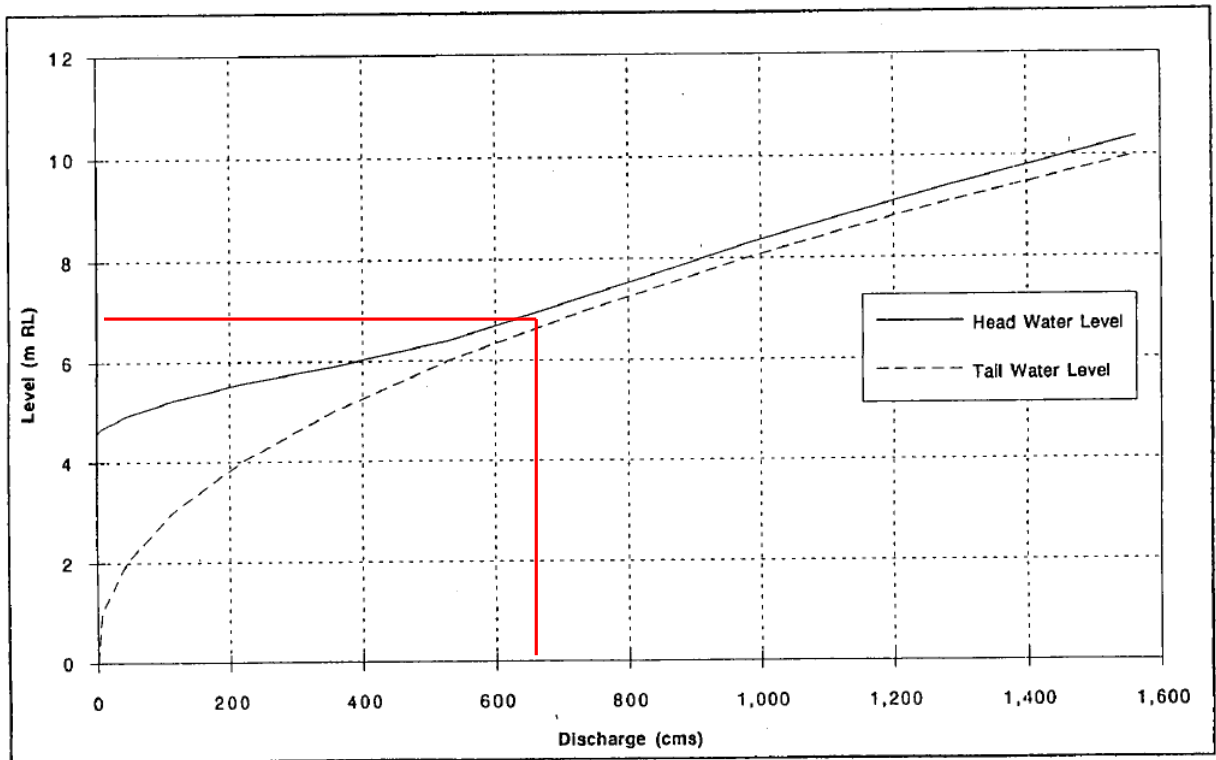
Figure 4-7: Rating Curve for Howard Alert (Burrum No 1 Dam)

because the corresponding discharge from Lenthalls Dam alone would have exceeded that flow. However, the results are entirely consistent if the gates were all closed. In this case, the estimated total discharge of 566 m³/s at Howard Alert compare favourably with the recorded discharge of 650 m³/s.

On the basis of the above results, it is concluded that the Lenthalls Dam gates were most probably closed during the peak of the December 2010 event.

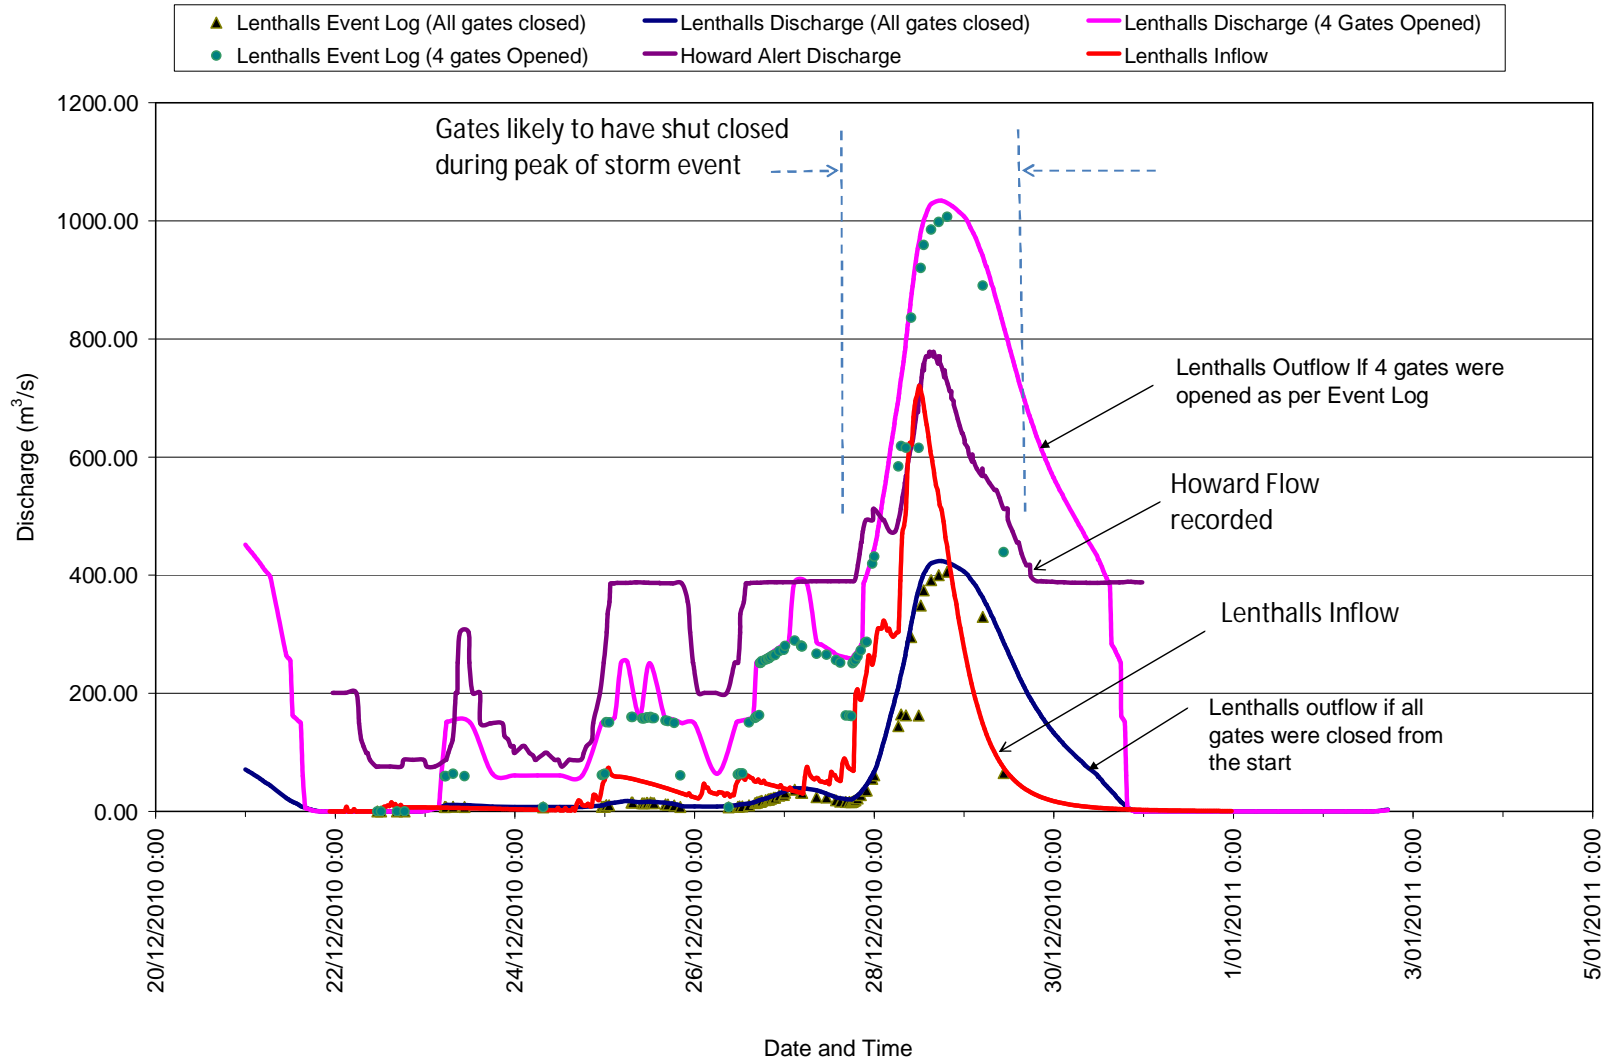
Figure 4-8: Analysis of Lenthalls Dam Gate Malfunction

Taking into account the December 2010 storm event, it is considered that the design flood levels established in the 2009 Report for the watercourses upstream of Lenthalls Dam are still relevant, appropriate and would remain unchanged. In essence, the December 2010 event was a relatively small event, and the unexpected high water levels in the dam was attributed to the failure of the crest gates.
