# Queensland Floods Commission of Inquiry

**STATEMENT OF PETER HUGH ALLEN**

## WIVENHOE DAM

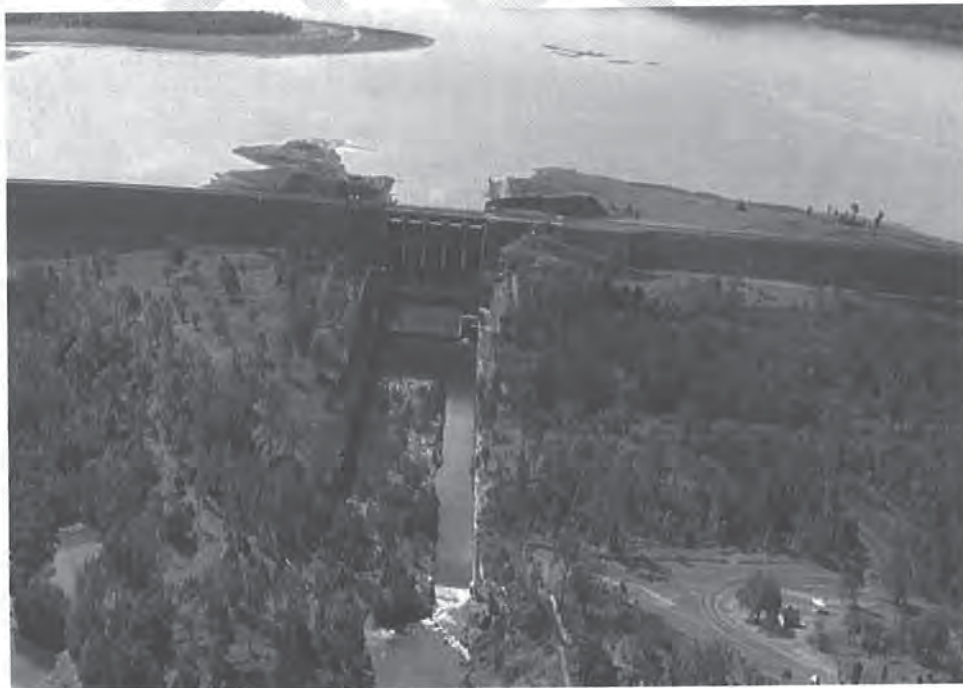
**Photo 1- Wivenhoe Outlet Channel and Spillway Prior to January 2011 Flood**

The spillway lookout recreational area had erosion cut down to the underlying rock material, leaving behind near vertical soil slopes up to 3 metres high, as well as damage to the bitumen roads and parking lots. The following photos are representative before and after shots of the January 2011 flood.

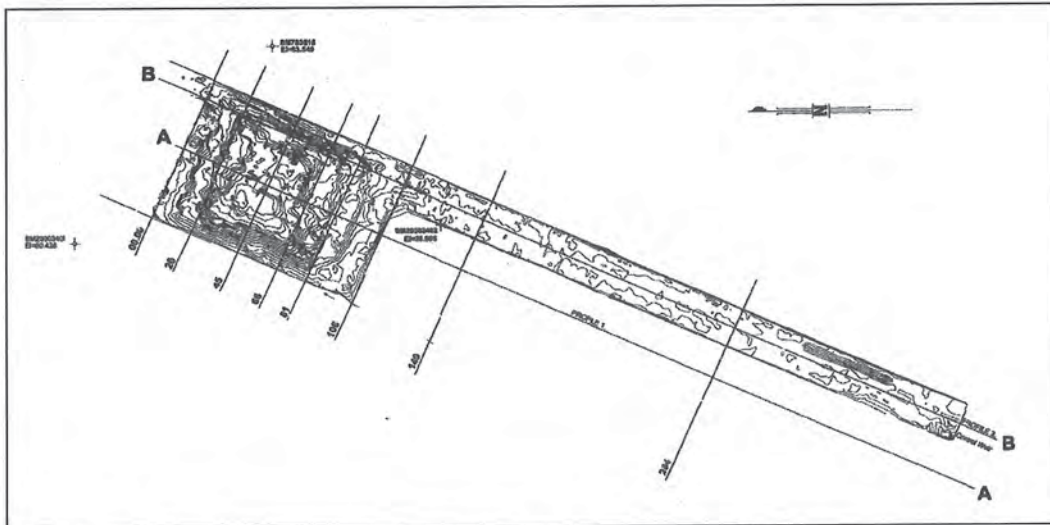
Figure 3 - Survey of Wivenhoe Outlet Channel and Spillway Post January 2011 Flood

It can be seen from cross section A-A in Figure 4 (left to right represents upstream to downstream) that the majority of material removed from the base of the plunge pool was located at the downstream side of the excavation. The plunge pool depth was decreased to a depth of EL14m and up to 10m of rock was removed from areas of the spillway structure. However, it should be noted that there was minimal head cutting of the upstream side of the plunge pool.

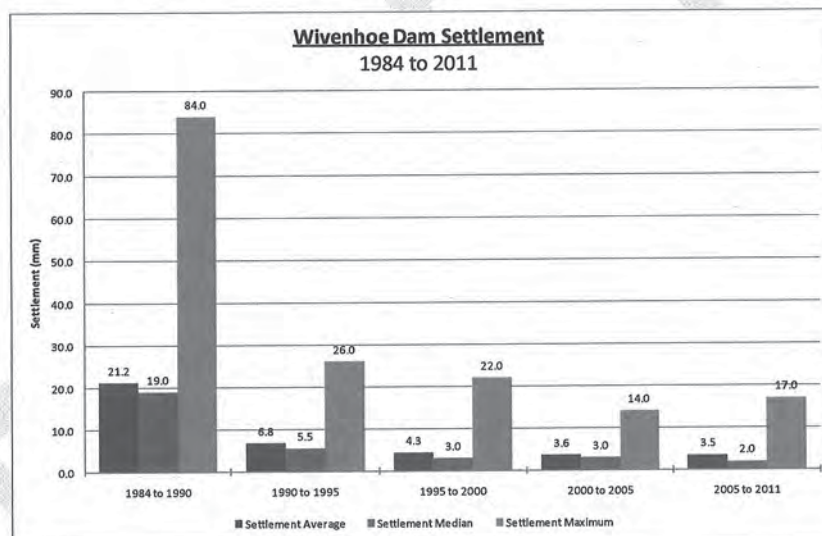
Figure 5 - Wivenhoe Dam Settlement Relative to the Time Interval

Deformation surveys are undertaken annually at Wivenhoe Dam. The last survey was undertaken after the January 2011 flood and is contained in Appendix B. Following a review of the movements, no values could be found that are cause for any immediate concern. The deformation at this dam is lower than expected for an embankment dam of 56 m in height. The rate of deformation has slowed and has stayed relatively consistent since the end of construction. Annualized summarization of settlement and displacement in relation to the specified time interval for all of the Wivenhoe Dam Embankment Monuments are shown in Figure 5 and Figure 6.

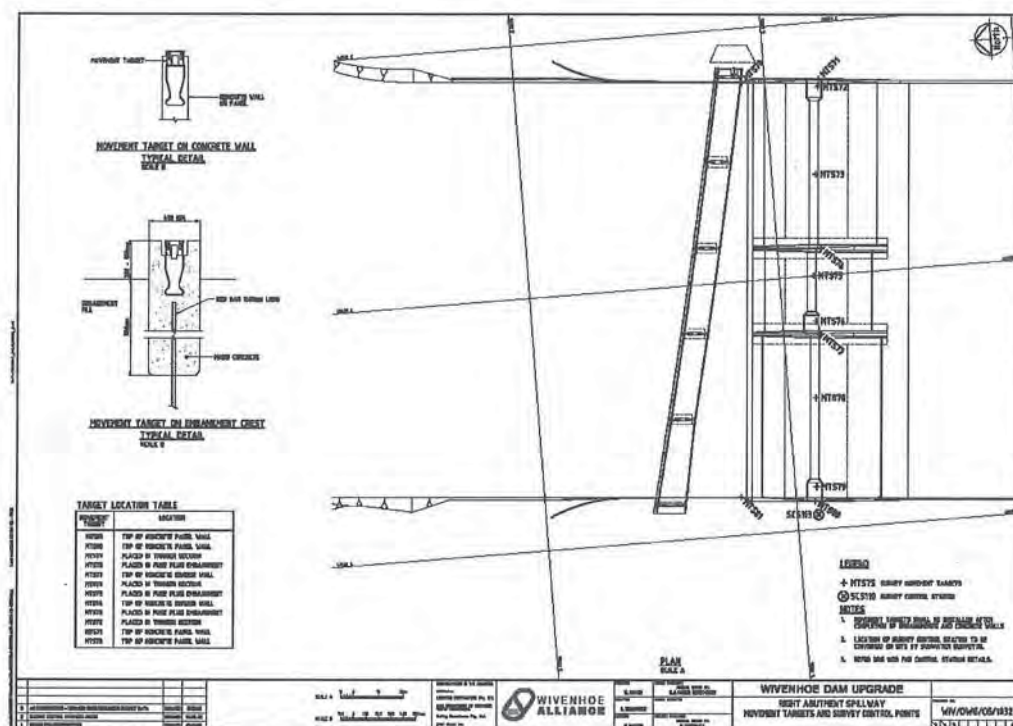
**Figure 14 - Location of monuments Analysed for the Fuse Plug**

Deformation surveys are undertaken annually at Wivenhoe Dam. The last survey was undertaken after the January 2011 flood. Following a review of the movements, no values could be found that are cause for any concern. The Wivenhoe Fuse Plugs are a bit over 5 years from construction. There is not a long enough track record to determine a rate of deformation with any consistency.

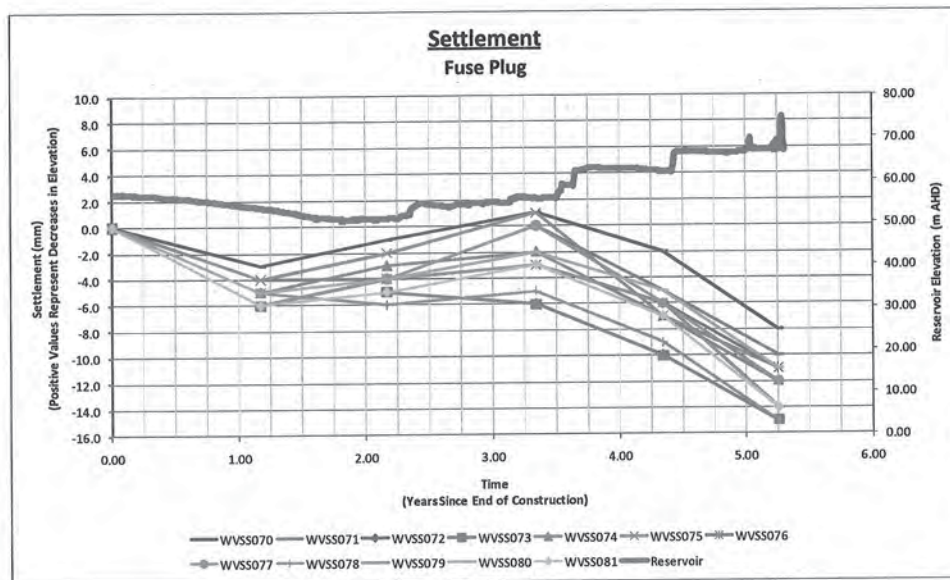
Figure 15 - Settlement of Monuments Analysed for Fuse Plug

Figure 15 presents the post construction deformation settlement versus time for the fuse plugs. The maximum value of settlement is 15 mm, with an average settlement of 5.8 mm. There is an issue to be investigated for the settlement of all the monuments, WVSSS070 through WVSSS081, that are located on or around the fuse plug. Within the last two plus years, there is a clear trend that the entire structure is gaining in elevation. It can be seen in the following Figure 15 that all the monuments are settling (or rising) at similar rates. A cross-section of the fuse plug design can be found in Appendix A.

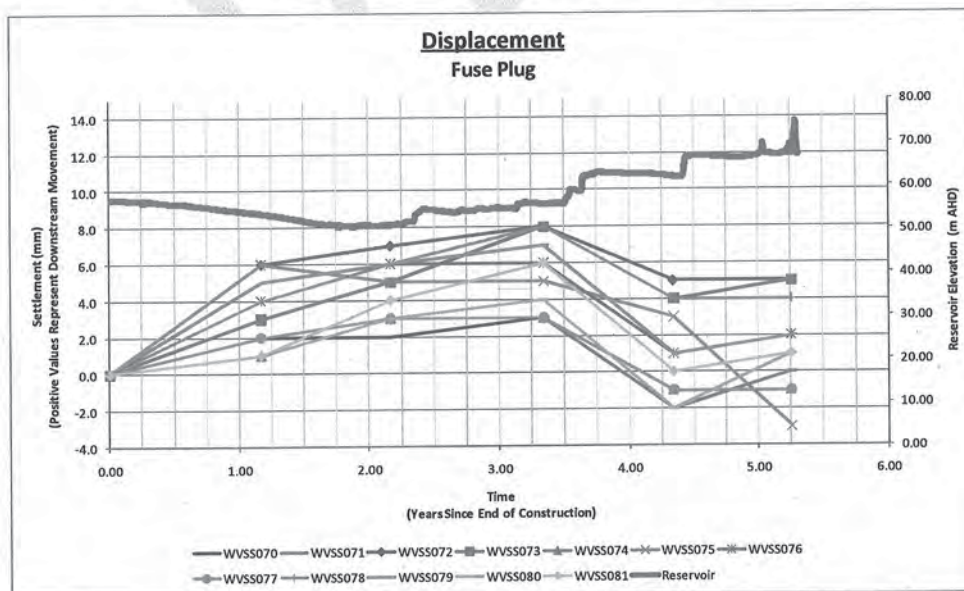
Figure 16 - Displacement of Monuments Analysed for Fuse Plug

Figure 16 presents the post construction deformation displacement versus time for the fuse plugs. The maximum value of displacement is 8 mm, with an average of 3.1 mm. With the exception of monument WVSS075, all the monuments are operating as expected. Monument WVSS075 is located in the embankment portion of the middle fuse plug and it should be noted that it has not been trending in line with the other monuments for the last year plus.

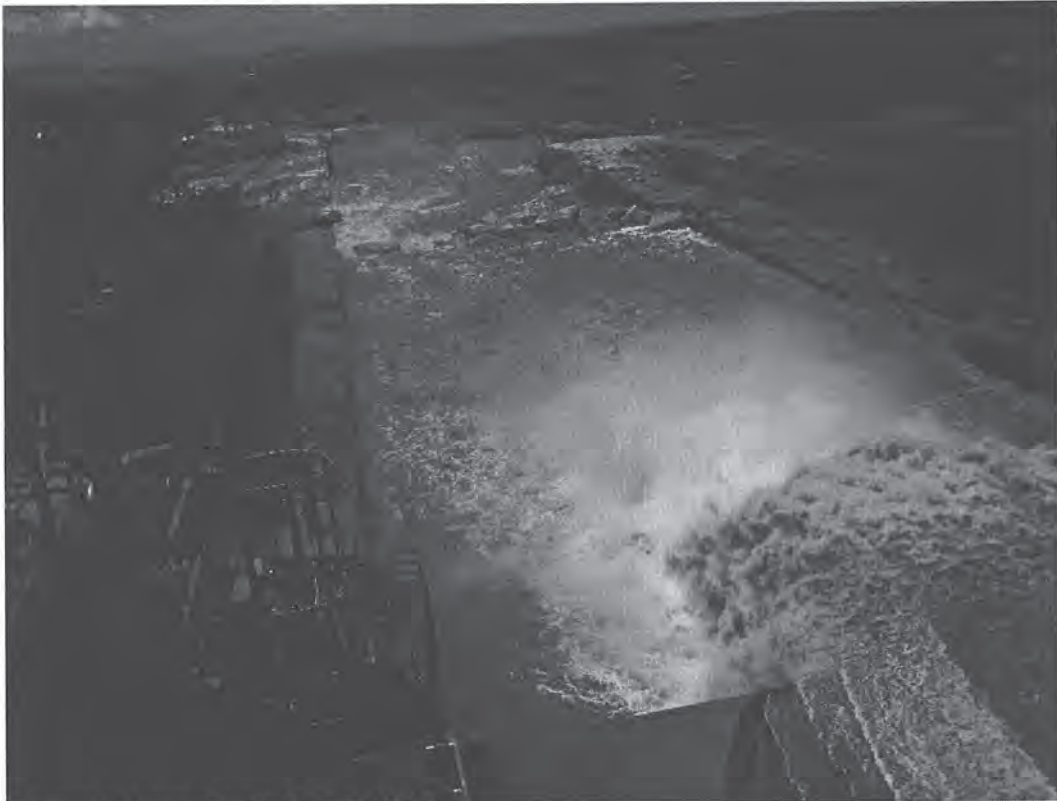
**Figure 1 Plunge Pool 10 am 19/1/2011**

As the tail water receded, a bank (Figure 1) of large blocks of sandstone rock emerged just downstream of the plunge pool. The bank was causing an afflux of about 4 meters.
