FAIRBAIRN DAM

EMERGENCY EVENT REPORT

10TH Sept 2010 to 1ST APR 2011

FAIRBAIRN DAM - EMERGENCY EVENT REPORT

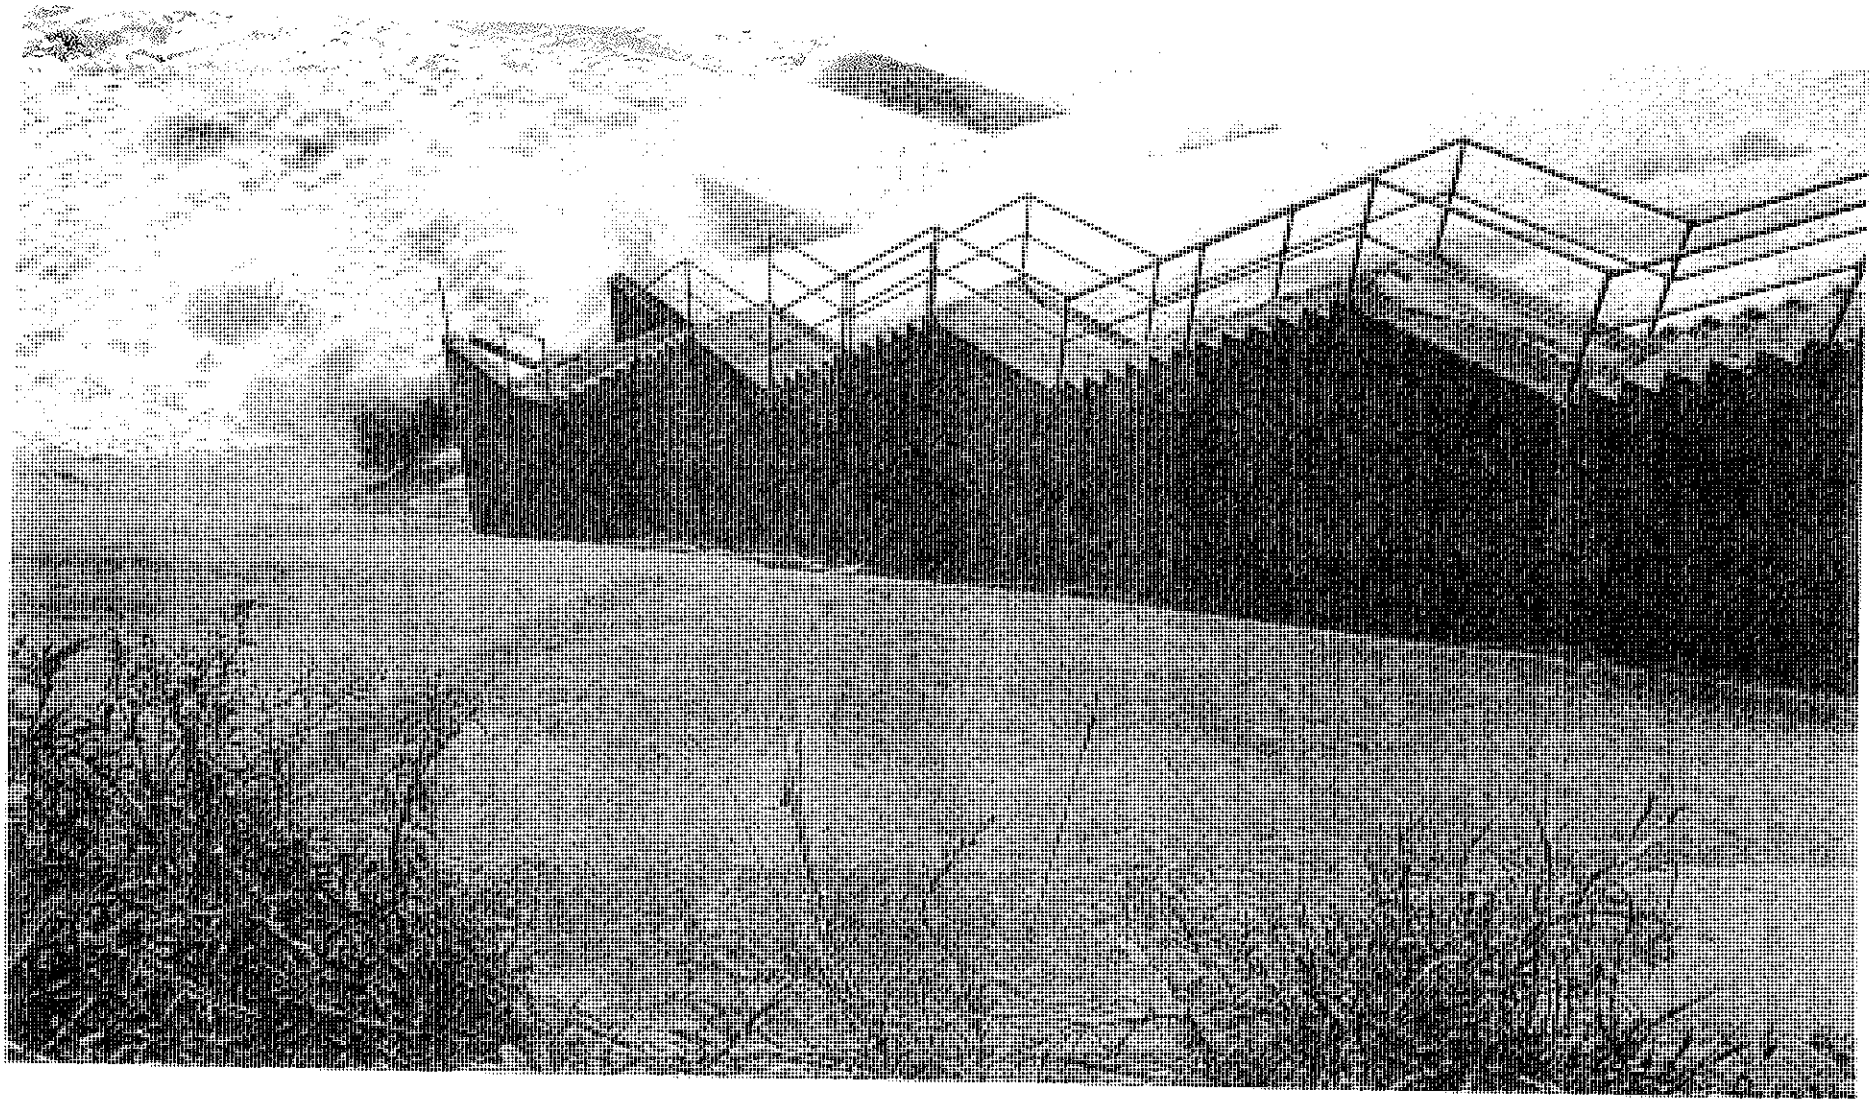
Some damage was sustained during the event and photos are included herewith. Left bank Siphon Actuator torn from mountings including deck and hand railing. Lower Piezometer pit flooded

View of left bank siphon with missing Actuator, deck and handrails torn off by floodwaters

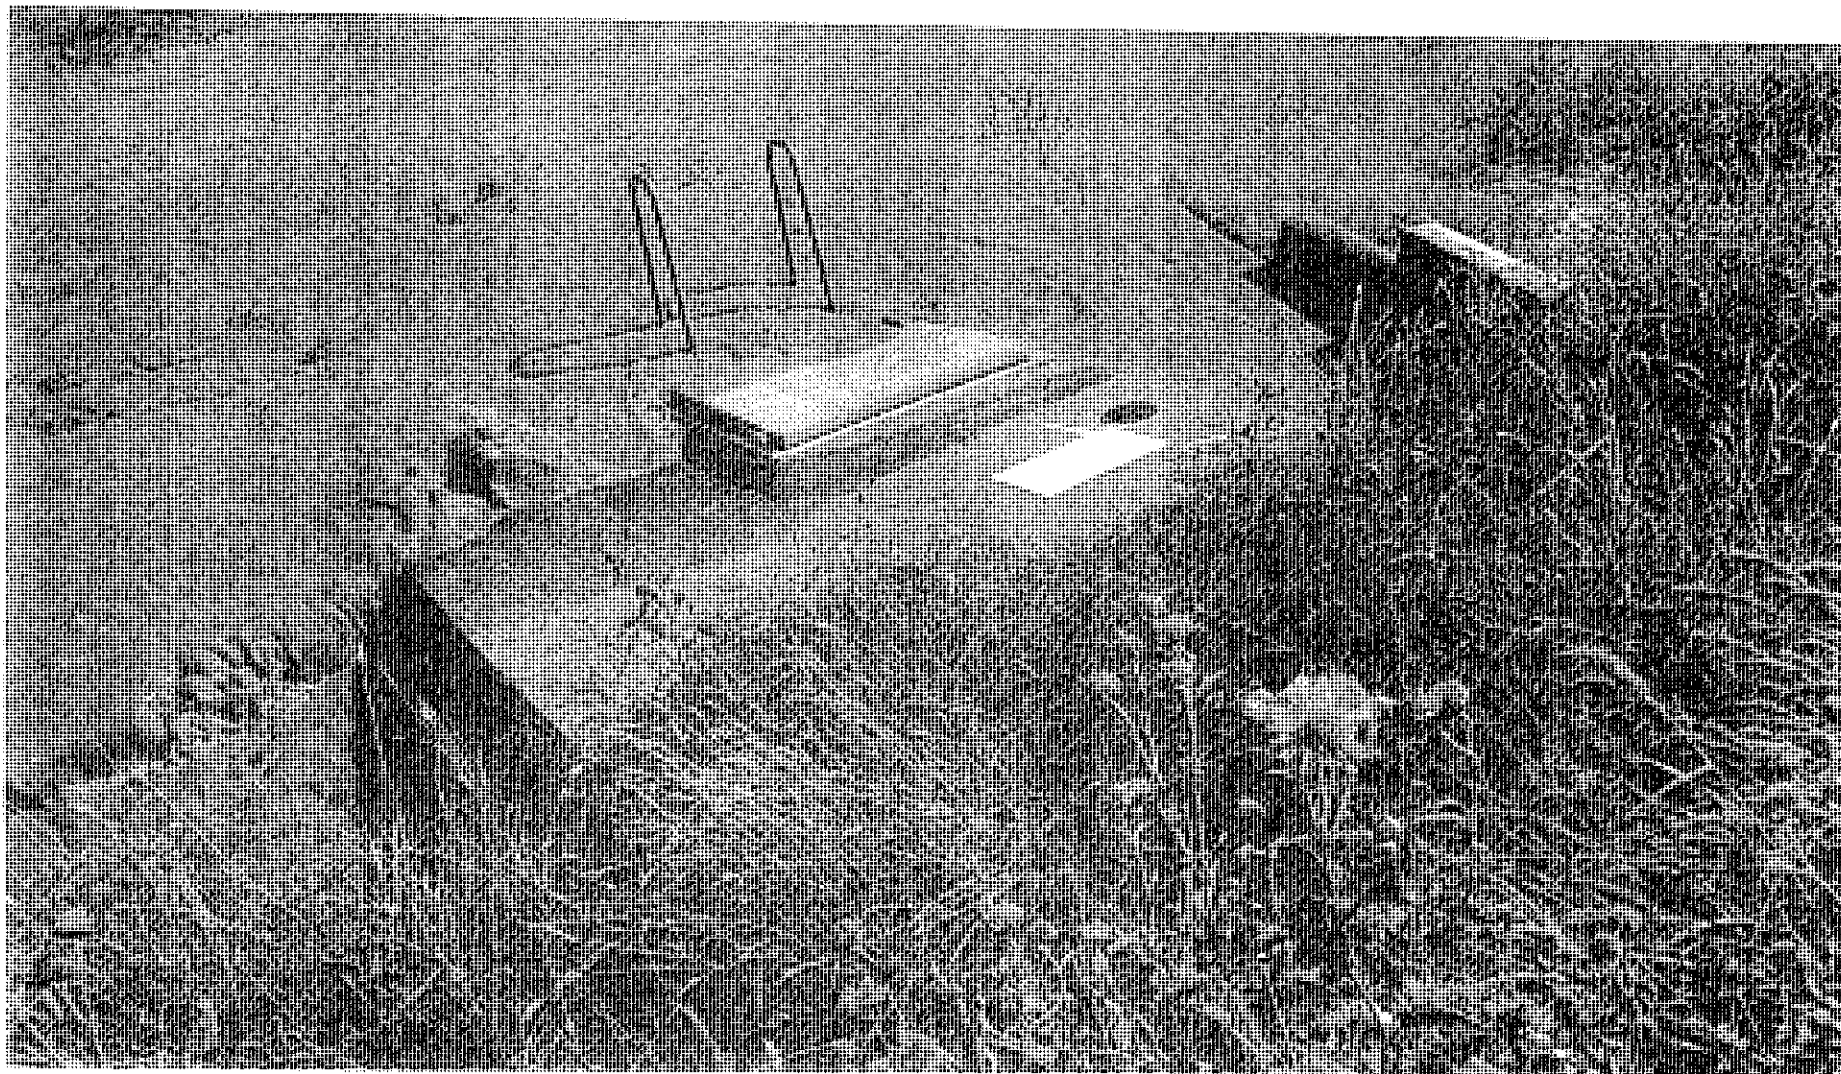
View of water flooding into lower Piezometer pit at peak of flood

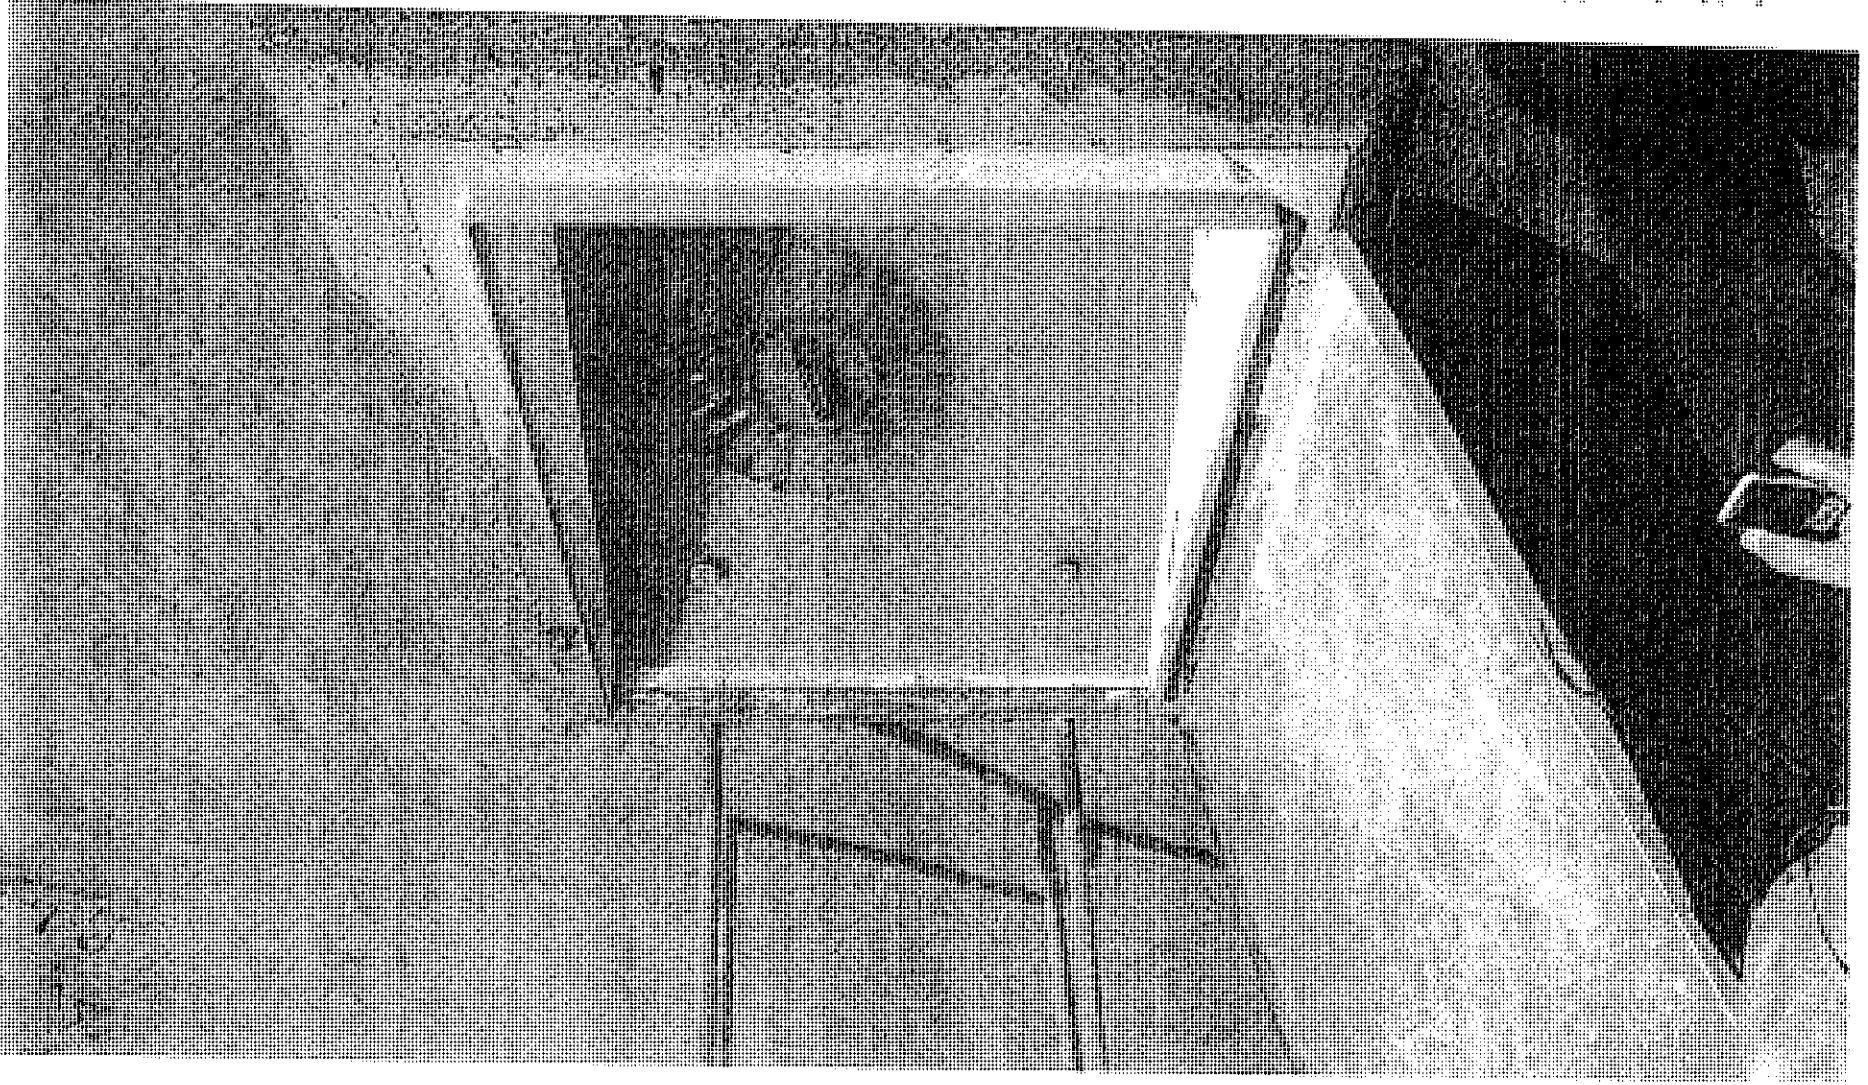
Inside view of flooded Piezometer pit

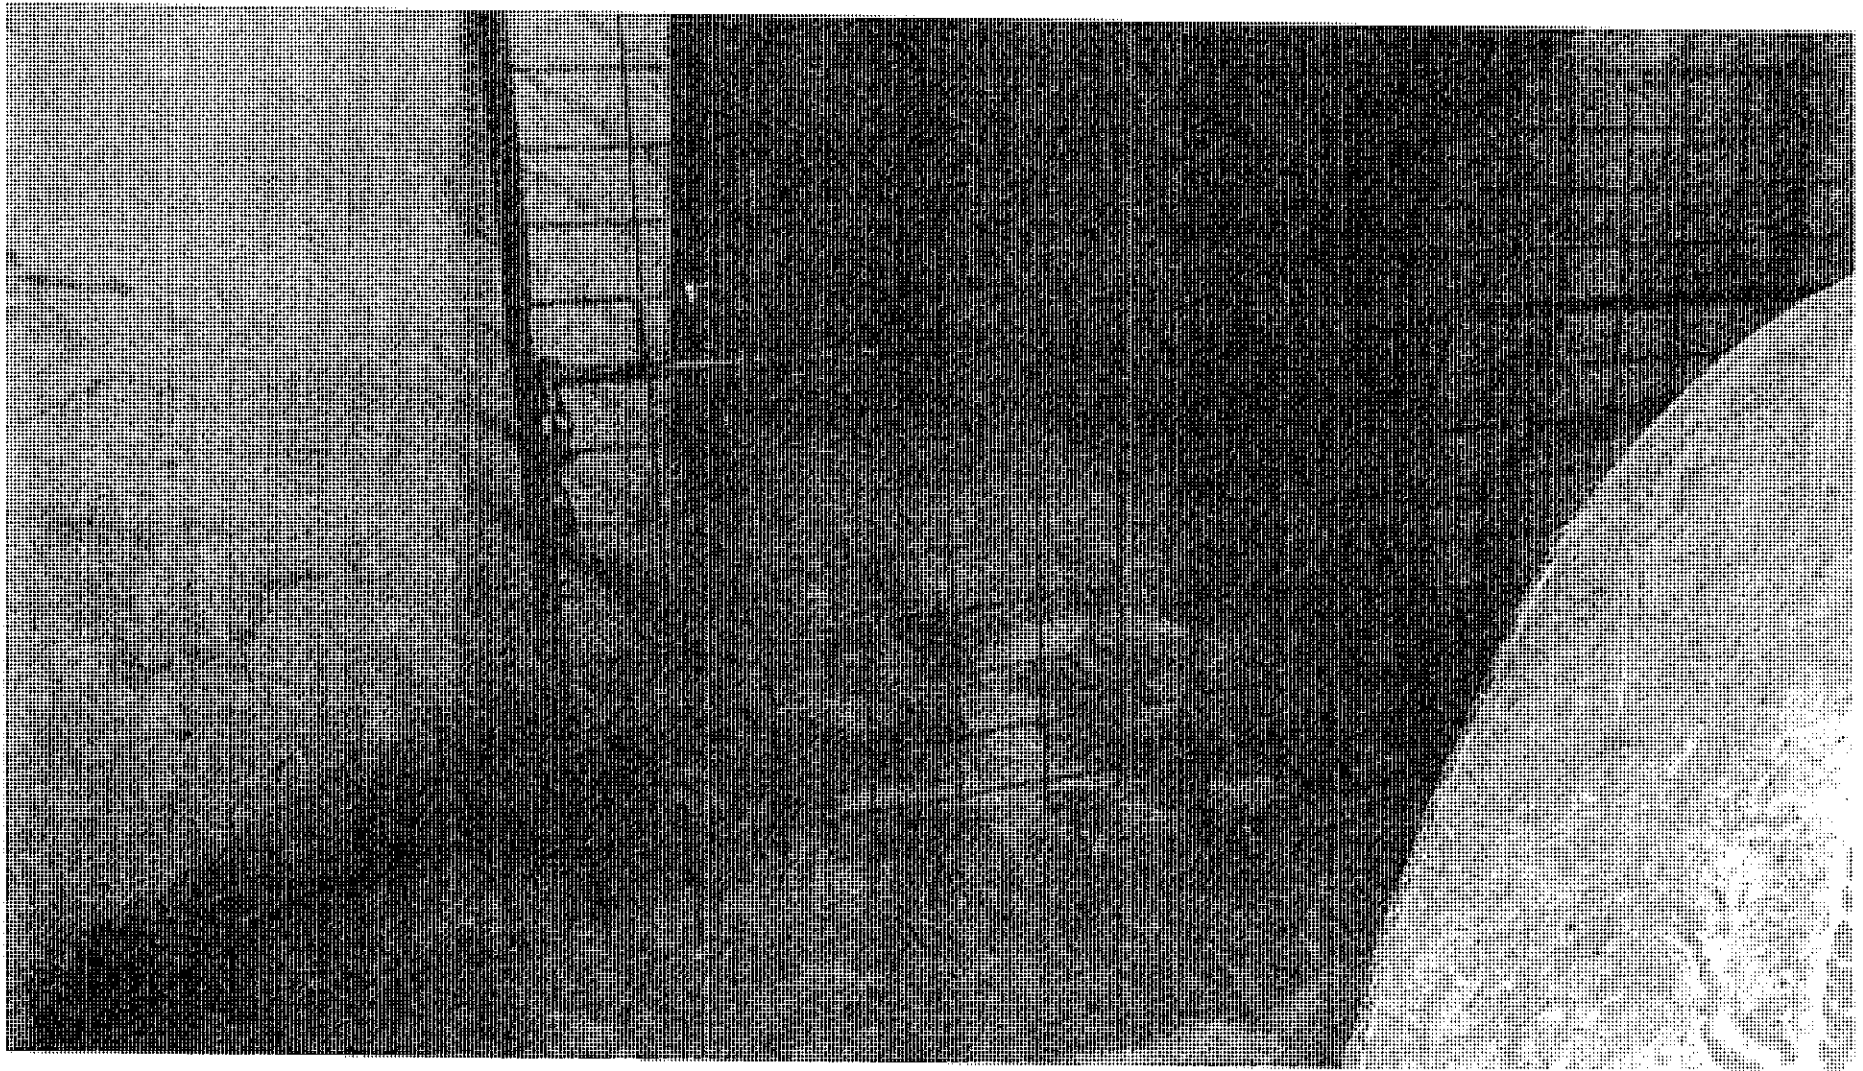
View showing leakage through inlet gate in Selma pump station coming out through drainage chute.

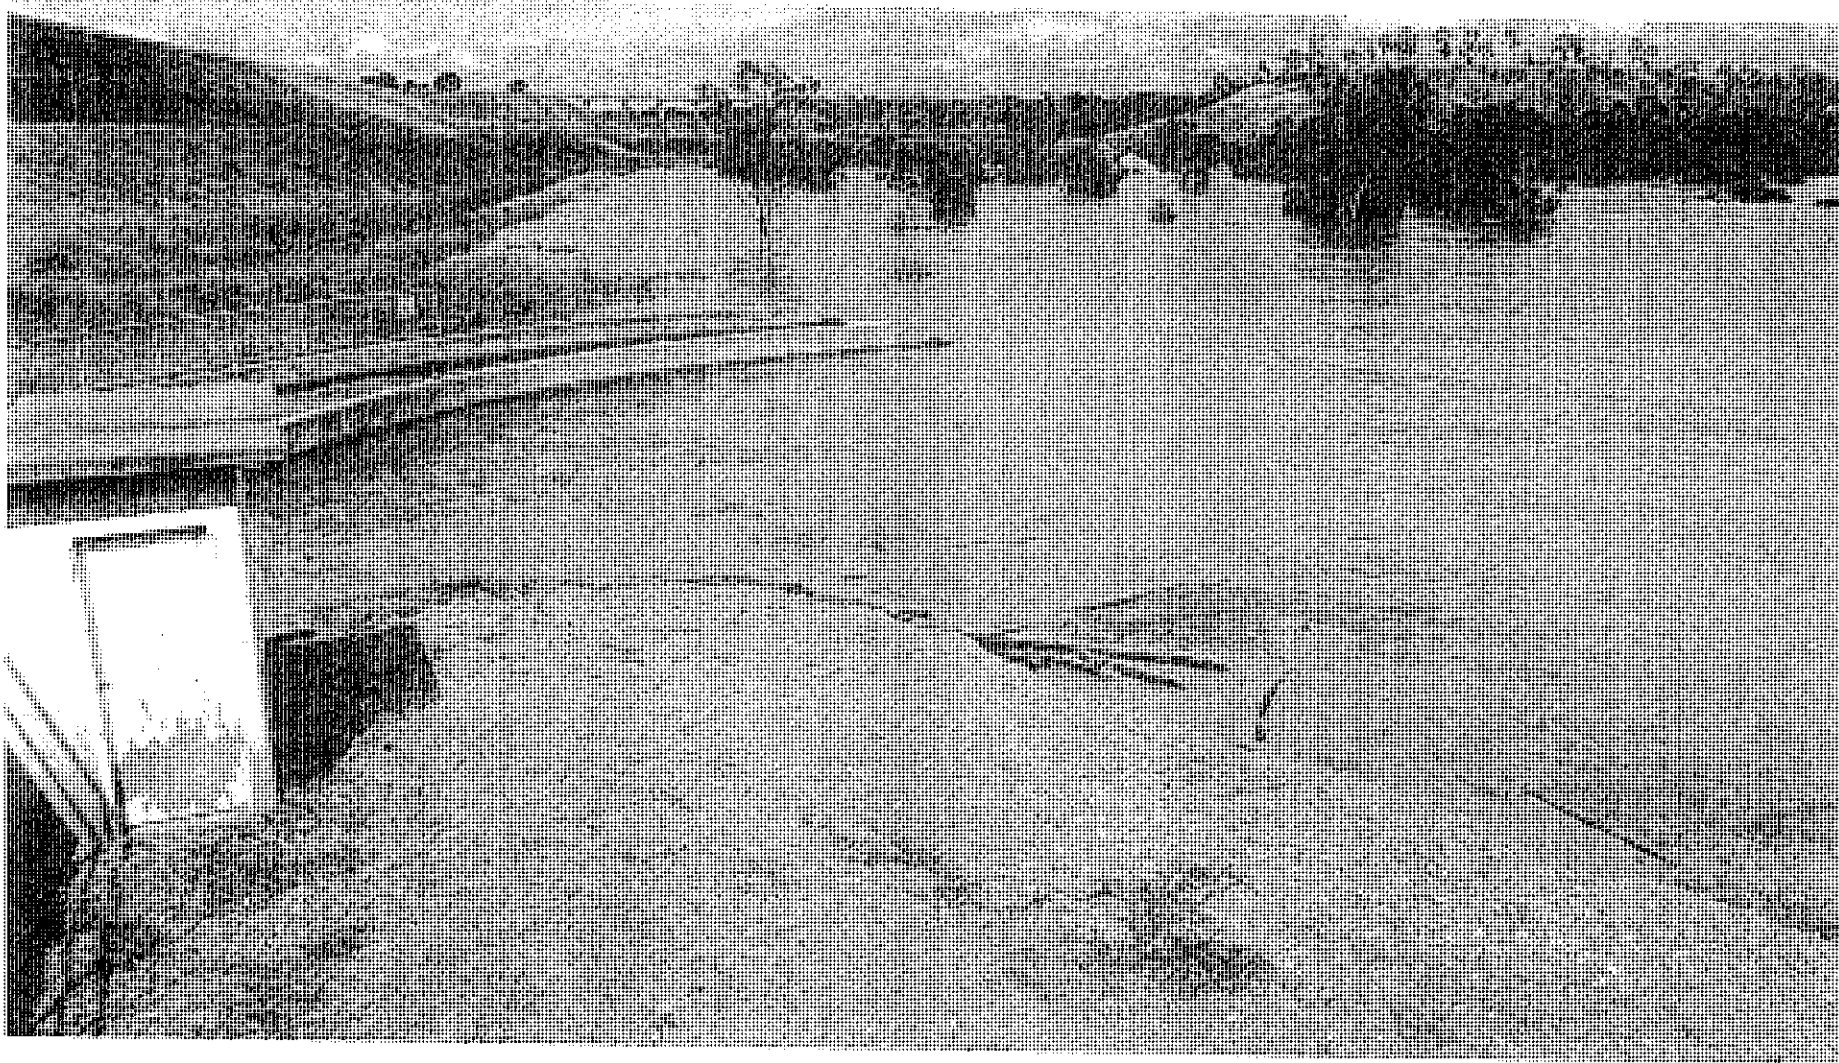
View showing flood waters backed up to landing beside bullring. (Right bank outlet works)
