**Toowoomba Regional
Council**

**Report for Cooby Dam
Special Dam Safety Inspection
following January 2011 Flood**

Rev 1 – February 2011

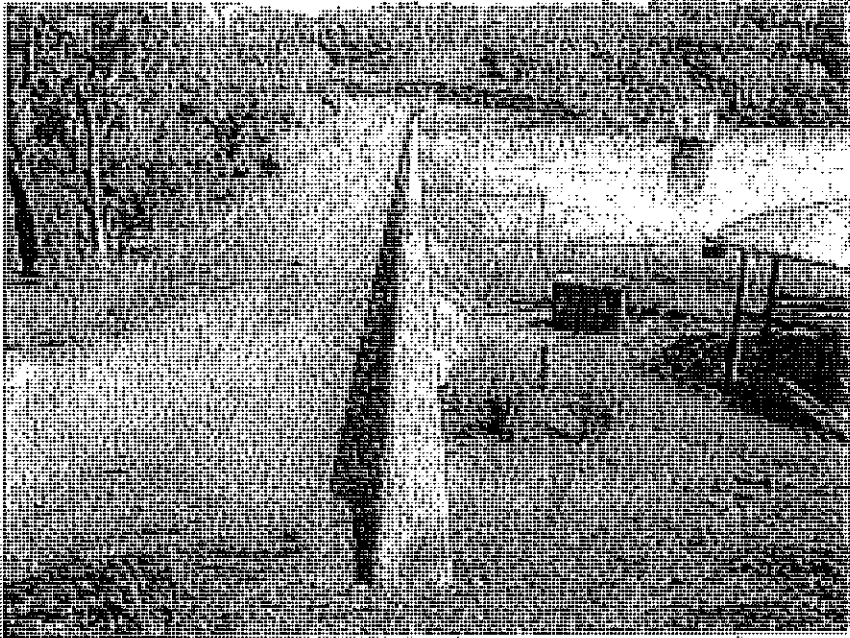
General condition	Good
Cracks	None significant
Spalling	None evident
Joint condition	Good. Minor opening of wave wall joints noted, but no change evident.
Seepage	None evident
Movement	None evident
Vegetation	None evident
Alignment	Straight (Photo 5)

Photo 5 Looking along wave wall on upstream side of dam crest from left abutment

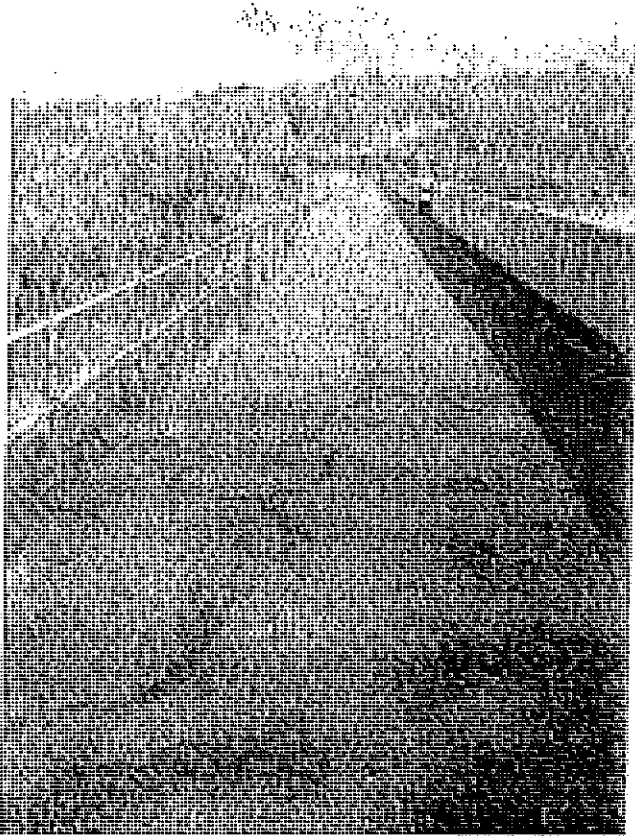
Pavement general condition	Bitumen seal generally in good condition
Cracks	No change noted in previously-noted cracks in bitumen (Photo 7).
Sinkholes	None evident
Alignment	Wave wall on the upstream side (Photo 5) and the fence on downstream side (Photo 6 and Photo 8) of the crest are generally straight. No change evident.
Erosion	None significant
Vegetation	None evident
Depressions	None evident
Settlement	None evident

Photo 7 Cracking in dam crest near left abutment

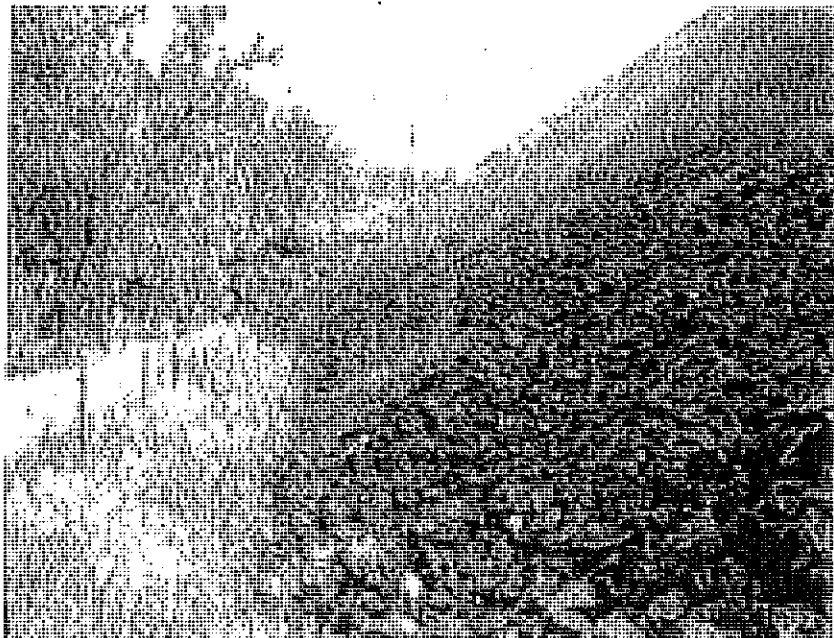
Cracks	None evident – downstream face is rockfill
Sinkholes	None evident
Slides	Minor ravelling noted on downstream face, but no change evident
Bulging	Occasional undulations at toe due to minor slides (Photo 12 and Photo 13)
Wet spots	None evident
Boils	None evident
Depressions	None evident
Deterioration of the slope protection	None evident
Erosion	None evident
Vegetation	Grass cover and small shrubs (Photo 9).
Animal burrows	None evident

Photo 12 Looking across downstream face and along downstream toe from left

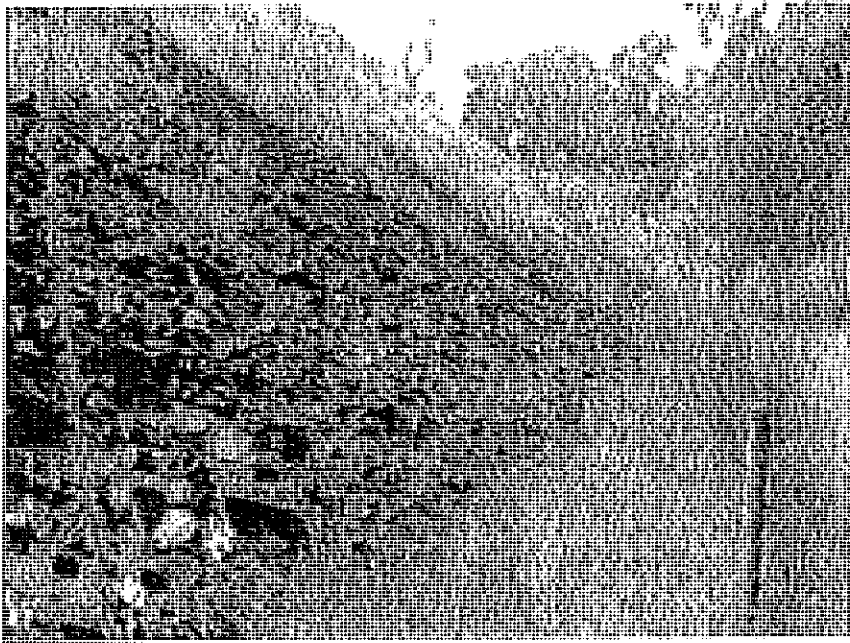
Photo 13 Looking across downstream face and along downstream toe from right

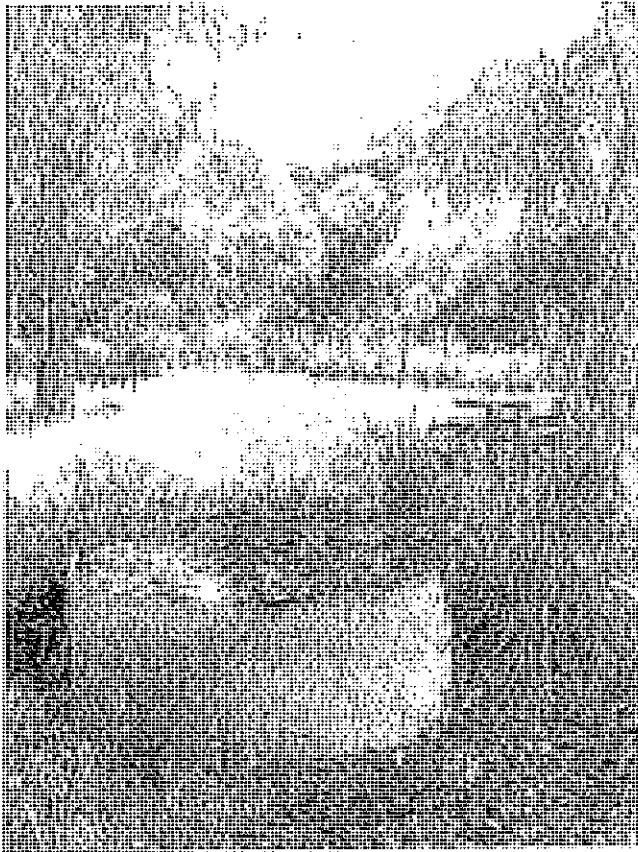
- ▶ A concrete drainage pit was noted in the middle of a garden bed approximately 10 m from the downstream toe of the dam (Photo 17). It is likely that this forms part of the foundation drainage network under the toe berm and is connected to the concrete pit at the toe of the toe berm (below the toilet block).

Photo 17 Drainage pit in toe berm (likely to be part of foundation drainage system)

Section	Ref No	Recommendation	Timing
5.5	R5.5.1/11-S	Undertake an inspection of the drainage pit to identify pipes connected to the pit and use service location equipment to plot the extent of any pipes connected to the pit.	March 2011 (prior to inspection for 2011 safety review)

- ▶ **R5.5.1/11-S – Undertake an inspection of the drainage pit to identify pipes connected to the pit and use service location equipment to plot the extent of any pipes connected to the pit.**

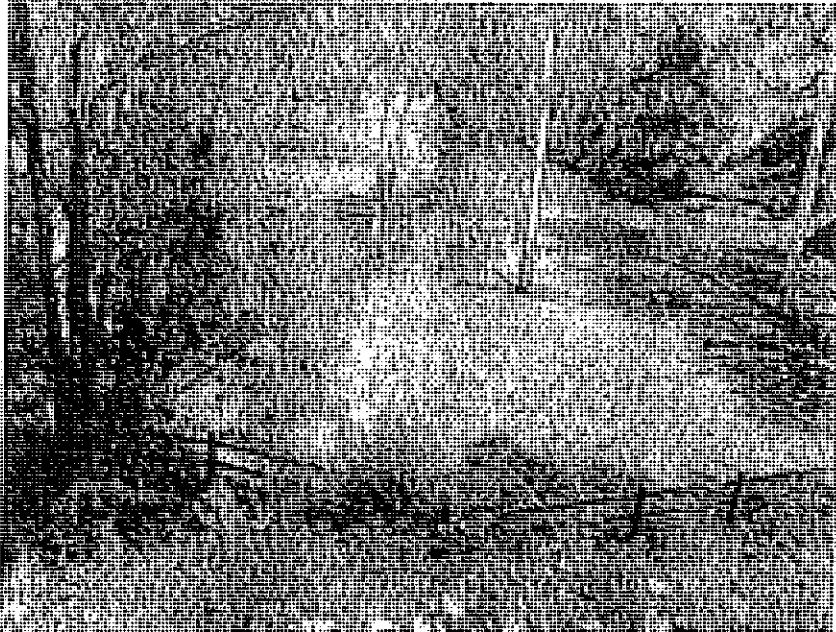
- ▶ Downstream toe area was inundated by the backwater from the spillway at the time of the inspection (Photo 19).
- ▶ Damage to the road on the left bank of the river channel evident from pieces of bitumen amongst debris.

Photo 19 Downstream toe area viewed from toe berm

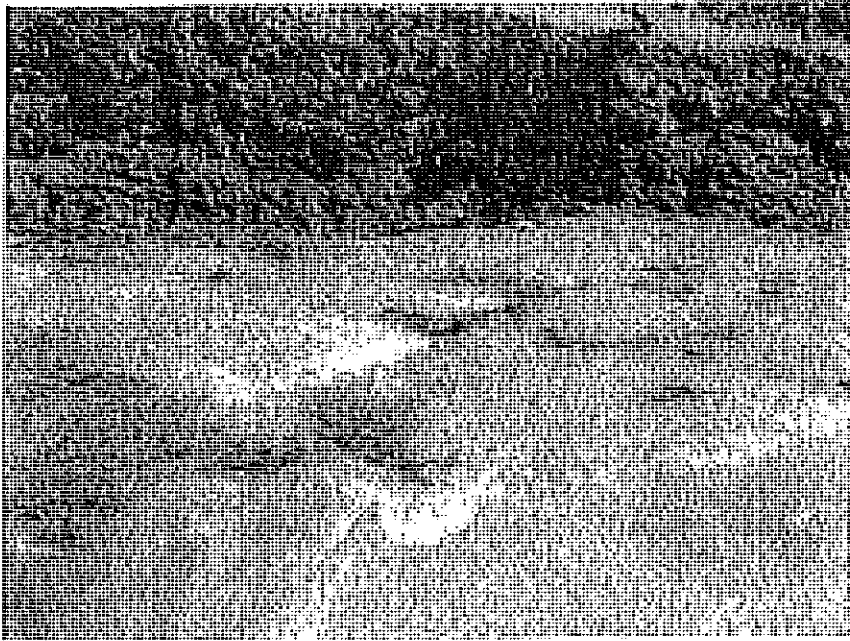
General condition	Not inspected in detail, but no significant damage observed.
Erosion	Erosion evident particularly in lower right side of chute (Photo 34).
Debris	Collection of debris from flood evident in spillway chute (Photo 29)
Loose rocks	
Vegetation

Photo 29 Flow in upper section of spillway chute viewed from left bank

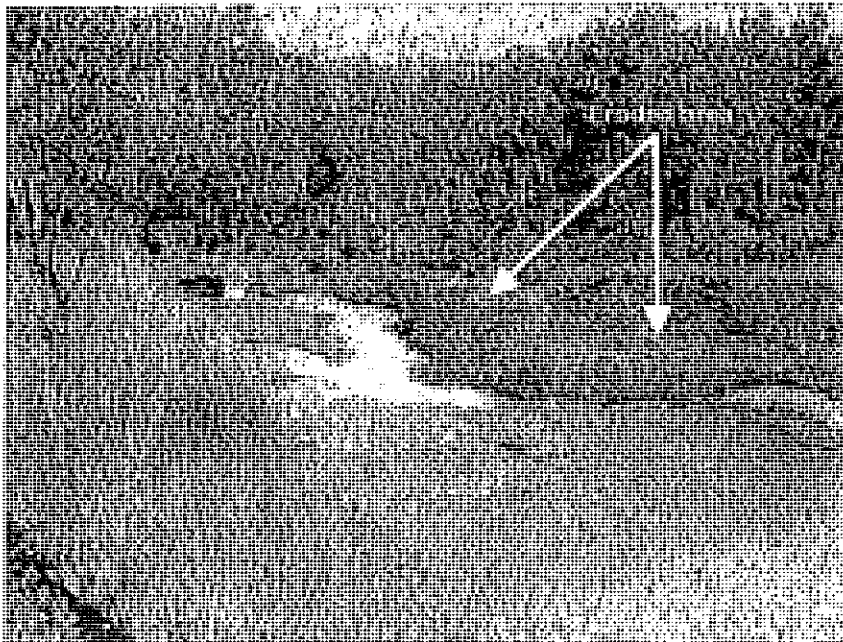
Photo 34 Flow in lower section of spillway chute looking downstream viewed from left bank

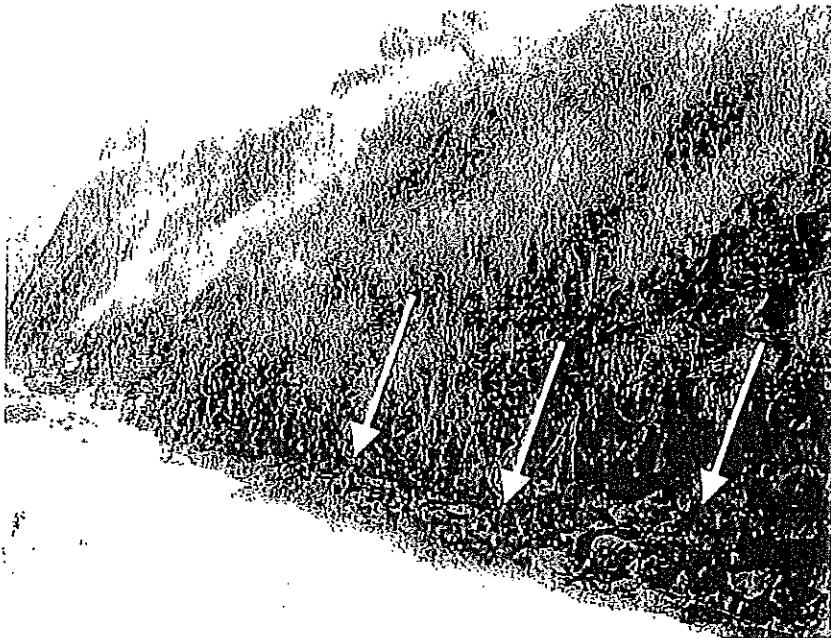
General condition	Not inspected in detail.
Erosion	Undermining of the left side cut towards the downstream end was observed, in particular in the vicinity of the bottom of the stairs (Photo 36 and Photo 38).
Debris	
Loose rocks	
Vegetation

Photo 36 Undermining of left side spillway cut

6.4	R6.4.1/11-S	Prevent public access to top of the left side spillway cut between the weather station and the downstream end of the spillway due to undermining of the cut slopes.	Immediate

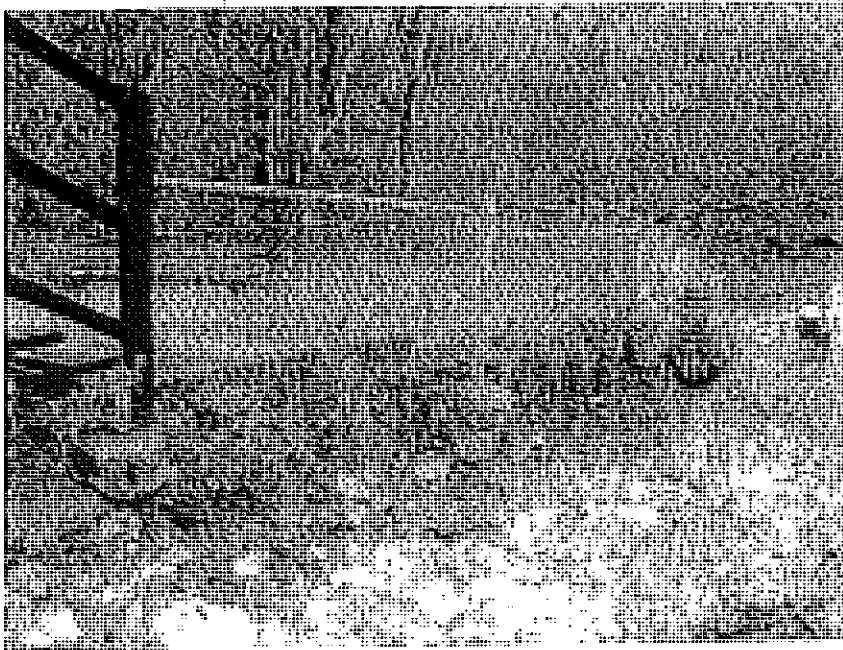
Photo 38 Undermined section of stairs and fence at downstream end of spillway

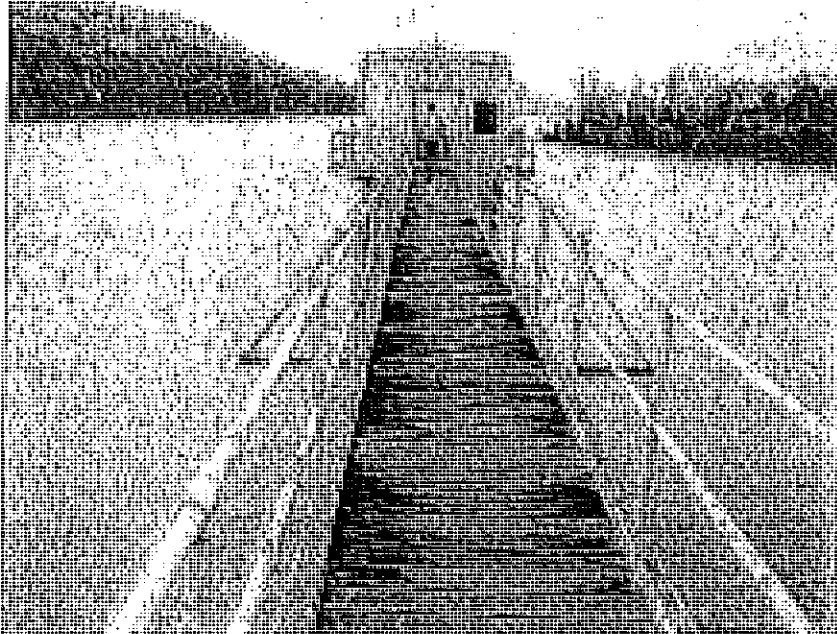
General condition	Good (refer Photo 47 to Photo 49)
Metalwork condition	As note previously, corrosion is developing.
Coatings	Satisfactory
Decking	Satisfactory
Abutments	Good.

Photo 47 Overview of intake tower bridge from dam crest

- ▶ Decking on the bridge is monitored on an ongoing basis and repaired as needed.
- ▶ It has previously been recommended to paint the bridge truss. It is understood that options for doing this are being investigated due to environmental concerns. Based on discussions with TRC, it is likely that significant maintenance of the bridge will be undertaken when the spillway upgrade works are done.

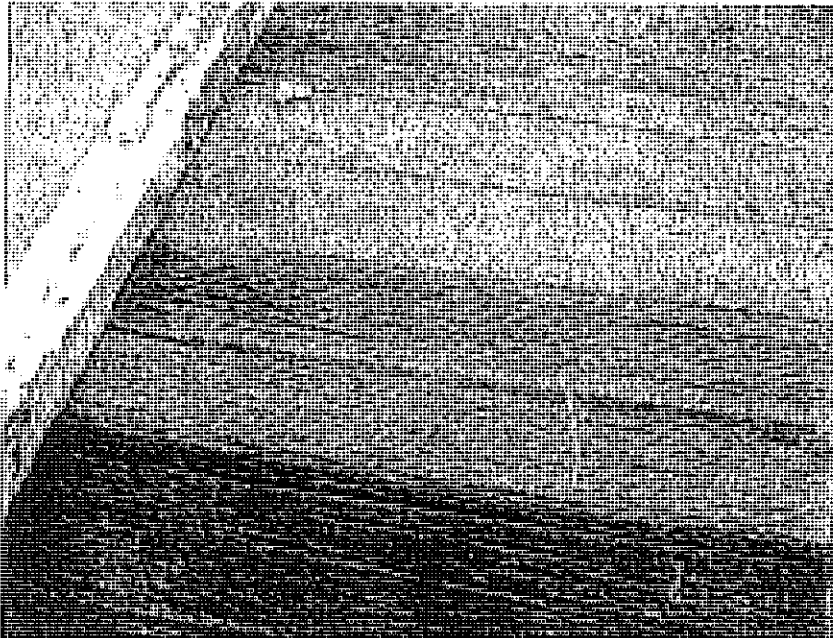
Photo 48 Close-up of bridge decking near intake tower end of bridge

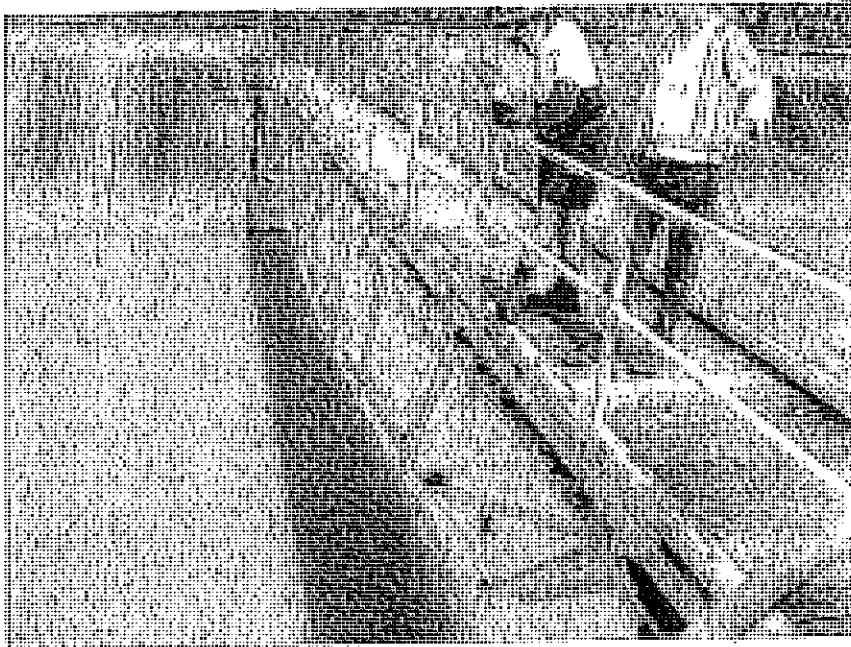
Photo 49 Intake tower bridge substructure viewed from intake tower

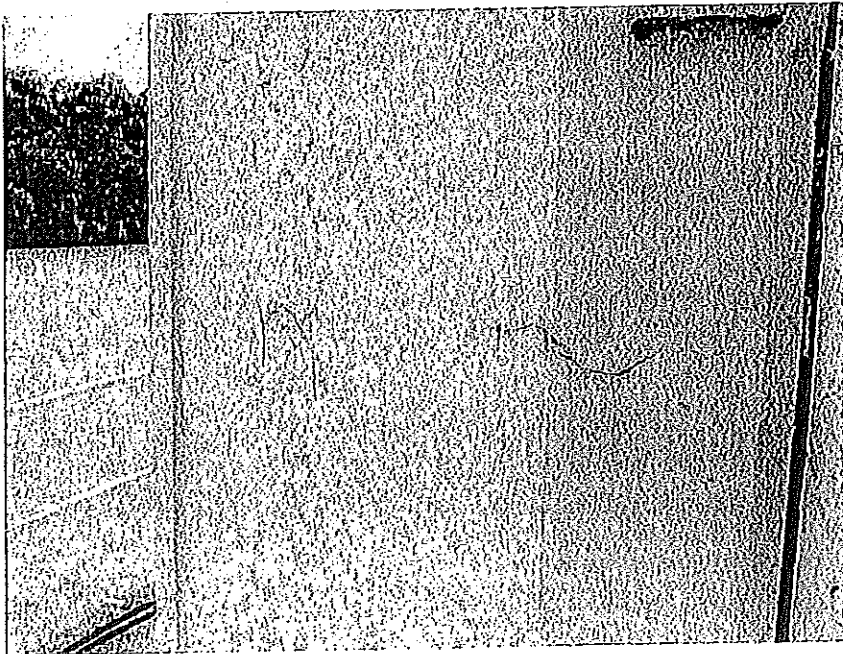
General condition	Very good. Note that the tower was only inspected from the bridge entry level due to flooding of the tunnel.
Cracking	A crack was noted around the intake tower at about mid-height between the bridge deck level and the top of the structure (Photo 50). It is unclear whether this crack has been noted previously, but close inspection of previous inspection photos has shown its existence. This crack is not considered to be a structural problem.
Spalling	
Joint condition	
Seepage	
Movement

Photo 50 Crack around intake tower at mid-height between bridge deck and roof
