25 November 2011  
Ref BRI-LET-003

### **Review of Hydraulic Modelling**

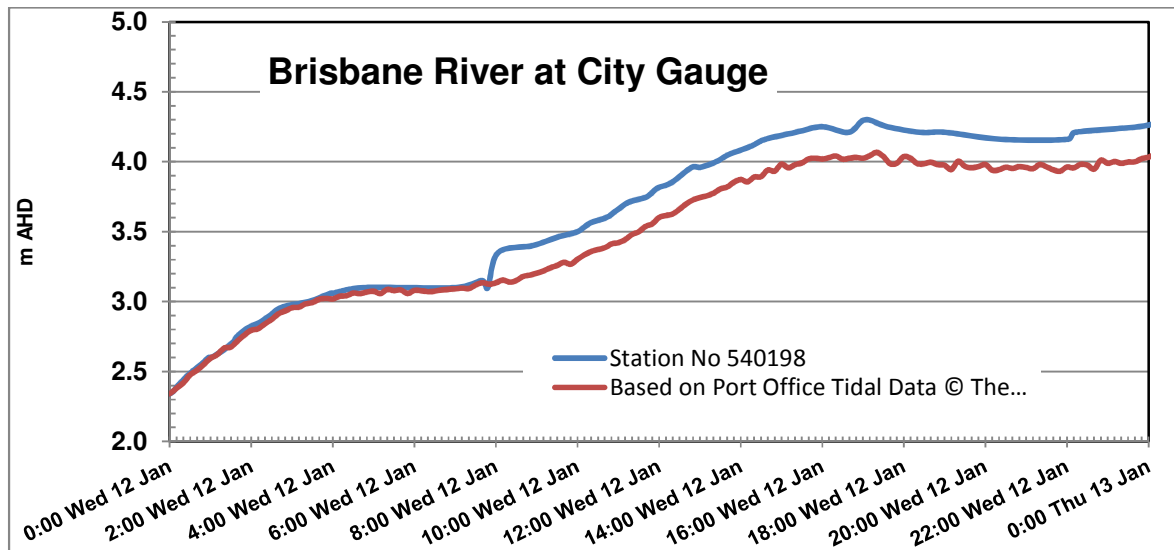
My comparison of the data from the two gauges over the period in question is shown in the plot below.

The above indicates that the gauge, Station Number 540198, experienced a displacement of approximately 250 mm between 07:48 and 08:09 Wednesday 12<sup>th</sup> January. Subsequently Station Number 540198 reported a river level approximately 200 mm higher than data provided by MSQ. Since gauge 540198 apparently records based on exceeding a particular change in level, it would seem that the displacement actually occurred close to the time of the recorded jump, i.e. 08:09 on Wednesday 12<sup>th</sup>.

The behaviour exhibited by the gauge Station Number 540198 is certainly not indicative of a natural event.

Rather than as indicated before the Commission on October 26<sup>th</sup>, that the data from Gauge 540198 was confirmed by manual gauge board readings, I have received unconfirmed advice that gauge 540198 was actually adjusted to match the reading from the gauge board. Presumably before the adjustment, the gauge board readings did not match the readings from Station Number 540198.

Again, unconfirmed advice is that the change in the reading from Station Number 540198 is due to the gauge being adjusted remotely to correspond with *“a level reported from an eye witness reading of the gauging board at Kangaroo Point hence the step in the data. The reading was taken at a time when the current speed would have been over 6 knots (a very strong current) and the level on the board pushed up well above the average level. It is difficult to achieve an accurate reading from a tide board in fast moving water as the force of the water against the board forces the level up”*.

A potential source of discrepancy is that both pressure sensors are calibrated to the water density that they operate in. The density of the water in the Brisbane River during the flood could be expected to have varied from brackish to sediment laden fresh water. The MSQ gauge is apparently calibrated to salt water and it is unclear exactly how Station 540198 was calibrated.

However, depending on the zero for each of the gauges, a correction from clear fresh water to clear salt water would not be sufficient to explain a 200 mm displacement. In addition it is likely that due to the sediment load in the Brisbane River the water flowing past the sensors would have a density substantially higher that of fresh water.
