## Statement of Mr Tony Martini

#### STATEMENT TO QLD FLOODS COMMISSION OF INQUIRY

### Moreton Bay Regional Council Male Road, Caboolture Flooding Assessment September 2011

# Moreton Bay Regional Council Upper Burpengary Creek Flood Mitigation Assessment

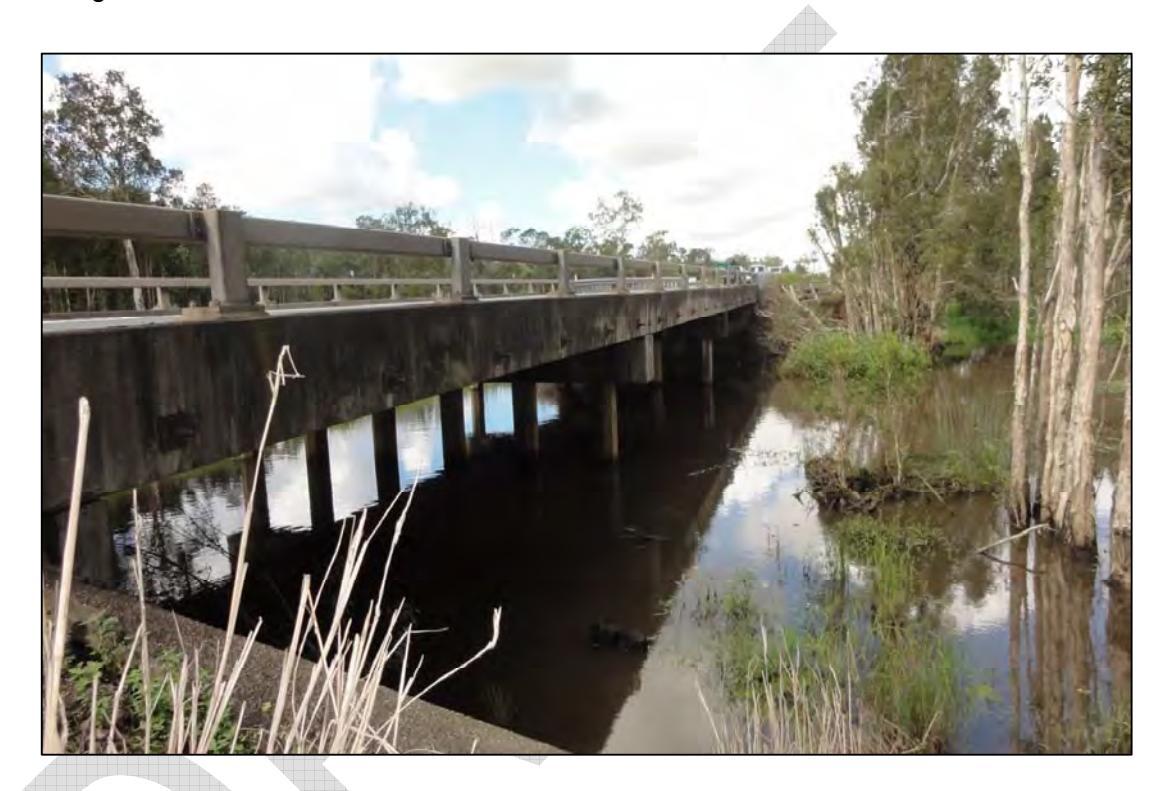
Figure 3.1 – Upstream Face of the Bruce Highway Bridge

The figure indicates that there are some minor trees immediately upstream of the bridge face. This vegetation could potentially increase the potential for blockages and as such should be removed as part of routine maintenance by the Department of Transport and Main Roads (DTMR).

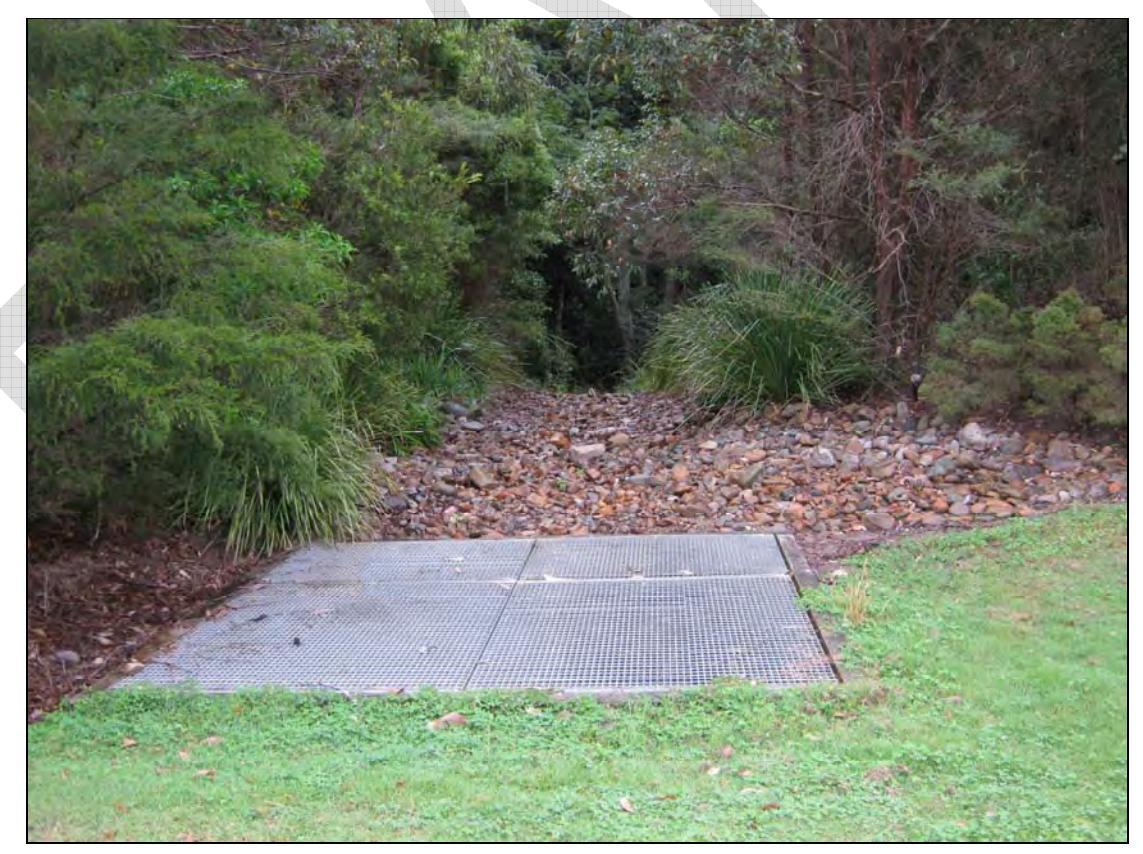
Figure 2.1 – High Capacity Inlet Pit and Overland Flow Path to Creek

An opening in the creek embankment was designed immediately on the downside of the high capacity inlet pit. It appears that this opening was designed as a fail safe measure to prevent ponding / flooding if the high capacity grated inlet pit became blocked. Figure 2.1 indicates the high capacity pit and overland flow path through the embankment leading to the creek. Figure 2.2 indicates the locality and major features of the area.

During the 11<sup>th</sup> January event, floodwater from Burpengary Creek back flowed through this opening, as well as backing up through the piped drainage system, flooding the adjacent properties.

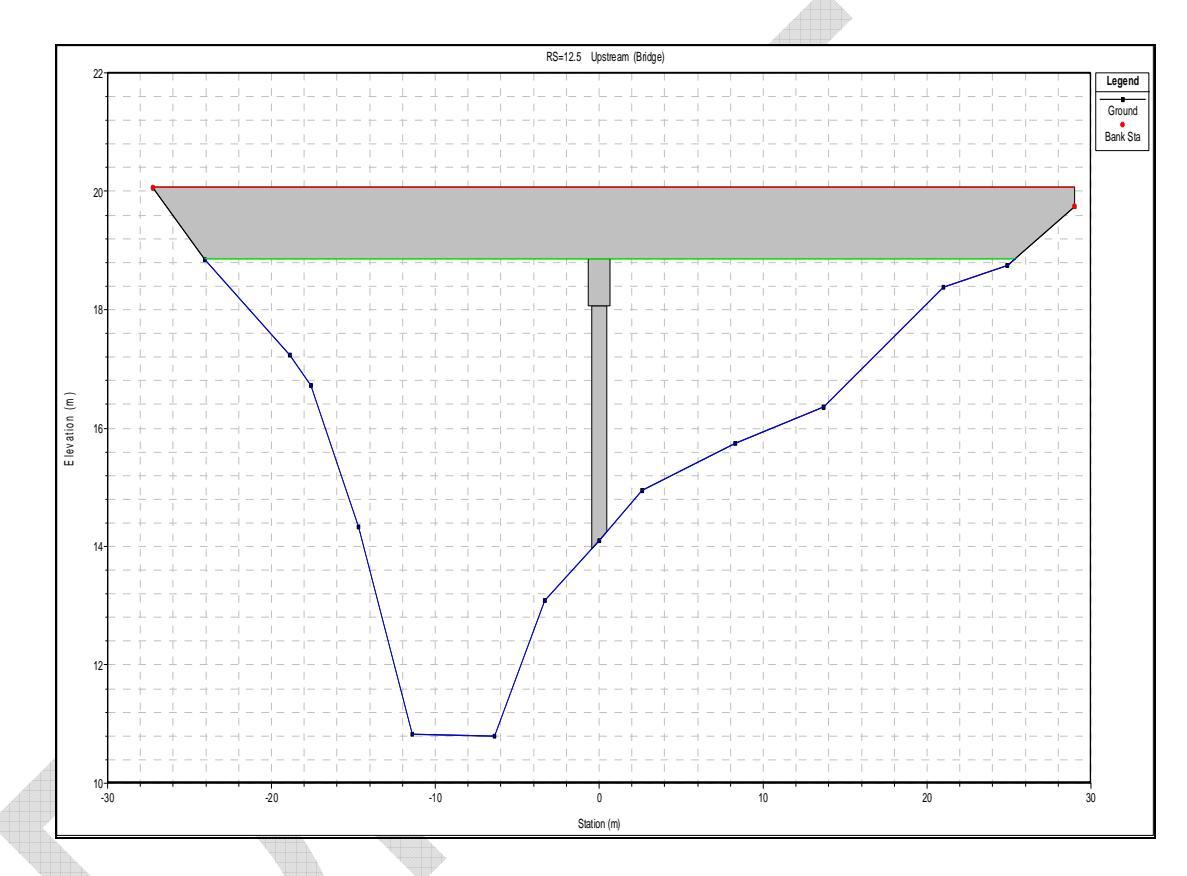
Figure 3.2 – Hideaway Close Footbridge (HEC-RAS representation)

Modelling was undertaken to assess the hydraulic impact of the footbridge which spans Burpengary Creek and provides pedestrian access to Hideaway Close from the north. The assessment was undertaken for the 1 % annual chance (100-yr ARI) and 0.1 % annual chance (1000-yr ARI) events. In the 1 % annual chance (100-yr ARI) event the flood level reaches approximately the soffit of the bridge. In the 0.1 % annual chance (1000-yr ARI) event the flood level reaches approximately midway up the bridge beams, but does not over top the bridge. To assess the impacts, the footbridge was removed from the Tuflow model and the flood level results compared with the existing model (with the footbridge included). The results indicate that the impact of the footbridge is negligible in both the 1 % annual chance (100-yr ARI) and 0.1 % annual chance (1000-yr ARI) events.

To confirm that Tuflow was modelling the bridge structure accurately, a comparison was undertaken using the HEC-RAS hydraulic model. The results indicate a good correlation between the two models. Figure 3.2 indicates the cross-section through the bridge structure, viewed in the downstream direction as modelled in HEC-RAS. All bridge dimensions were obtained from field survey undertaken for the RFD.
