# CENTRAL HIGHLANDS REGIONAL COUNCIL FLOOD MANAGEMENT REPORT

## **Section A: Upper Nogoa – Fairbairn Dam Catchment Assessment and Evaluation**

## **Section B: Fairbairn Dam – Emerald: Urban Flood Plain Analysis**

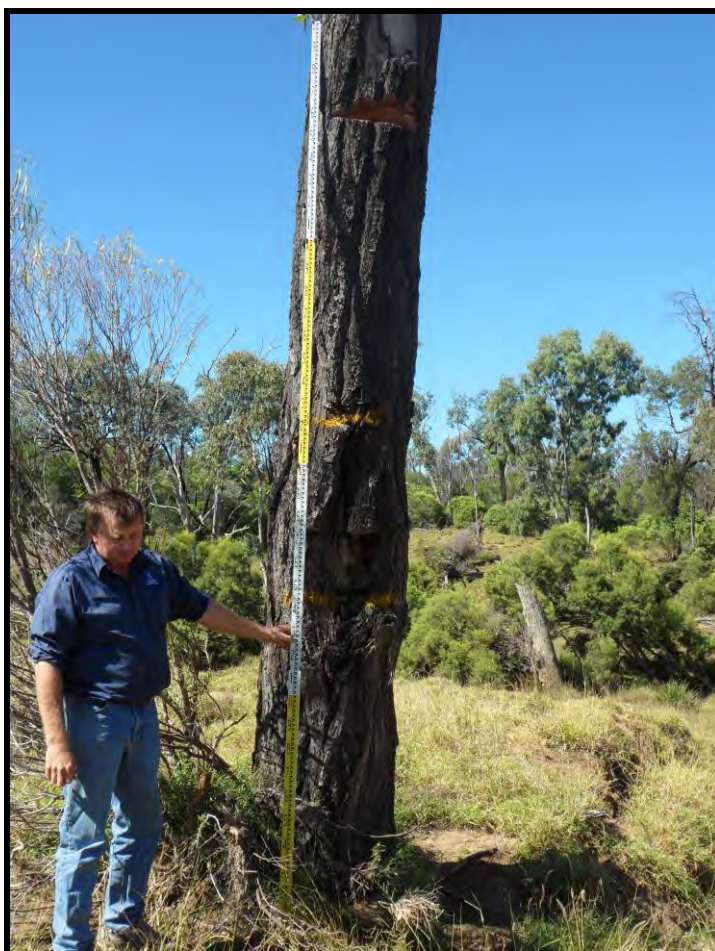
Figure 6: Wharton Creek Historical Flood Marker

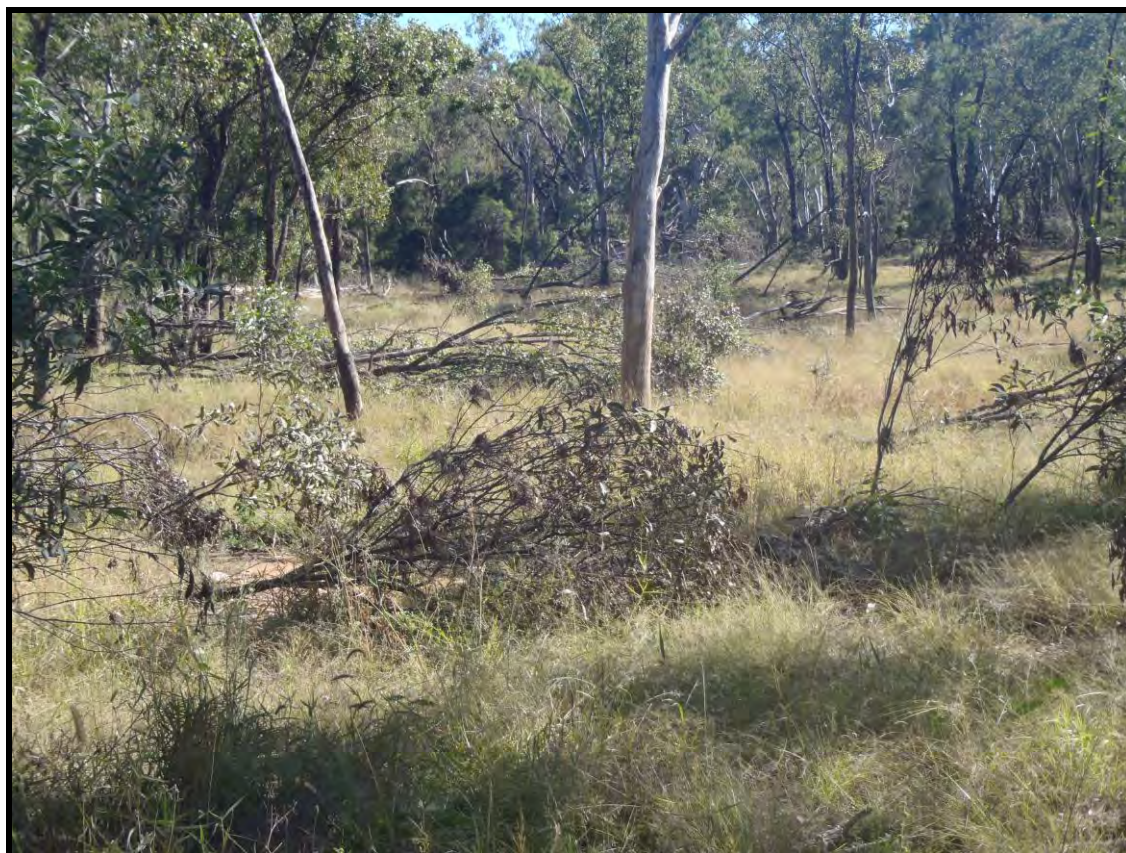
Figure 9: Destruction through Barra Hole Pinch Point

With such a slowing point and ultimately three intersecting streams at peak flows caused the water from the Claude to back up and over the Mantuan Downs property. Once out of this narrowing point the water picked up velocity once again and left trees lying flat in its wake, cutting across a small hill along the access road to the Barra holes

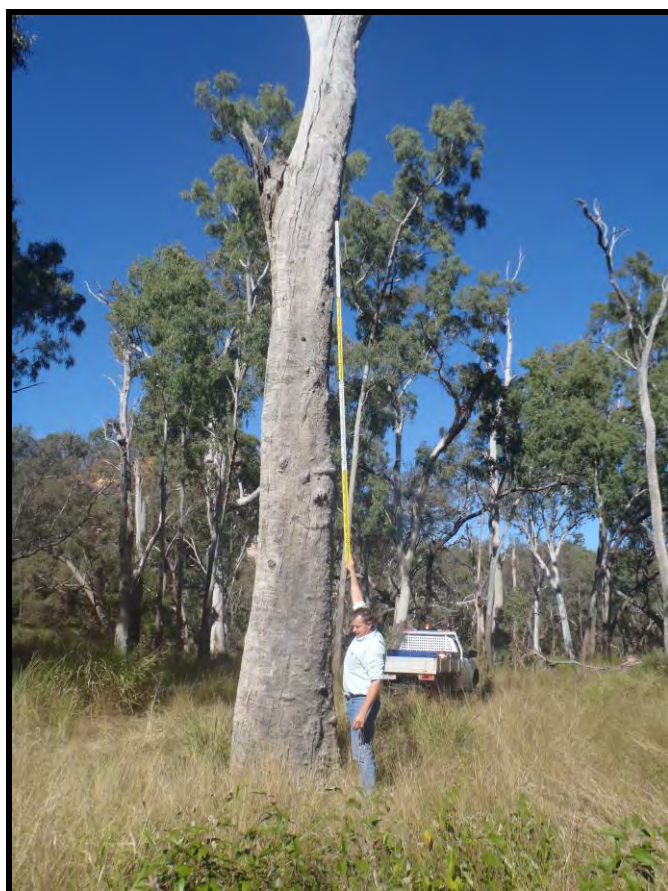
Figure 10: Pinch Point at base level (flush with top of river banks) showing height of water up the trees.

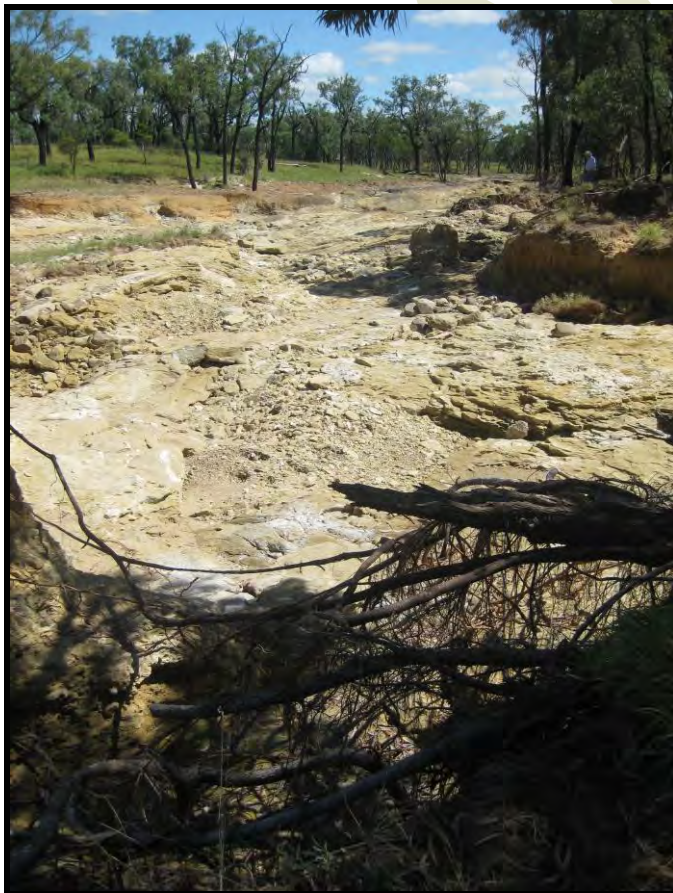
**Figure 12: Hill scoured out at Tresswell School**

Other readings:		
	Other Information:		
<b>Resident Comments:</b>	The water had backed up so much on the west side of the school that the water surged over a small hill and scoured away revealing a stream bed. Nandowrie owners described the water passing through to have waves 6m high pulsing over the hill.		
<b>C&amp;R Comments:</b>	Downstream at the Treswell school, surveying equipment measurements from 2008 (78cm) and 2010 (170cm) indicated a 92cm difference between the two events.

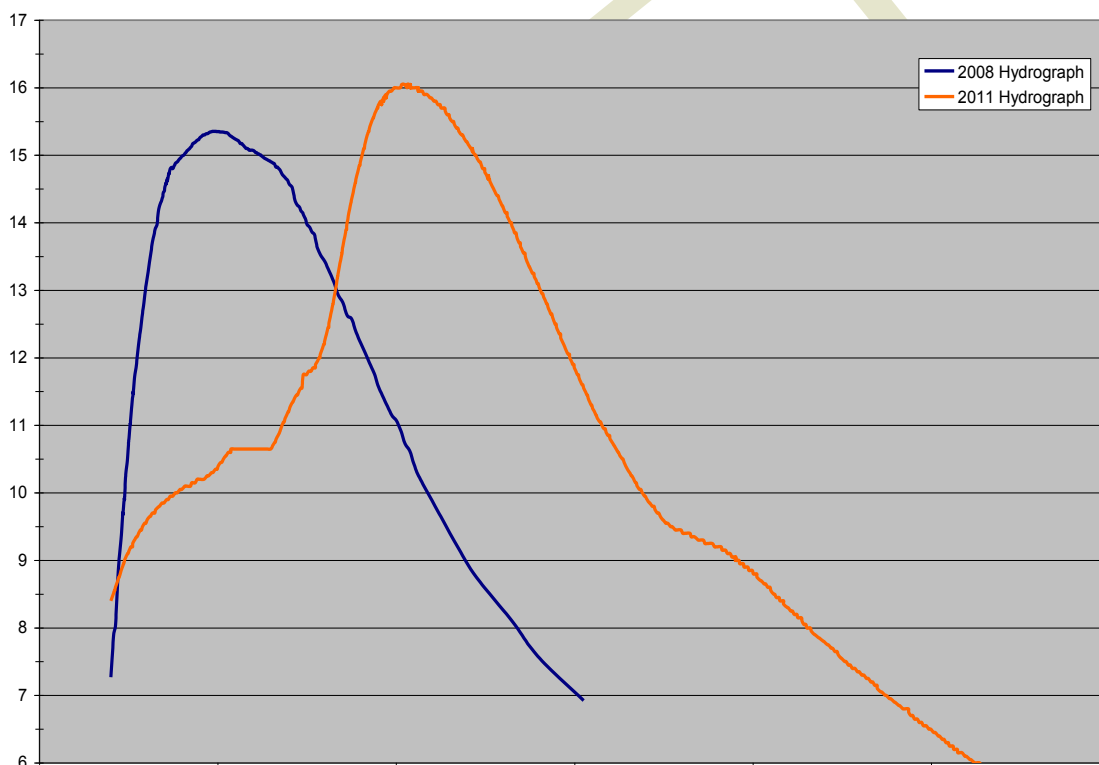
During the 2010/11 event the Fairbairn Dam acted as a buffer and reduced the discharge by 26%. In 2008 it reduced the discharge by 30%.

Figure 1: 2008 vs 2010/11 Hydrograph

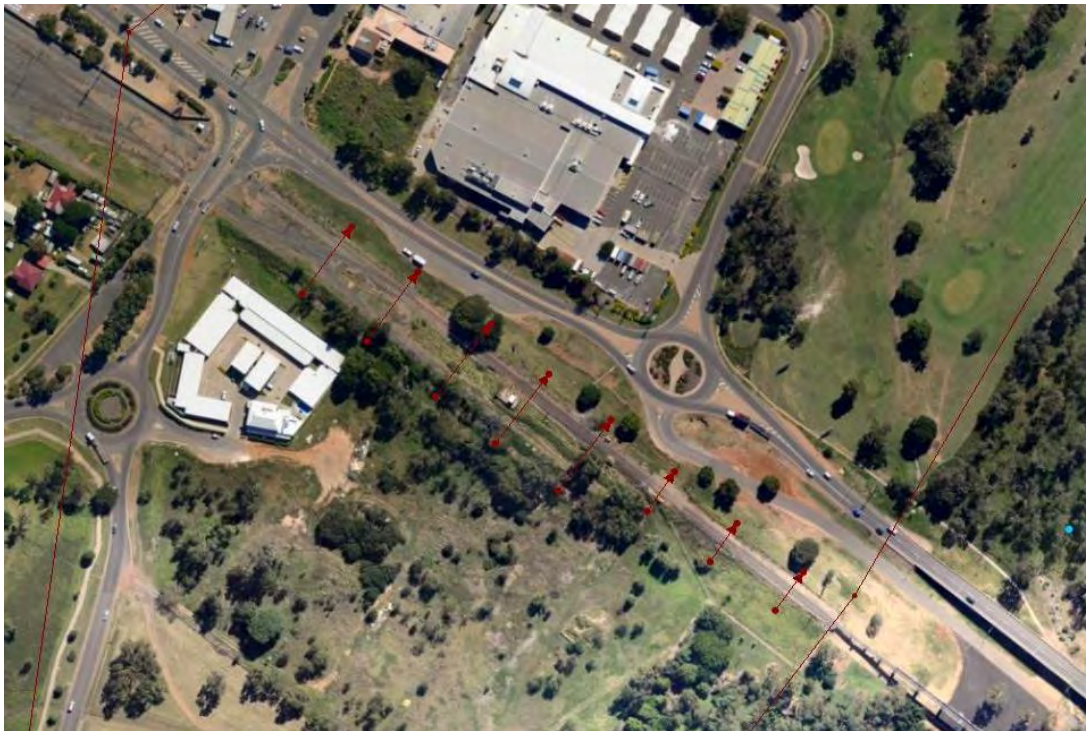
C&R Consulting have modelled the effects of an increased flow path under the Rail Bridge by inserting either a small bridge or 8 culverts under the Vince Lester Bridge, increasing the capacity by an additional 20% to the main channel. Each culvert within the model represents five 1.5 m x 1 m rectangular box culverts, located in the positions indicated in Figure 4. The effect that this has on the flow can be seen in Figure 5 and Figure 6. Figure 5 shows the current situation where the ballast of the railway bridge acts as a levee bank holding back the flow, with pooling increasing the depth of the flow (darker blue) until it spills over the bridge. This also has the effect of not allowing the water to clear downstream of the bridge as quickly and creates flow towards the river along the ballast towards the river on the upstream side.

**Figure 4: Culvert locations under western side of the railway bridge**

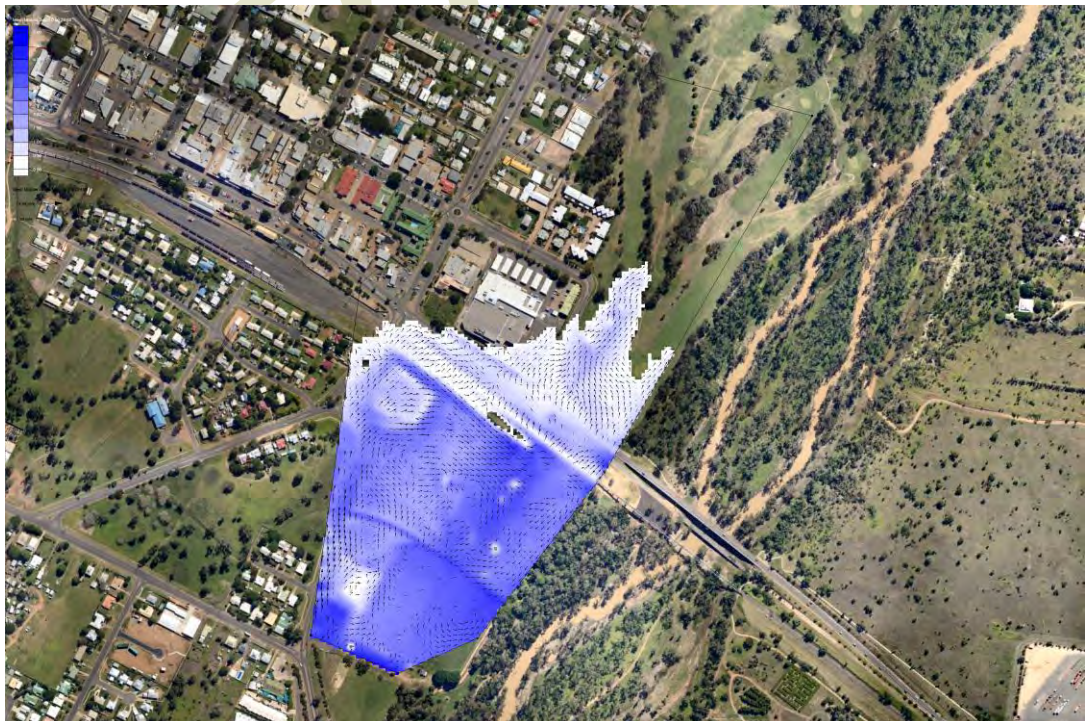
**Figure 5: 500 m<sup>3</sup>/sec test flow with no culverts**

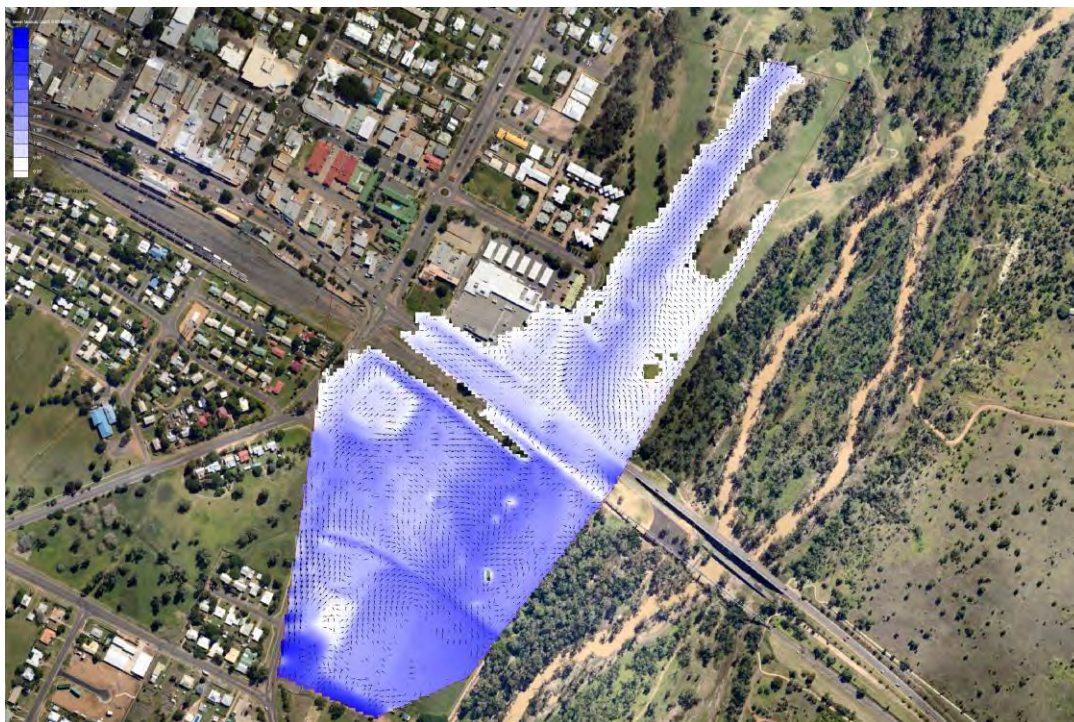
Figure 6 shows exactly the same modelled flow with the culverts included, and shows a shallower depth on the upstream side of the railway bridge as the flow goes through the culverts and clears the downstream area along the golf course. The flow through these

culverts also prevents floodwater from going over the highest section of the bridge in this model which has a much higher flow rate than was experienced in the 2010/11 event.

Figure 6: 500 m<sup>3</sup>/sec test flow including culverts under the levee

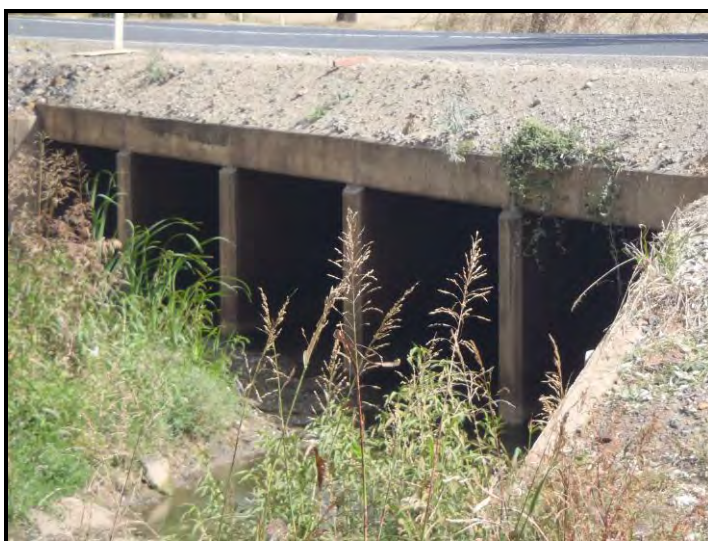
The current Gregory Highway crossing over LN1 consists of 5 x 2.1 x 2.1 RCBC's which have 33% less flow capacity than the crossing up stream on Hogans Road. The recommendation is to double the capacity under the Gregory Highway by adding 3 new 2.1 x 2.1m RCBC's as well as 8 new 1.2 x 1m RCBC's or their equivalent in pipes. This crossing is currently expected to allow the capacity of flow from the railway pedestrian underpass, LN1 break out flow on the eastern up steam side which moves down through Egan Street as well as the flow in LN1. This was also recommended in a report commissioned by Gordonstone Coal Management PTY LTD and prepared by Blain Johnson PTY LTD in 1991.

Figure 7: Gregory Highway crossing flow structure

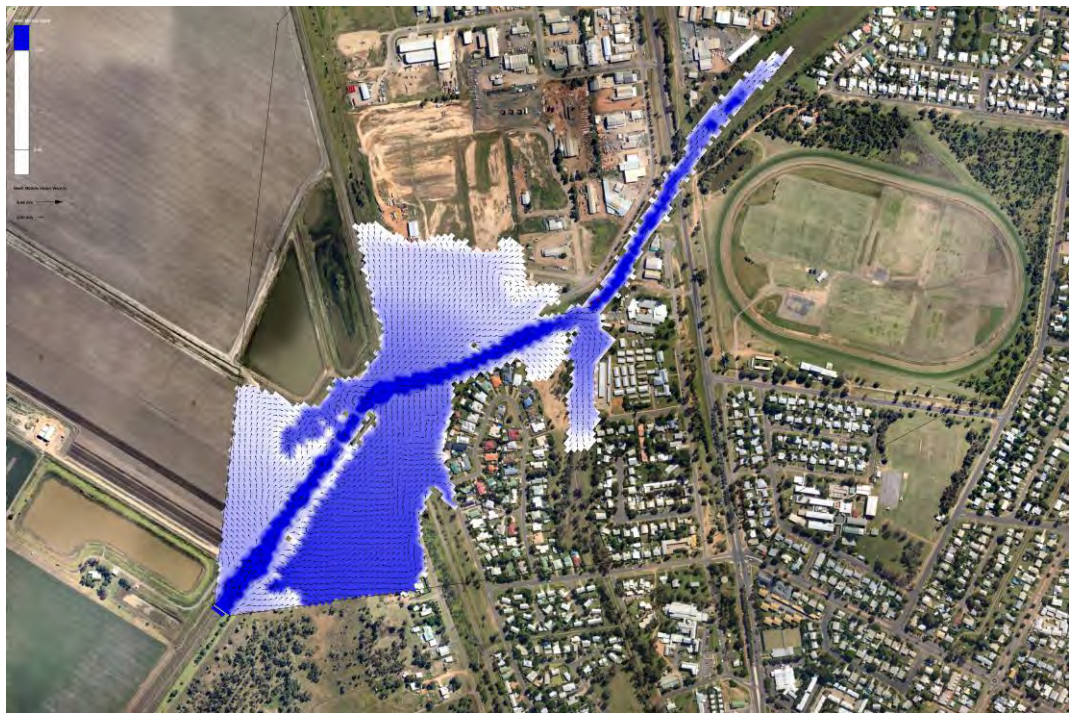
Figure 9: Modelled 100 m<sup>3</sup>/sec flow along LN1 drain

These figures show that the amount of flooding is drastically reduced in the Cameron Rd industrial estate to the north of Munro Rd. Similarly the extra water storage and flow within the drainage channel reduces the out-of-bank flow to the south through the parkland leading toward Egan St.

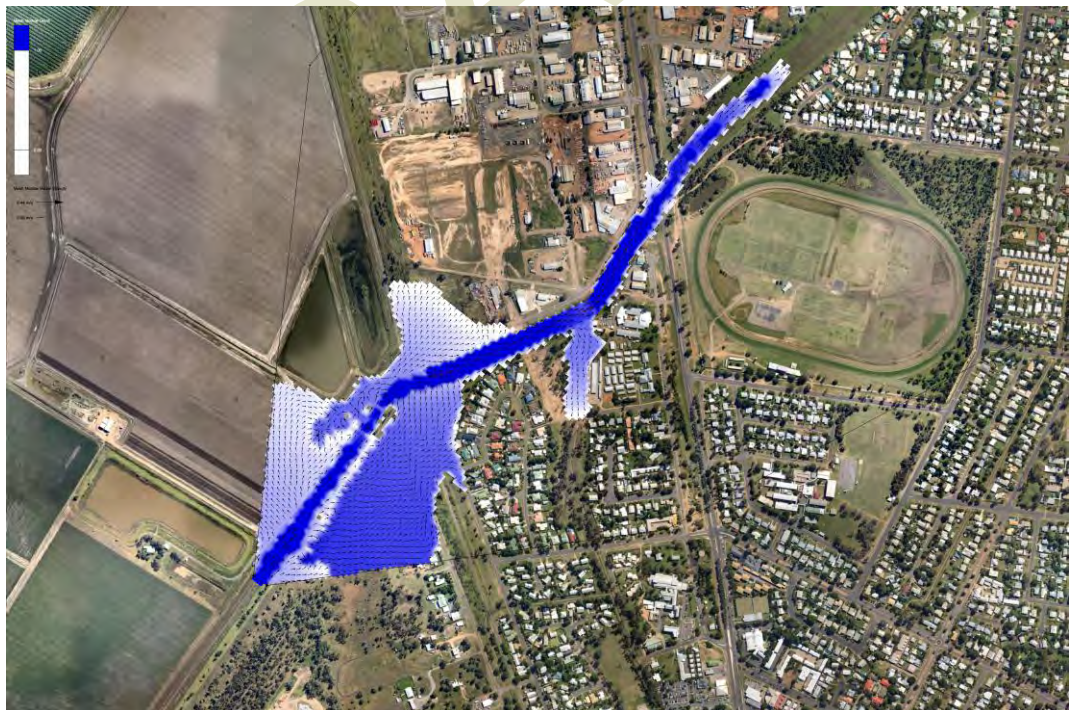
Figure 10: Modelled 100 m<sup>3</sup>/sec flow along widened LN1 drain

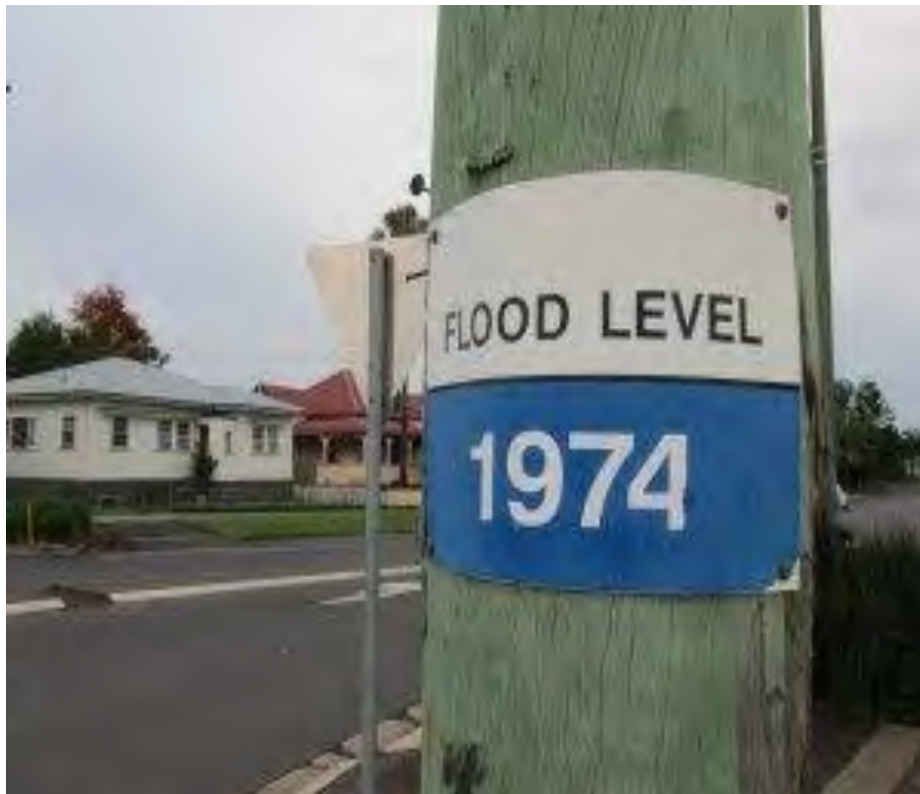
To assist in another flooding event, flood height markers from the 2010 event are recommended as a reference point for people to understand the possible risk and impact to their property. In consultation with household owners, 8-12 sites are suggested in less sensitive areas around town. It could be extended to the Vince Lester Bridge being home to a number of flood levels from the 1918, 1950, 1956, 2008 and 2010/11 flood heights. They may represent something like the image below of flood markers in South Lismore.

Figure 12: Flood Marker Example

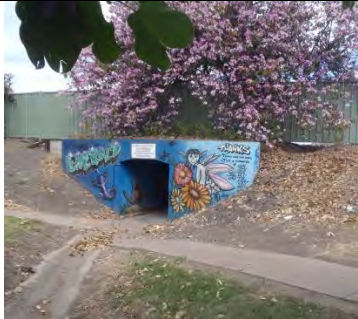
Centre of town rail line walk through	55K 0618087	UTM 7397855	Box culvert	Opening 1.7m × 1.8m

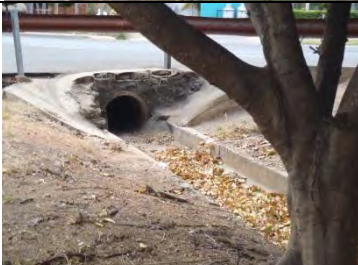
Centre of town HWY (directly opposite above)	55K 0618089	UTM 7397854	pipe	600 mm

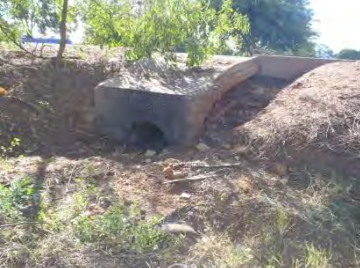
Long Street Dip	55K 0618290	UTM 7397255		350mm

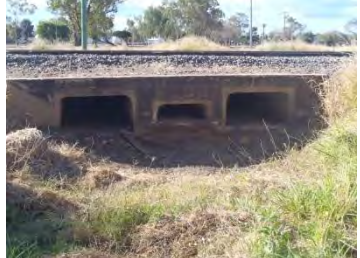
Rail Line (street Corner)	55K 0617578	UTM 7397798		(2) × 1200 × 600 (1) × 900 × 300

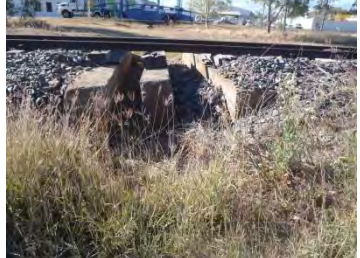
Rail Line (2)	55K0616938	UTM 7397740		(2) × 450 × 500

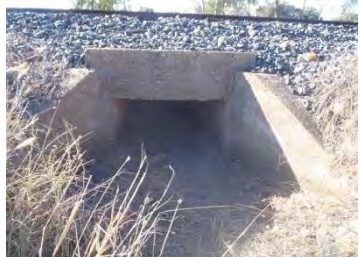
Rail Line (3)	55K 0616668	UTM 7397714		900 × 500

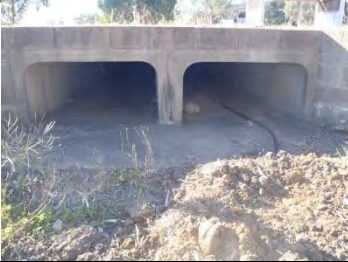
Capricorn Highway (TAFE)	55K 0616665	UTM 7397749		(2) × 1200 × 600
