Hydrological Advice to Commission of Inquiry Regarding 2010/11 Queensland Floods

TOOWOOMBA AND LOCKYER VALLEY FLASH FLOOD EVENTS OF 10 AND 11 JANUARY 2011

- Report to Queensland Floods Commission of Inquiry
- Revision 1
- 12 April 2011

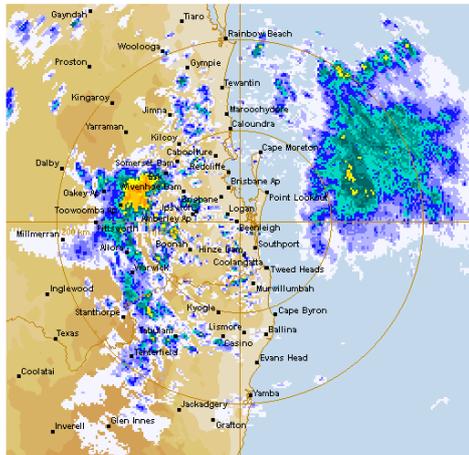
Rain Rate
 Light Moderate Heavy
 Mon, 10 Jan 2011 02:54:00 UTC Monday, 10 January 2011 12:54:00 PM

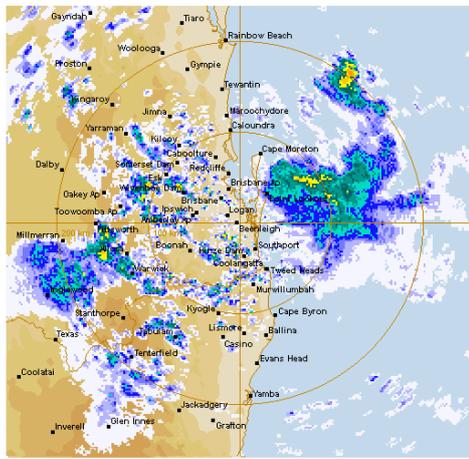
Rain Rate Light Moderate Heavy
 Mon, 10 Jan 2011 04:54:00 UTC Monday, 10 January 2011 2:54:00 PM
