Provision of Hydrological Advice to Queensland Floods Commission of Inquiry

ASSESSMENT OF IMPACT OF QUARRYING
OPERATIONS ON FLASH FLOODING IN GRANTHAM
ON 10 JANUARY 2011

- QE06544-NHY-RP-0001-Revision0
- 16 September 2011

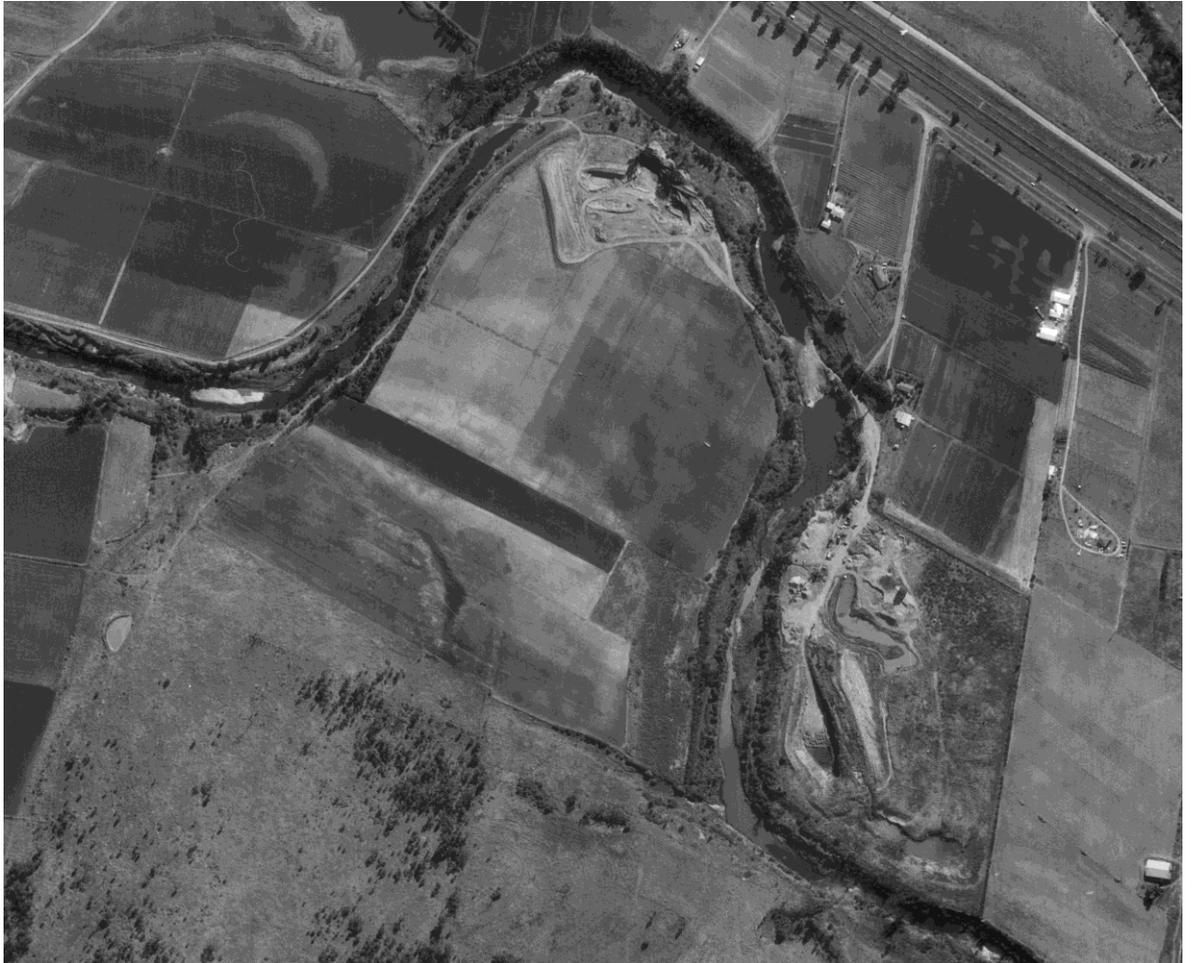
- **Figure 3–4 Aerial photograph of the area that later became the quarry currently owned by Wagner Investments Pty Ltd upstream of Grantham, captured 13 May 1982.**

Figure 3–4 shows an extract from the 1982 aerial photography that shows the area that later became the quarry currently owned by Wagner Investments Pty Ltd. It shows that quarrying operations had commenced in the northern part of the site, with evidence of removal of material and creation of mounds and material stockpiles on the northern part of the site. At the time of photography on 13 May 1982, ninety percent of the area that was later affected by quarrying operations was in its pre-quarrying state. It is apparent from the aerial imagery that the land that would later become the quarry was farm land before that time.

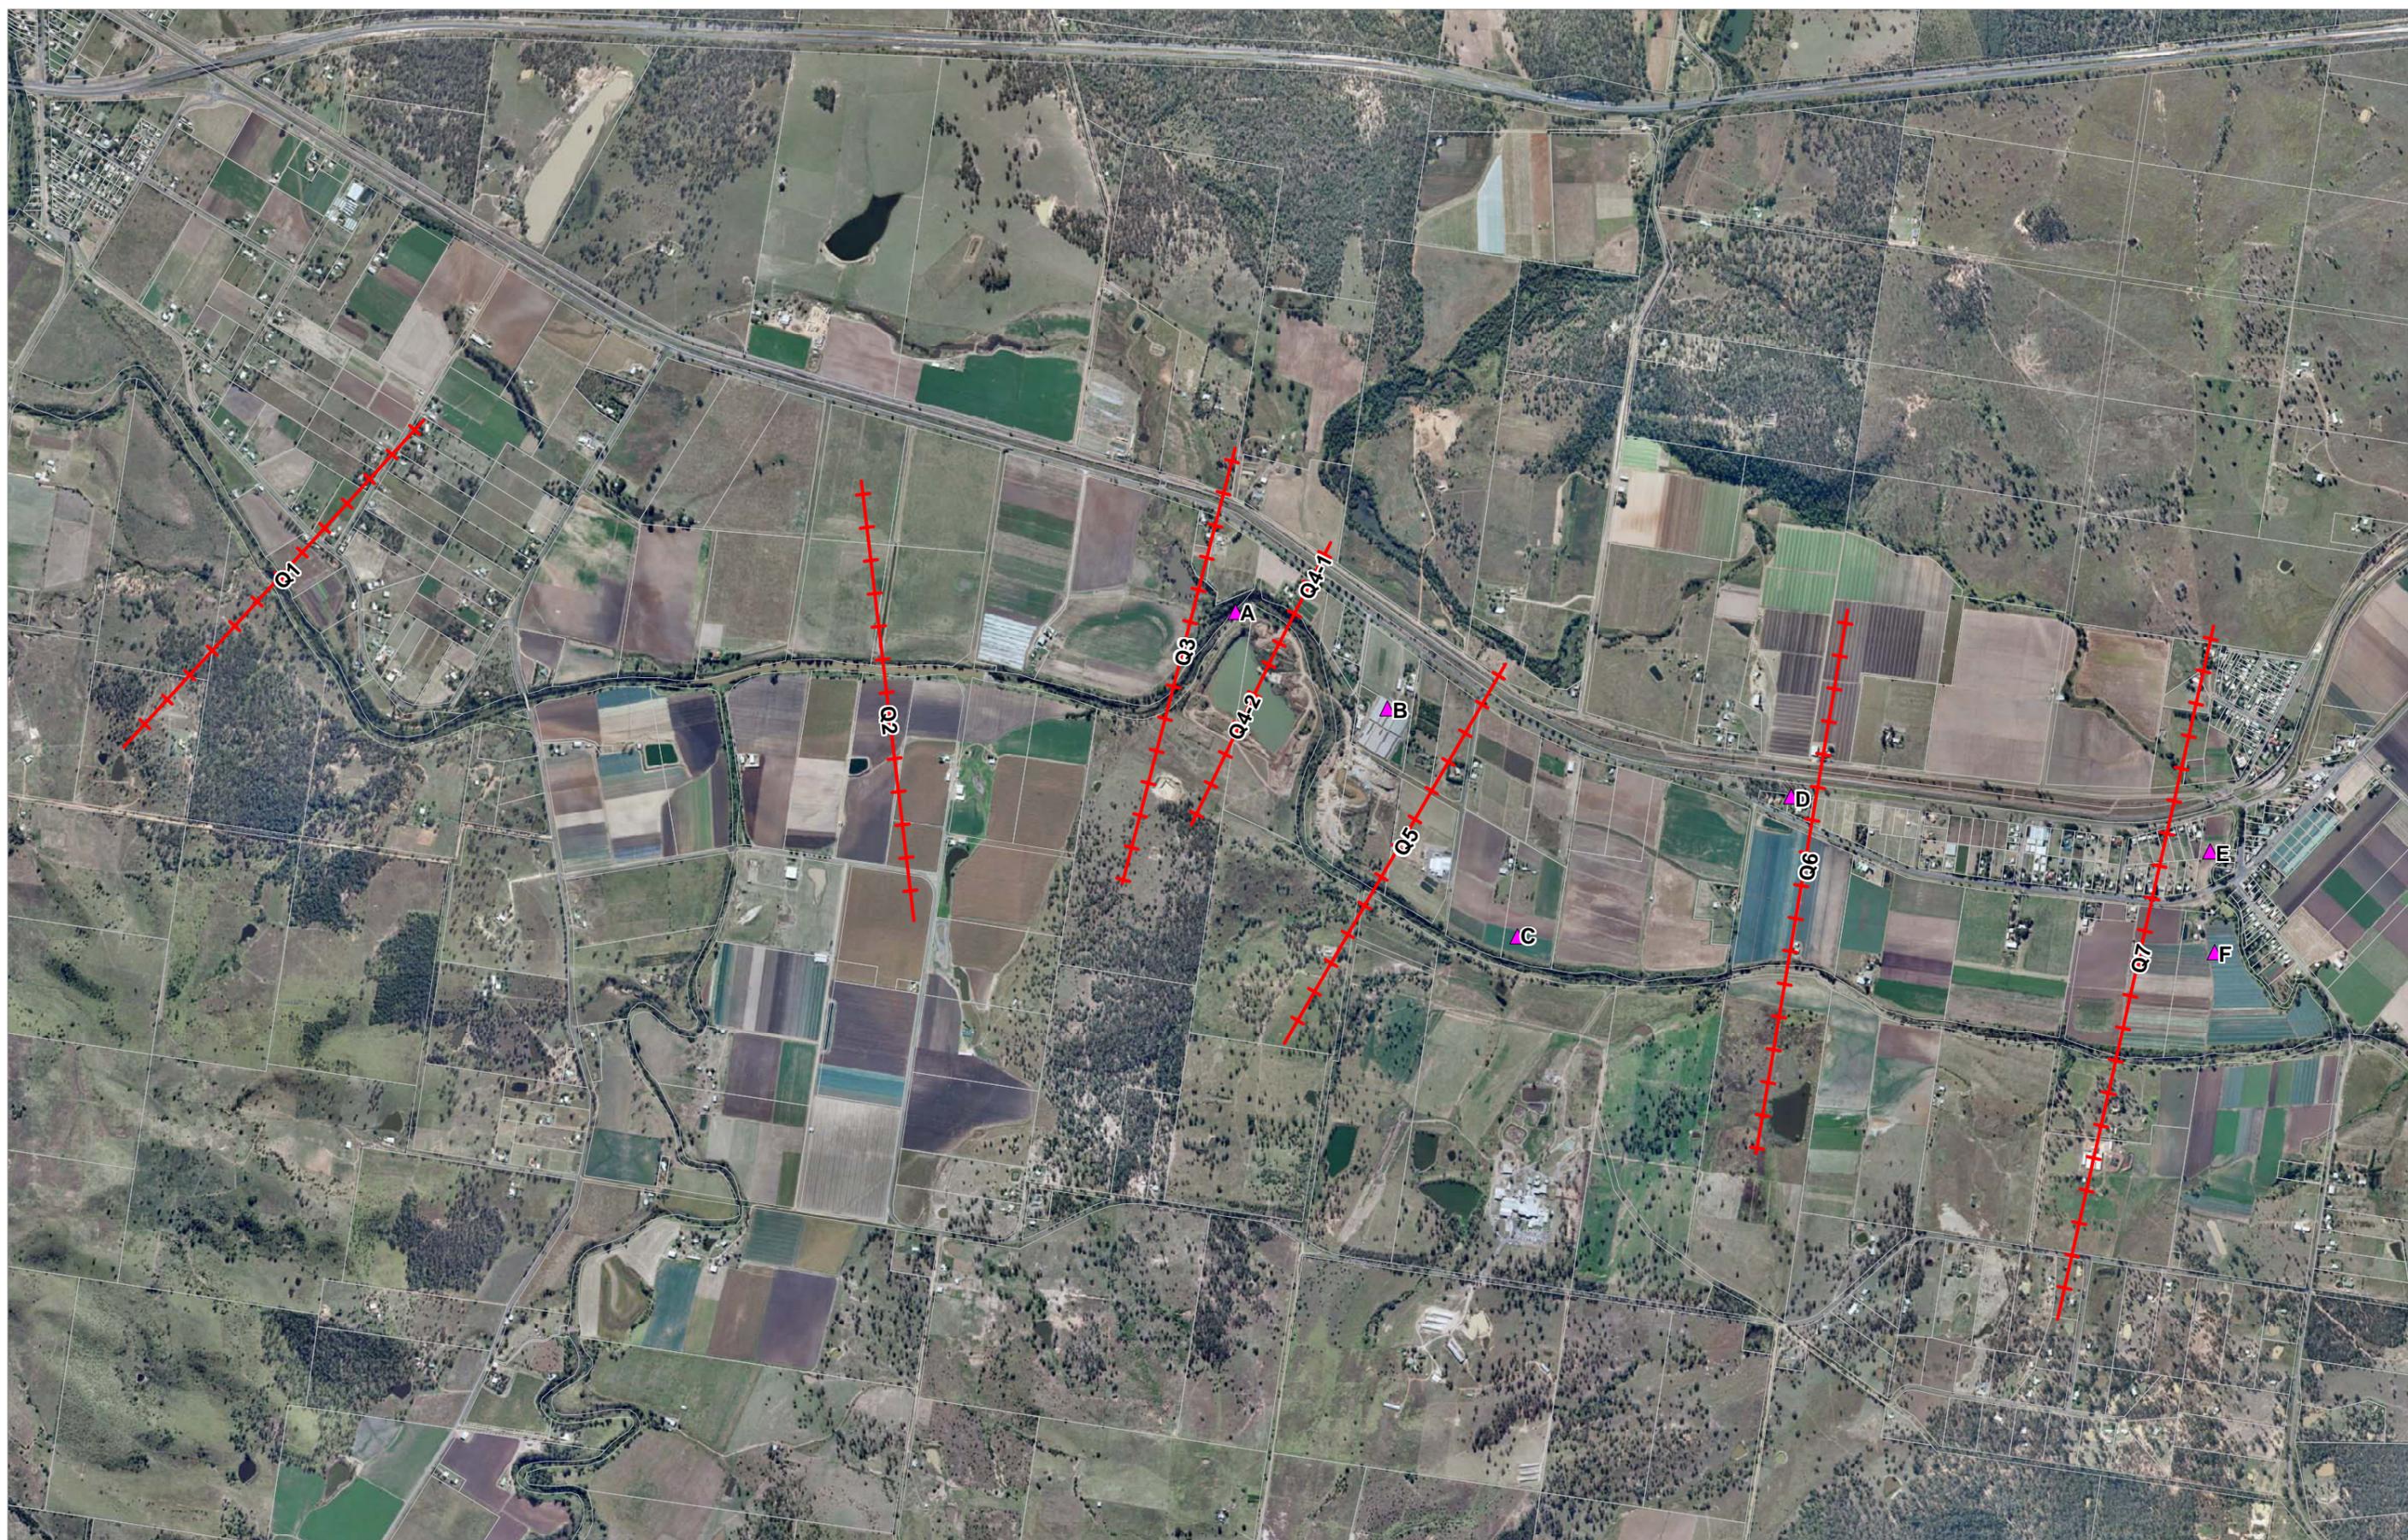
Figure 4.1
Locations of Interest
 Assessment OF Impact of Quarrying
 Operations on Flash Flooding in
 Grantham on 10 January 2011

Figure 4–12 shows hydrograph of water level at six locations (with locations as denoted in Figure 4–1). At location A, just upstream of where the breach occurred in the quarry wall, the hydrographs demonstrate that the embankment on the western side of the quarry pit constrained flows along Lockyer Creek and caused flood levels at this location to be 0.3 m higher with the quarry incorporated and breaching than in the pre-quarry terrain scenario. The shape of the hydrographs are similar with the peak occurring at 3:55 pm in both scenarios. The simulated breach of the quarry wall at 3:05 pm is evident in the water level hydrograph at location A as the two scenarios with the January 2011 terrain (with and without breach) diverge at this time, consistent with the model simulating flow through the breach.
