Rural Environment Planning Association Inc.

Submission on Brisbane Floods, January 2011

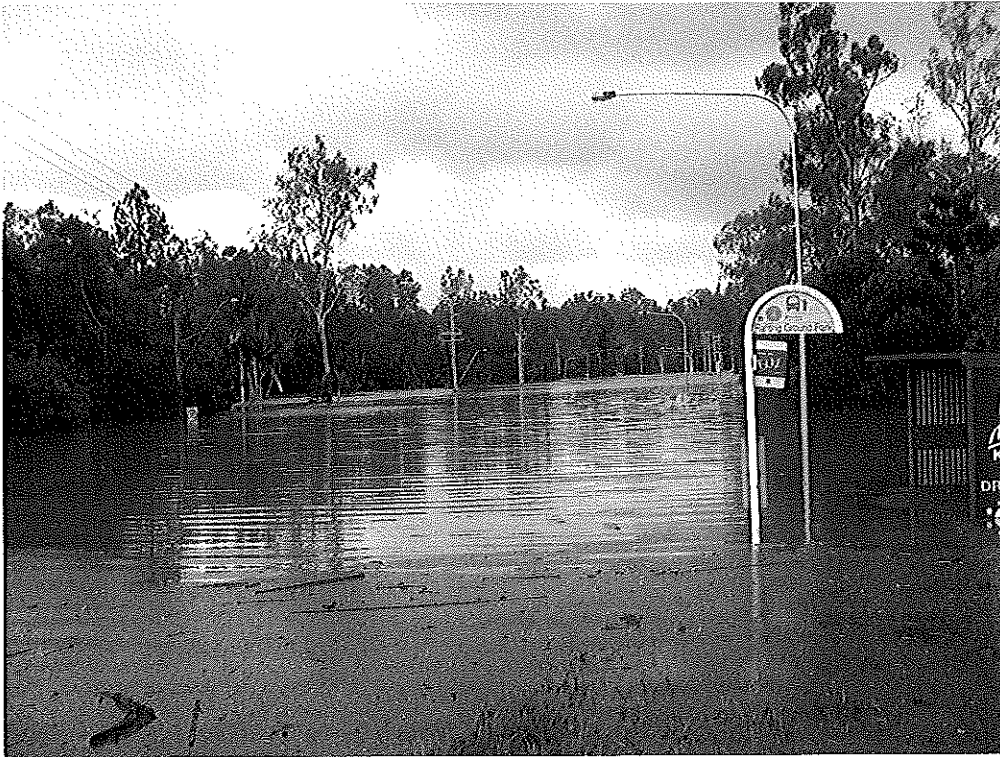
Moggill Road between Pullenvale Road and Kilkiven Avenue,
during and after the January 2011 flood. Photographs Rachel Griffiths.

Moggill Road, Rafting Ground Park bus stop - 12 January 2011

1. **Transport** – need all-weather connectivity for communities – possible use of light rail – easier to construct at raised levels
 - i. The Brisbane suburbs of **Moggill and Bellbowrie** are in serious need of all weather access. Currently, the recently upgraded portion of Moggill Road between Pullenvale Road and Kilkivan Avenue is the **ONLY** link between the suburbs of Pullenvale, Pinjarra Hills, Anstead, Bellbowrie and Moggill and Kenmore and hence Brisbane, other than the cross-river links at Moggill Ferry, Colleges Crossing and Mt Crosby Weir, all of which are subject to flooding. This section of Moggill Road is subject to both river and creek (Moggill Creek) flooding (photos Moggill Road, attached).

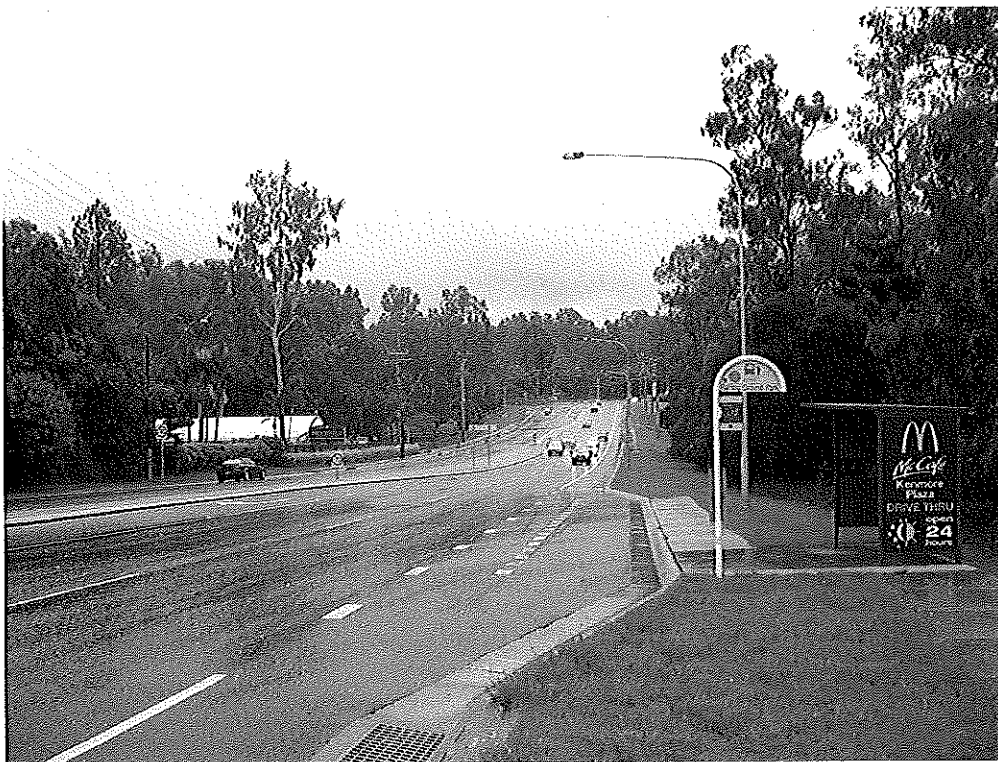
Moggill Road, Rafting Ground Park bus stop - 4 March 2011

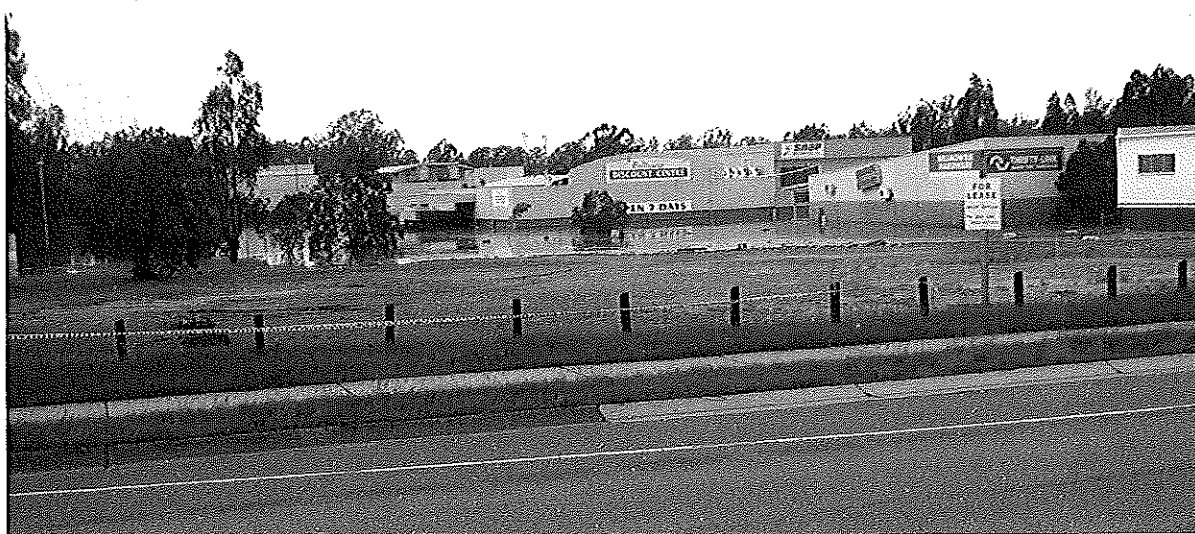
Bellbowrie shopping centre -- 11:53 am 12 January 2011.
Photograph John Bristow

7. Consideration should be given to the provision of **alternative sites** for commercial enterprises that have suffered during the recent flooding. The shopping centre at Bellbowrie in western Brisbane was completely inundated during the recent floods and it is not known (14 March 2011) when the major supermarket (Coles) will be able to re-open (photos of Bellbowrie Shopping Centre, Bellbowrie, during January 2011 floods).

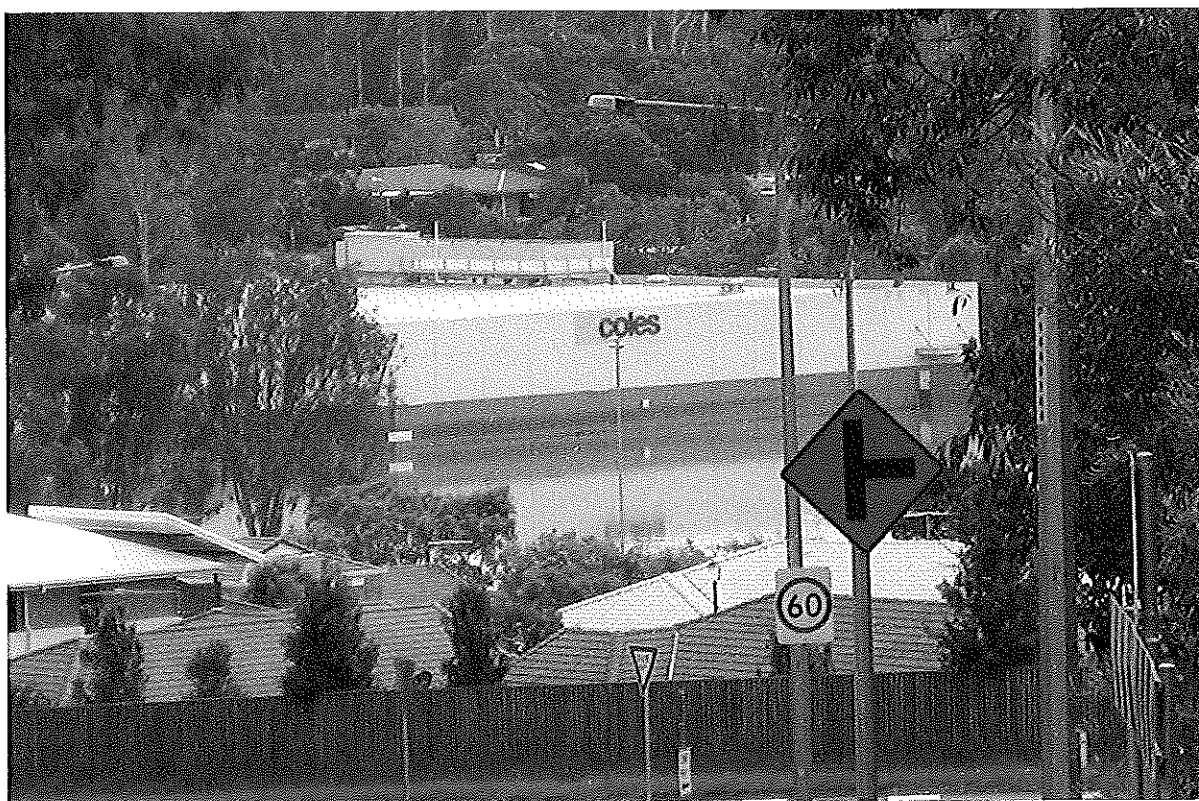
Coles supermarket, Bellbowrie – 5:55 pm 12 January 2011.
Photograph Anna Williamson
