Name of Witness	Richard Paul ROBINS		
Date of Birth			
Address and contact details	Duncan Street, West End		
Occupation	Archaeologist		
Officer taking statement	Det Insp Mark Ainsworth		
Date taken	22/8/2011

Queensland Floods Commission of Inquiry

Submission to the Queensland Flood Enquiry Robins

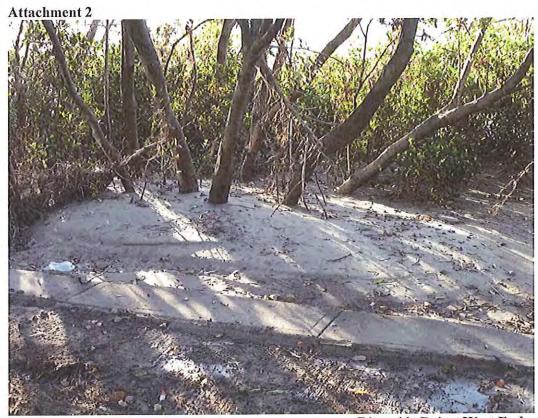
Figure 1: Mud and sand deposited amongst mangroves, Riverside Drive, West End

- 6. During the January, 2011 floods there was a massive build-up of sand and mud in the mangroves and on the paths along the edge of Riverside Drive. In places these deposits extend out to 15 metres into the river. The deposition of these sediments is indicative of an impediment reducing the velocity of water flow at that point, resulting in the dropping of the rivers sediment load. Such impediments could have had a damming effect resulting in localised increases in flood heights.

The explanation for this discrepancy could be that since the 1974 flood, the construction of bridges, walkways, buildings and the growth of mangroves along the river has contributed to a restriction of the flow of flood waters, thus causing a bottleneck for floodwaters and an increase in flood heights in particular areas! Attached photographs show a massive build-up of sands and mud in the mangroves along the edge of Riverside Drive. In places these deposits extend out some 15 metres into the river. The deposition of these sediments is indicative of an impediment reducing the velocity of the flood flow at that point resulting in the dropping of the rivers sediment load. Such impediments (and mangroves are only an example), could have had a damming effect resulting in localised increases in flood heights.

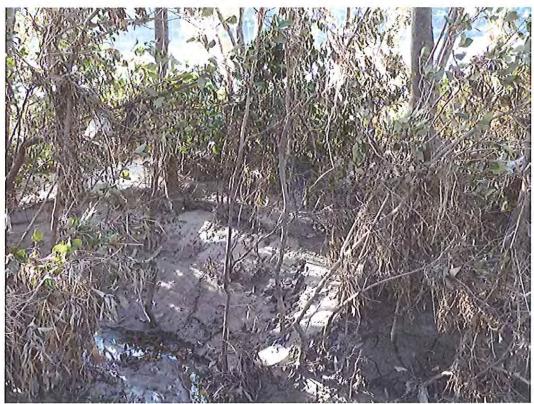
Figure 2: Mud and sand deposited amongst mangroves, Riverside Drive, West End
