# **INSURANCE COUNCIL OF AUSTRALIA**

## **THE NATURE AND CAUSES OF FLOODING IN TOOWOOMBA 10 JANUARY 2011**

**ICA HYDROLOGY PANEL  
14 FEBRUARY 2011**

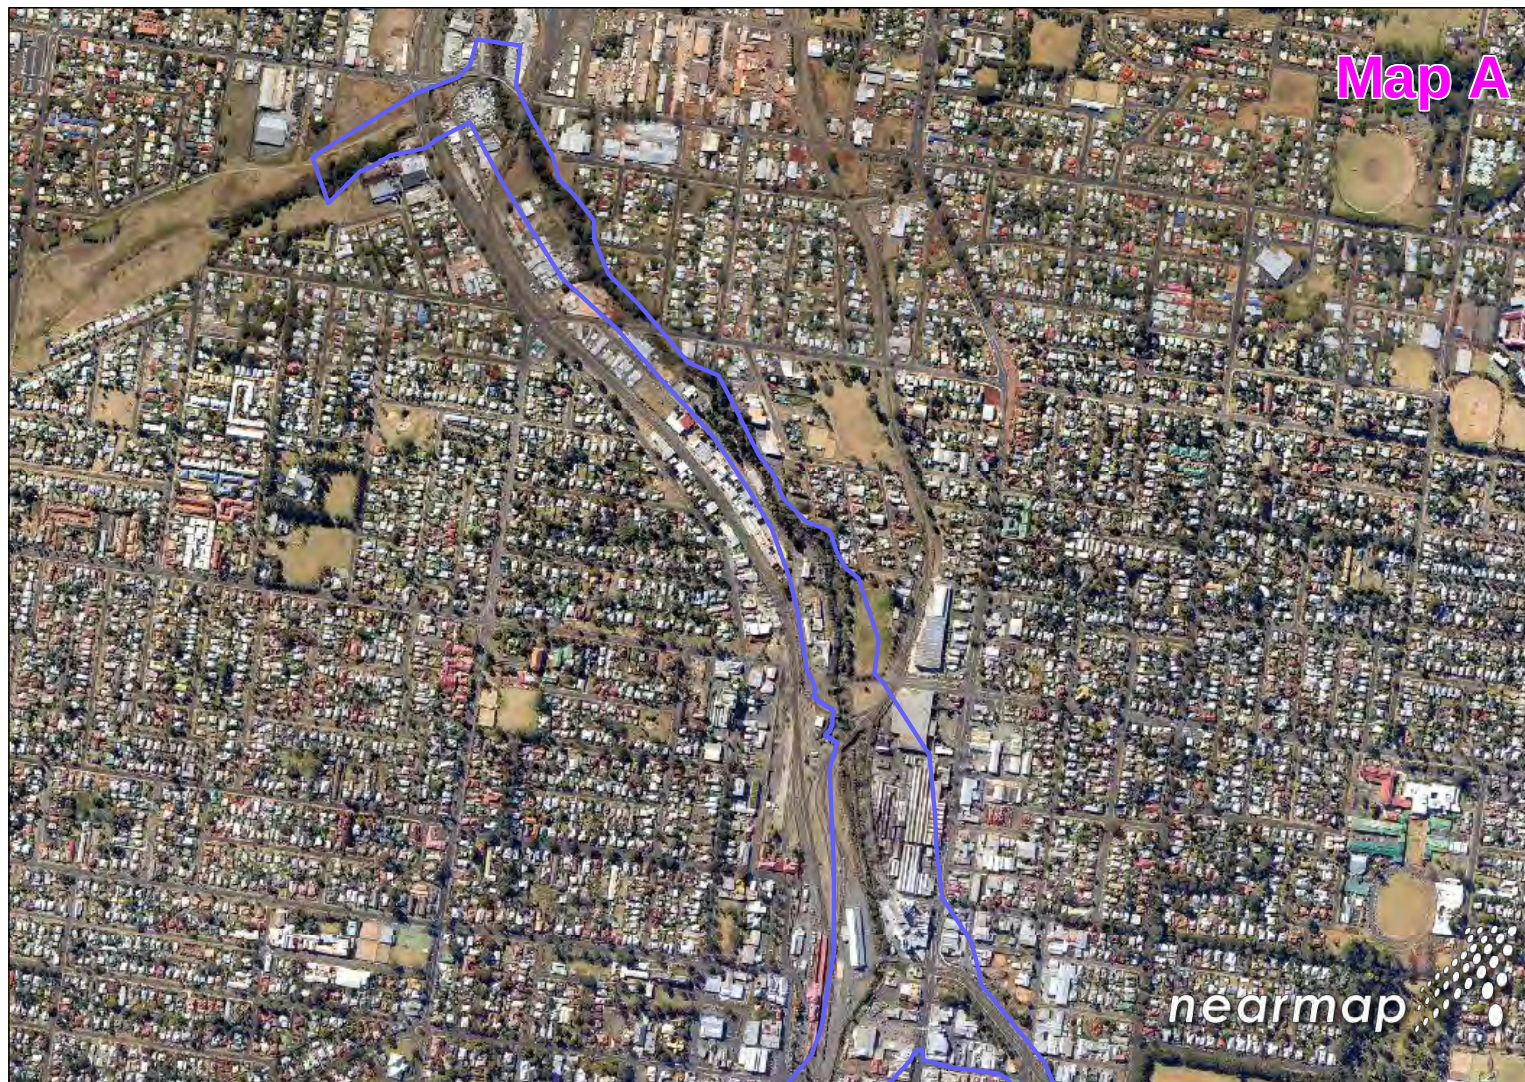
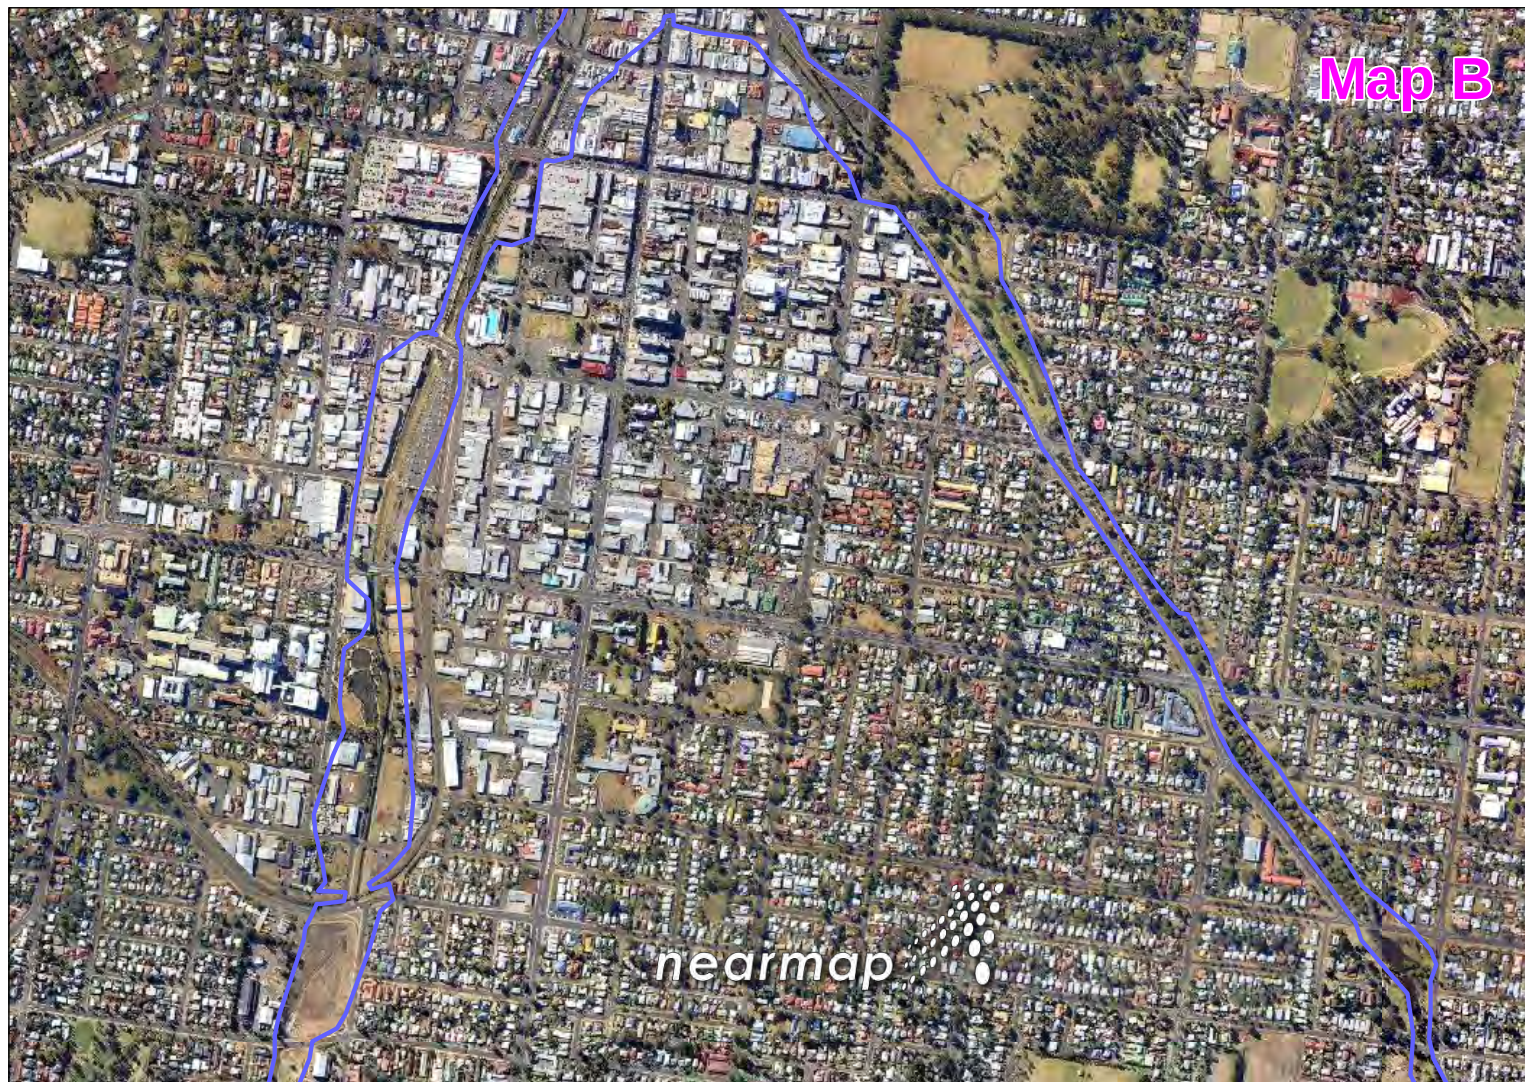
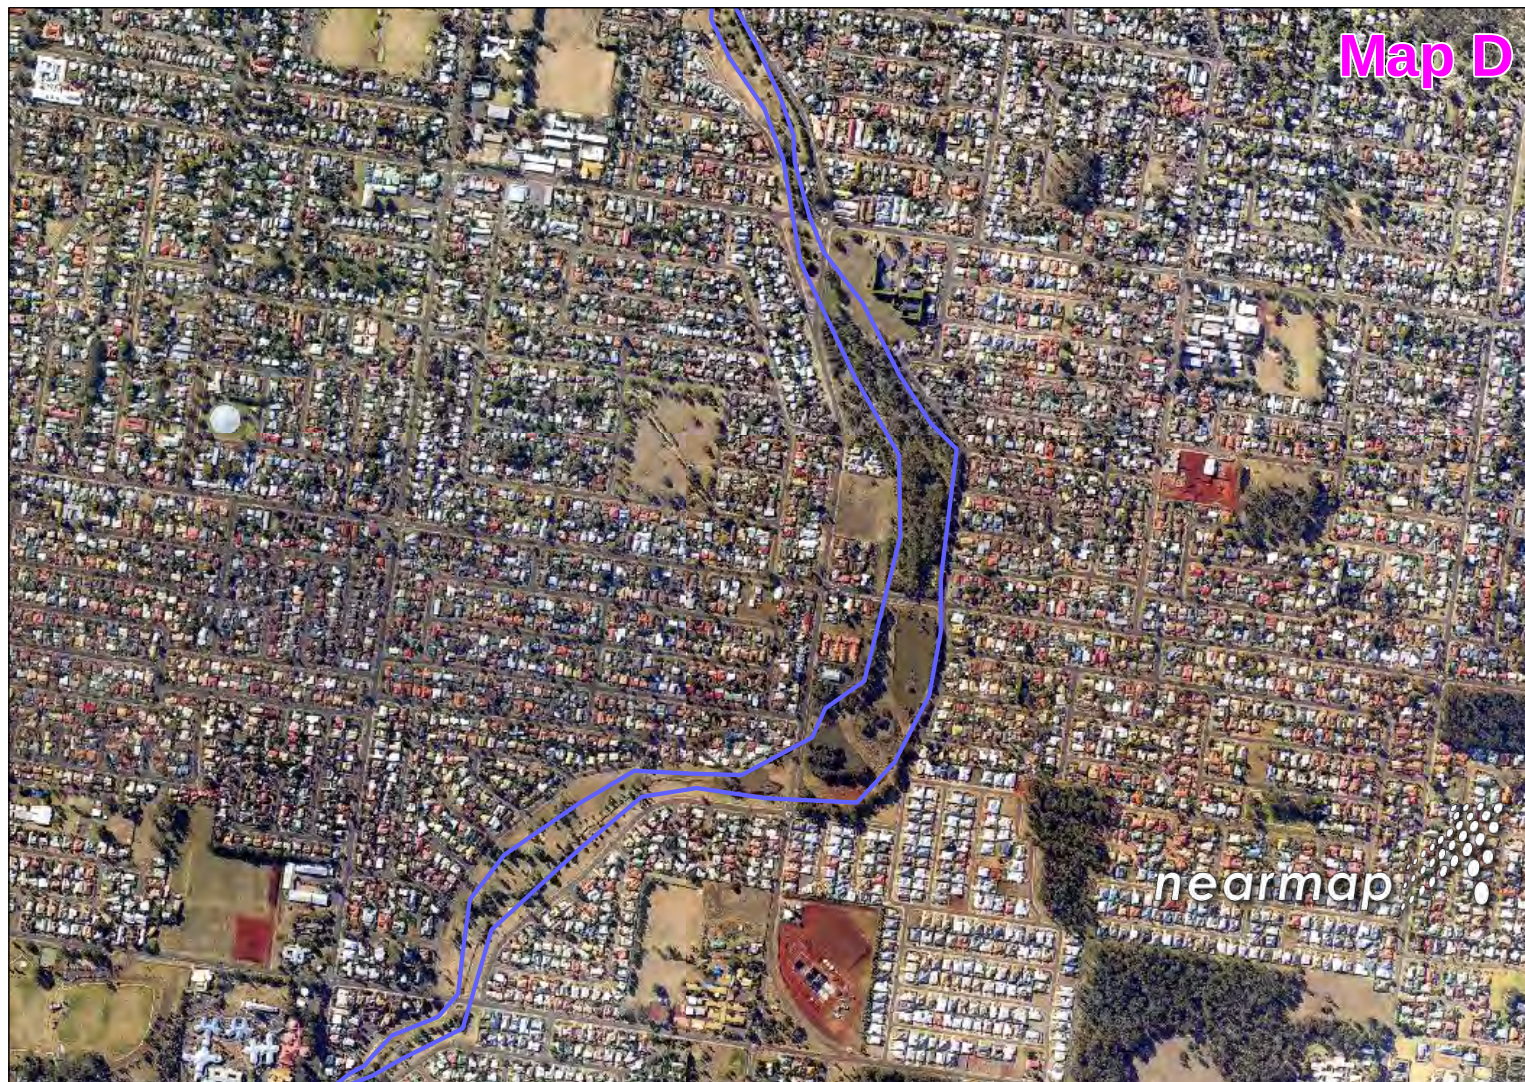
## **EXTENT OF INUNDATION MAPS**

Figure 8.2 shows the approximate extent of inundation caused by floodwaters from Gowrie Creek and its tributaries, as estimated by Toowoomba Regional Council (TRC) on the basis of flood debris marks. The four diagrams in Appendix C show the estimated extent of inundation in more detail. Regarding the estimated extent of inundation:

Hence any inundation that occurred in areas clearly remote from the limits of inundation shown in Figure 8.2 and Appendix C *will have been caused by overland flow.*

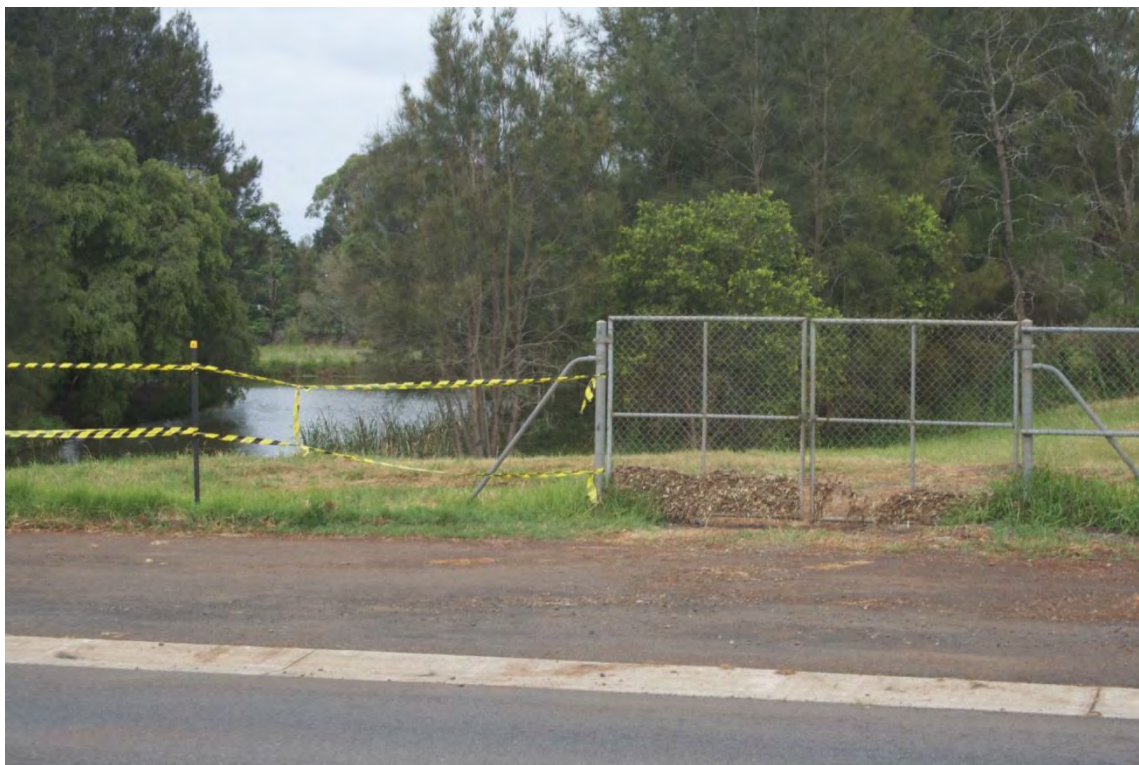
*Photo No. 1      East Creek at Spring St Looking Upstream: Debris Indicates Depth of Flow Over Road*

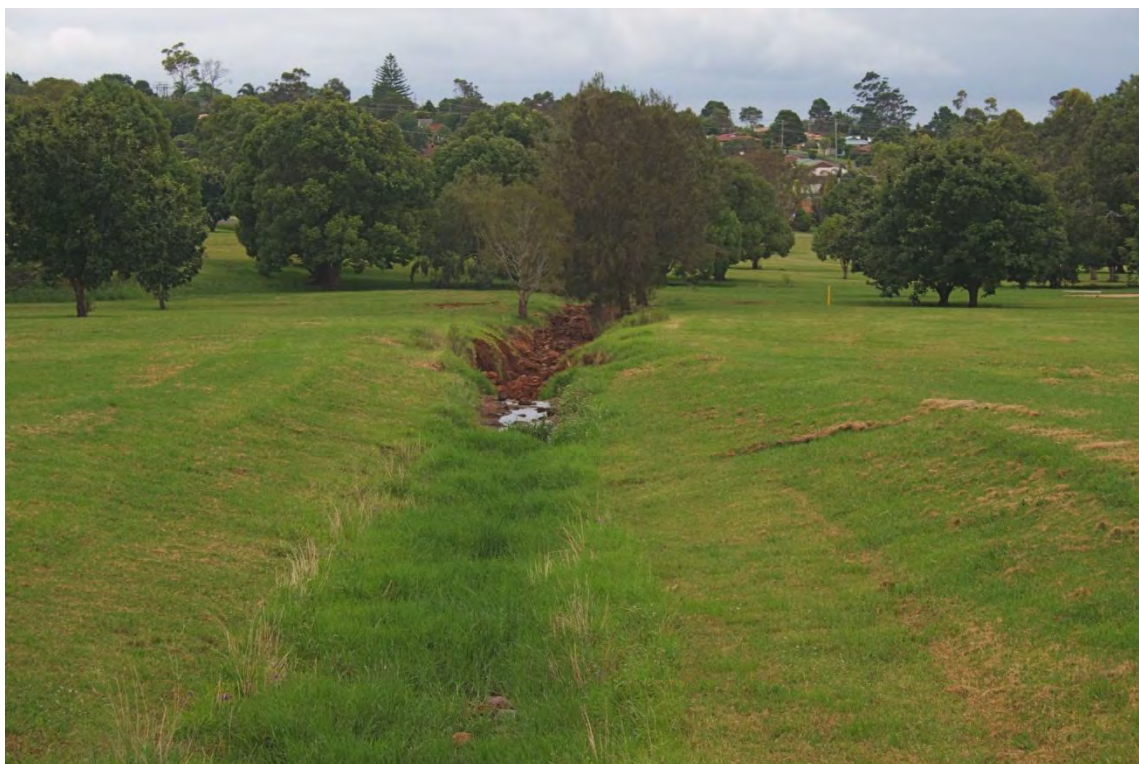
*Photo No.2      East Creek at Spring St Looking Downstream: Bank Erosion Along Grassed Waterway*

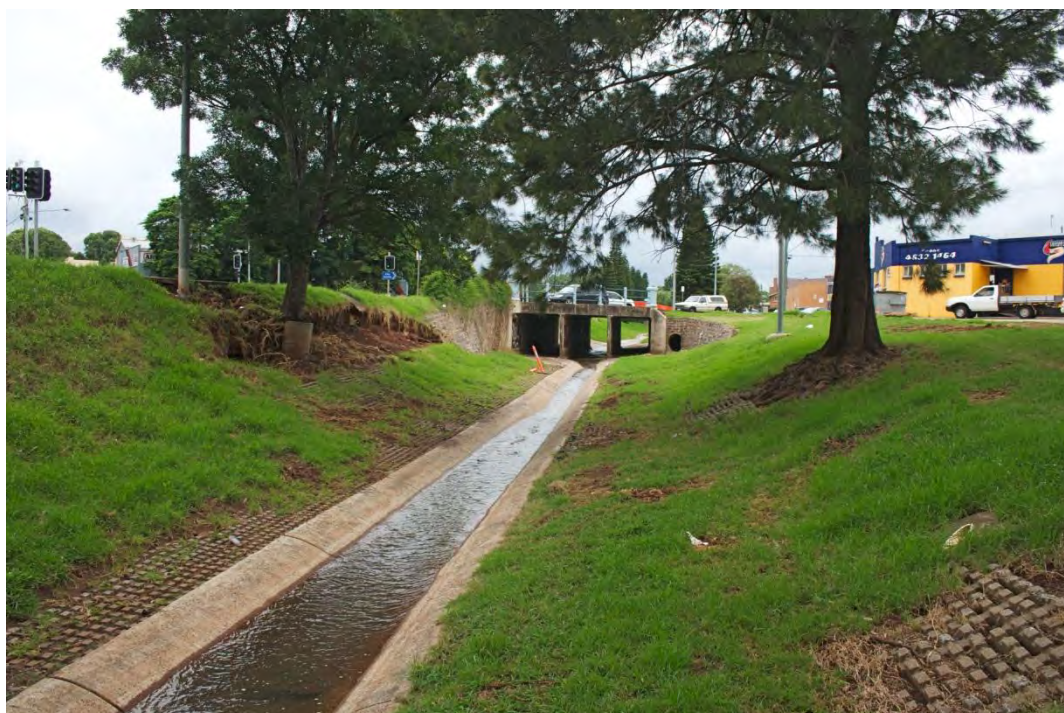
Photo No. 4      *East Creek Looking US at Neil St Culverts: Grassed Waterway with Concrete Low Flow Channel, Erosion on RH Bank, Depth of Flooding 1.5-2 m above Neil St*

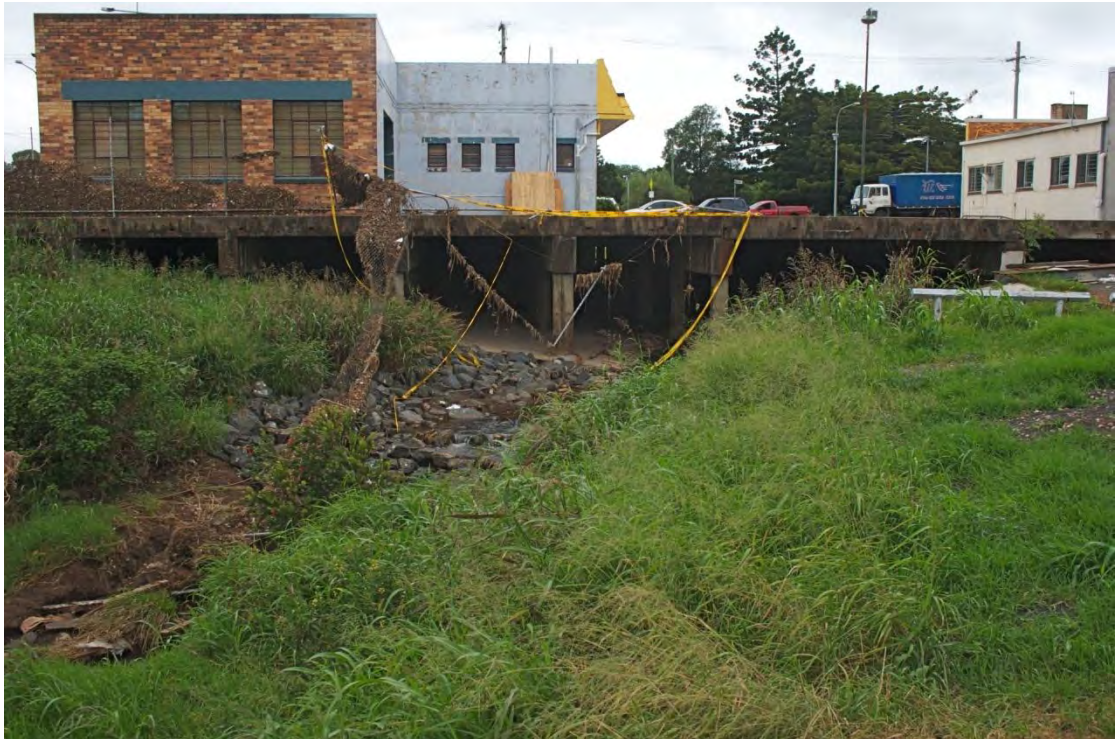
Photo No. 5      East Creek Outlet Under Ruthven St: Note Flood Debris on Fence; Floodwaters were some 2m Above Deck Level

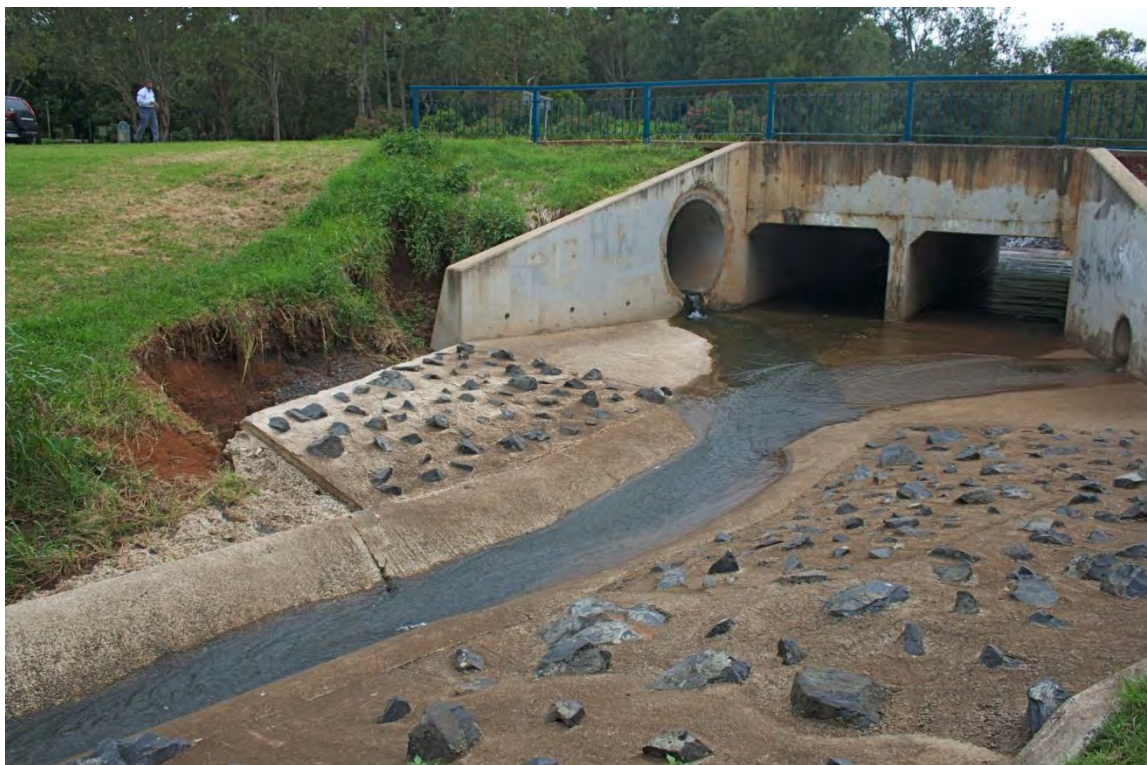
Photo No. 6      West Creek at Spring St, Looking Upstream: Spring St overtopped by 0.5-1 m, Erosion on RH Bank Caused by Floodwaters Overtopping Road

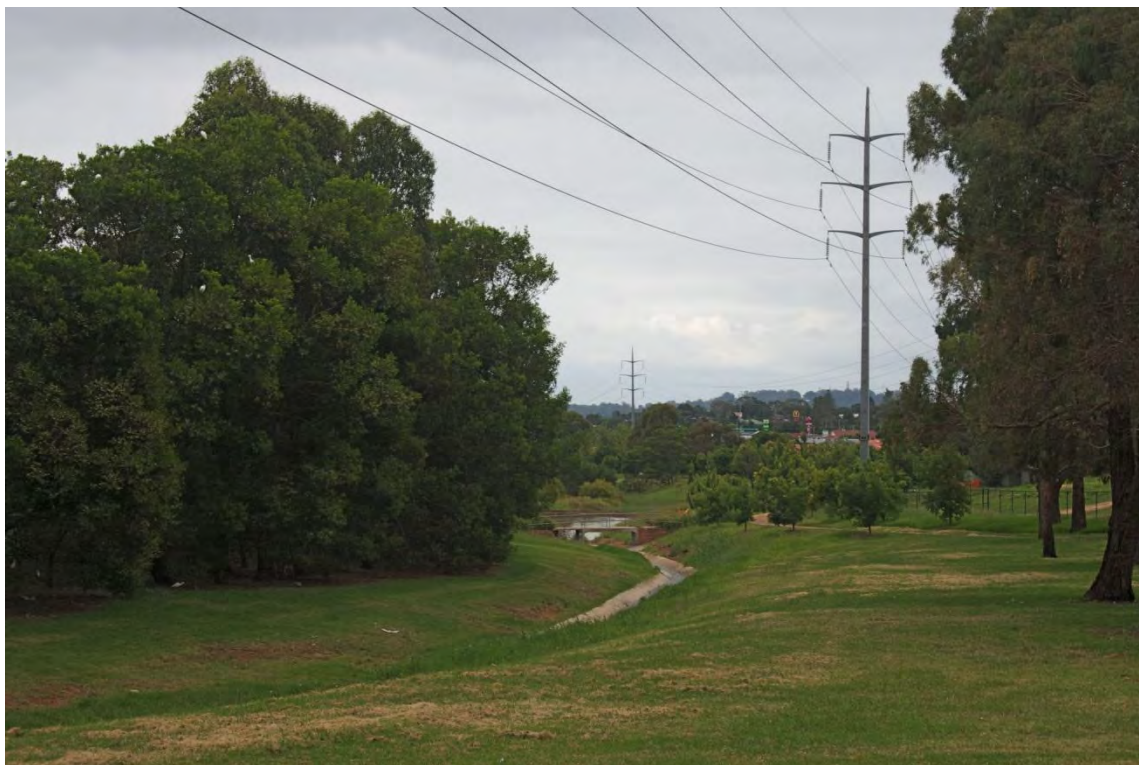
Photo No. 7      *West Creek at Spring St Looking Downstream: Grassed Waterway with Concrete Low Flow Channel.*

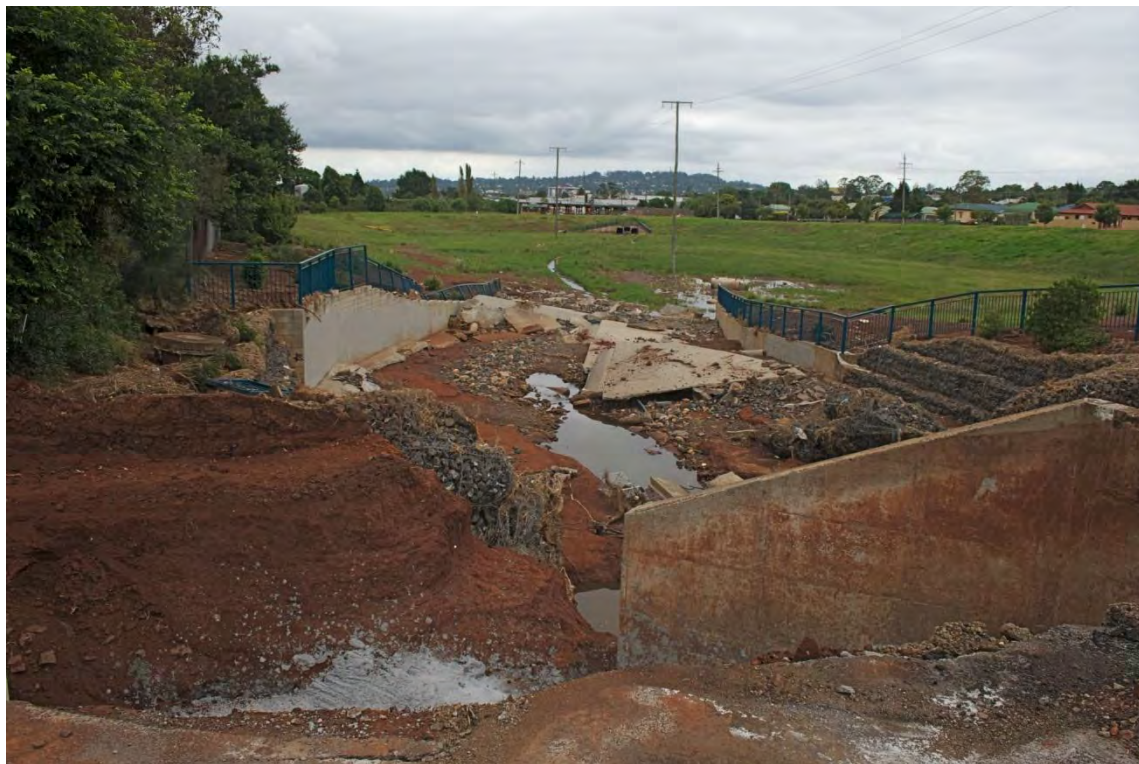
In passing, it is noted that all detention basins along West Creek were overtopped but did not breach. It is not expected that the basins had any significant effect in mitigating waterflows passing through them.

Photo No. 8      *West Creek at James St Looking Downstream into James St Detention Basin: Outlet Works Under James St Destroyed.*

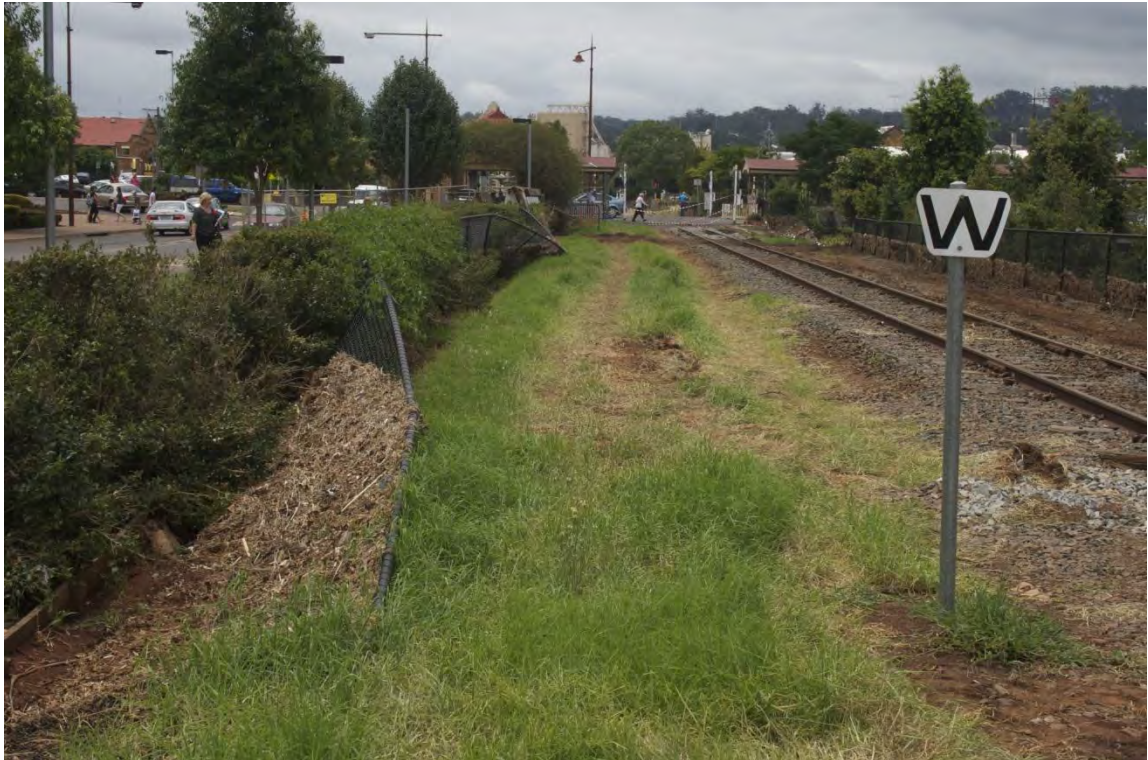
*Photo No. 9 Looking North Along Railway Line Opposite Dent St (LHS), Russell St Crossing in Background: Northward Flowing Floodwaters from Dent St Flowed Eastwards across Railway Embankment and Back into West Creek (RHS Out of View)*

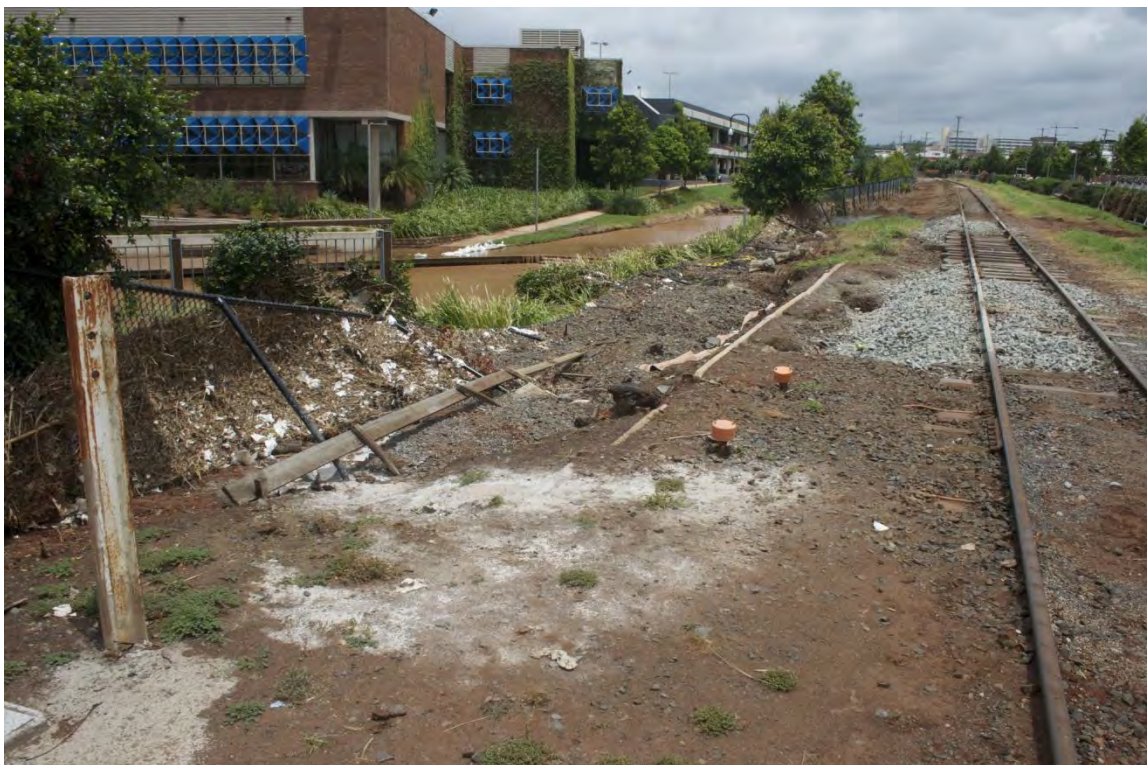
*Photo No. 10 Looking South Along Railway Line Opposite Dent St, West Creek to LHS: Easterly Flowing Floodwaters that Overtopped the Embankment Destroyed Fence When Returning to West Creek*

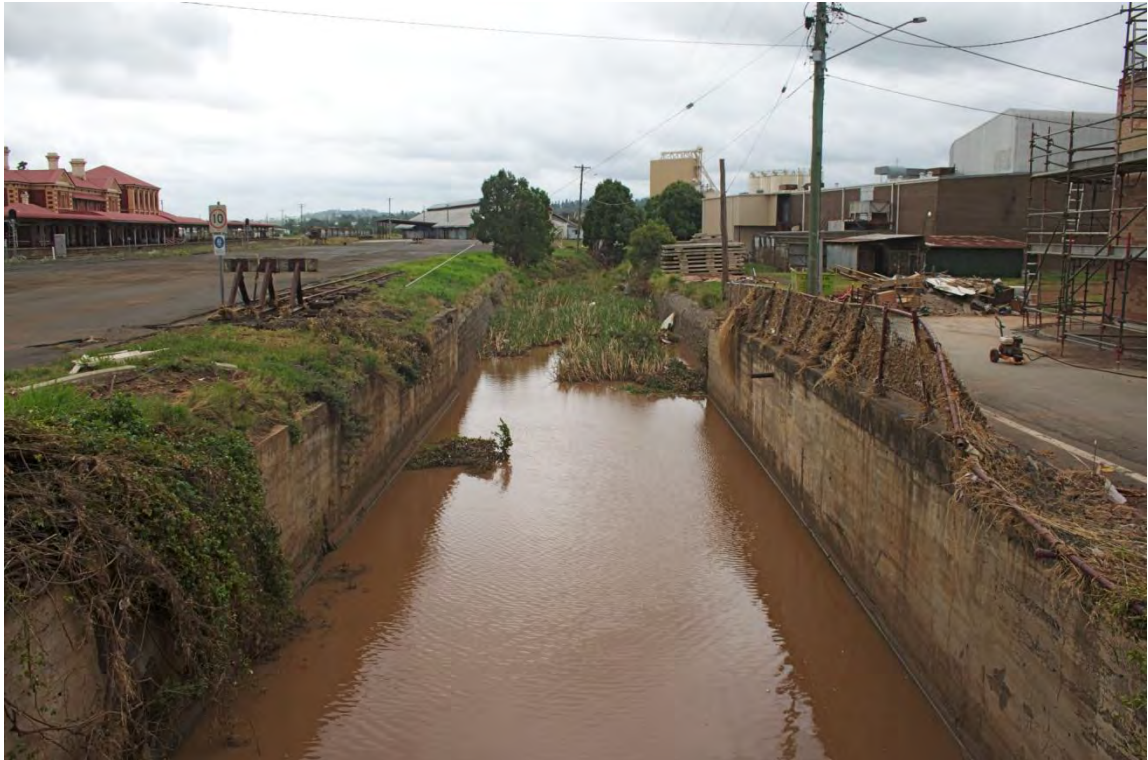
Photo No. 11 West Creek North of Russell St, Looking Downstream (Flour Mills in Background): Extensive Inundation Along Russel St.

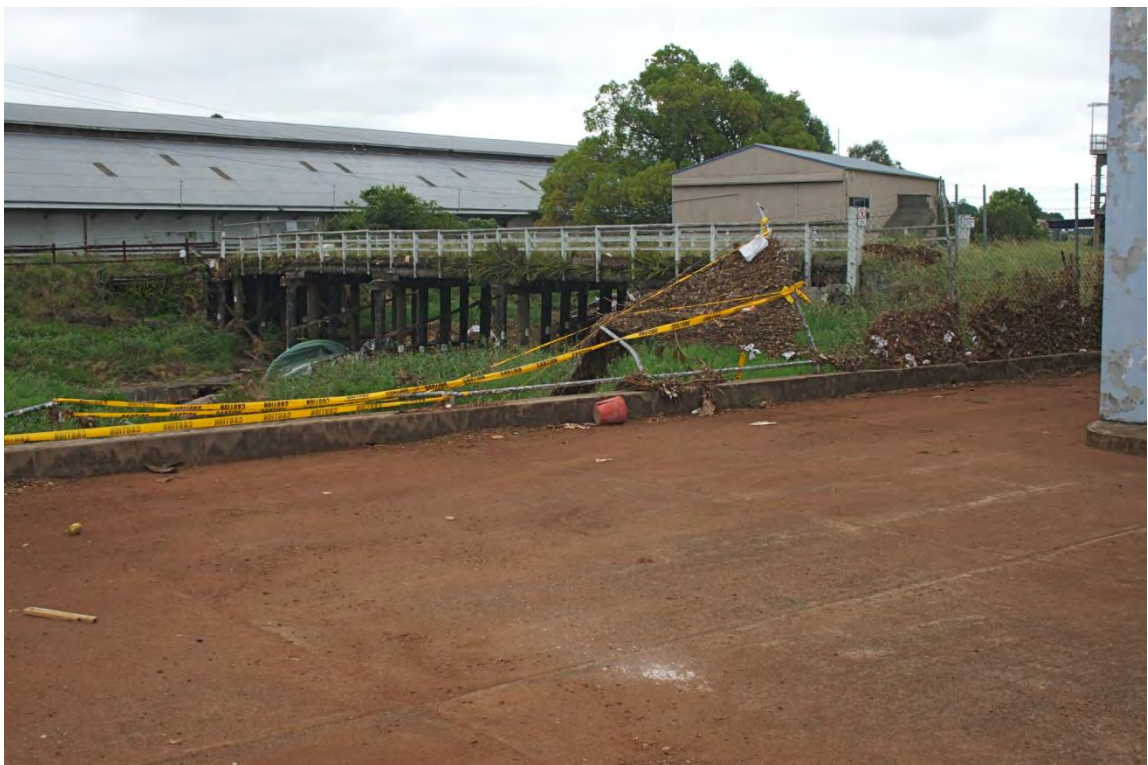
Photo No. 12 Gowrie Creek at Junction of East and West Creeks From East Creek Waterway Crossing: Floodwaters 2 m Above Deck Level

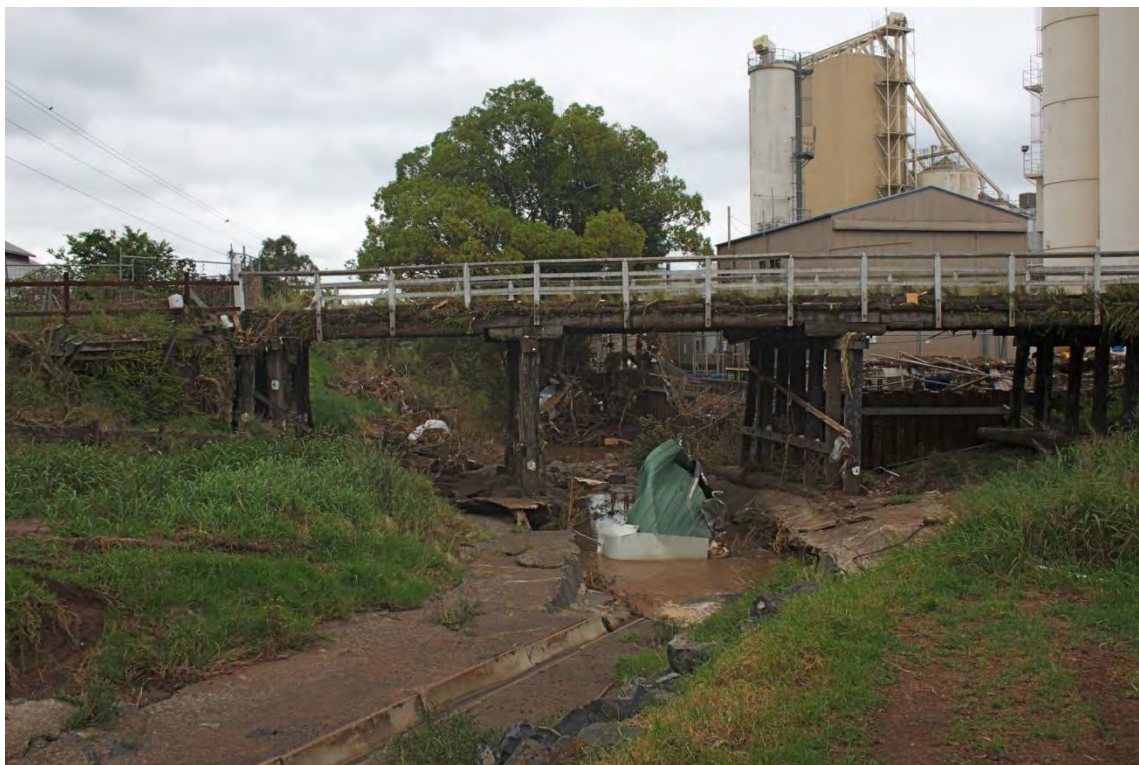
*Photo No. 13 Disused Bridge Immediately DS of Junction of East and West Creeks (Flour Mill in Background):  
Floodwaters 1.5-2 m Above Deck Level of Bridge, Flood Debris Readily Apparent in Creek.*
