COOLMUNDA DAM FLOOD EVENT REPORT

Emergency Event Recording Sheets

Coolmunda Dam Event Report

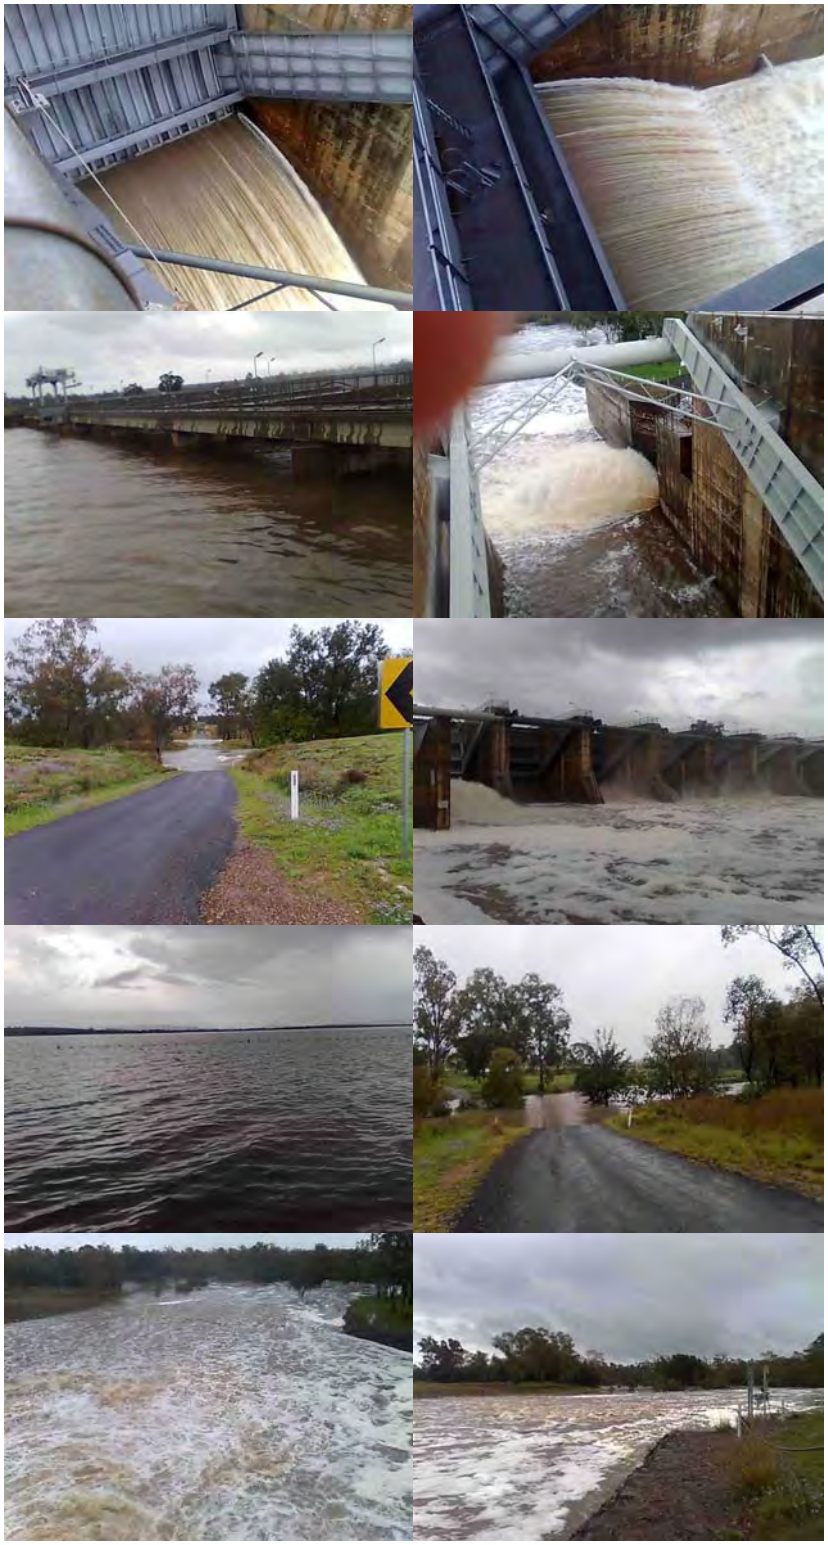
25 9:17

Access service ladders damaged and missing lower ladder, washed away

Dam crest seal failure

Missing floating buoys
