Beardmore Dam Emergency Event Report

Beardmore Dam Event Report

EMERGENCY EVENT REPORT – BEARDMORE DAM – 16th November 2010 to 3rd February 2011

Beardmore Dam – Damage Report.

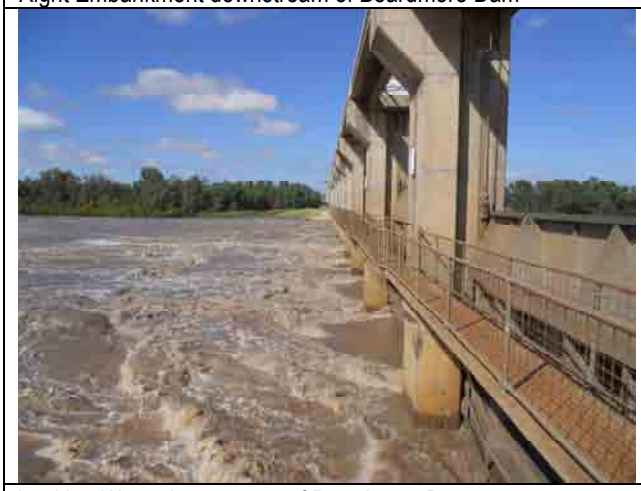
Right Embankment downstream of Beardmore Dam

Looking west upstream Beardmore Dam
