Submission to Queensland Floods Commission of Inquiry Order (No. 1) 2011

Aura Apartments: A Case Study for Reviewing Planning in Flood-prone Areas in Brisbane

36 Units in Ferry Road, West End, Brisbane

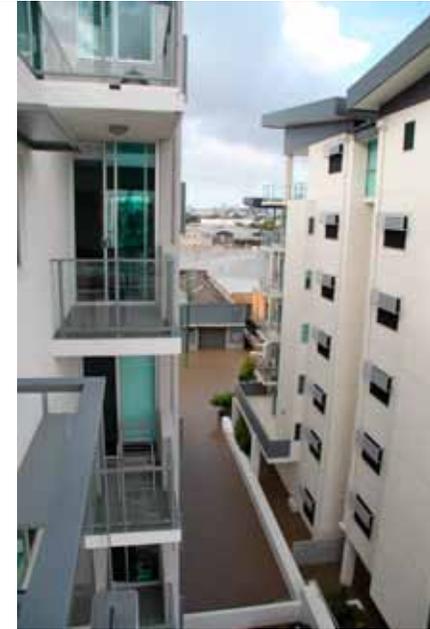
The ground floor was built at RL5.9, a level approved under the existing regulations. This was inadequate for Aura as water rose up to around 6.4 metres in our building and street in the January 2011 floods. This implies a design Q100 flood level of RL5.4. This level was far too low in Riverside South, West End and may even have been below the 1974 flood.

Taken from Unit 32 at Aura on 12/01/11 at 5.13 pm looking towards the city

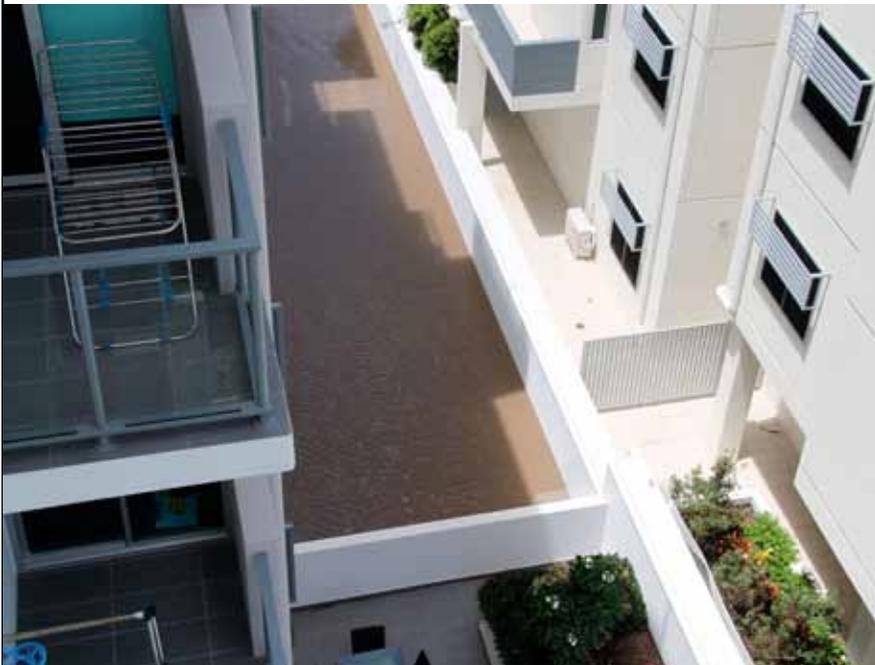
View of the carpark entrance with water still rising at 1.19 pm on 12/01/11

The building has two basement carpark levels. It took 2 days to remove water from the first level, but another 7 days to empty the second level. Regulations need to stipulate building designs with access holes that make it easier to pump water out of second or lower level basements.

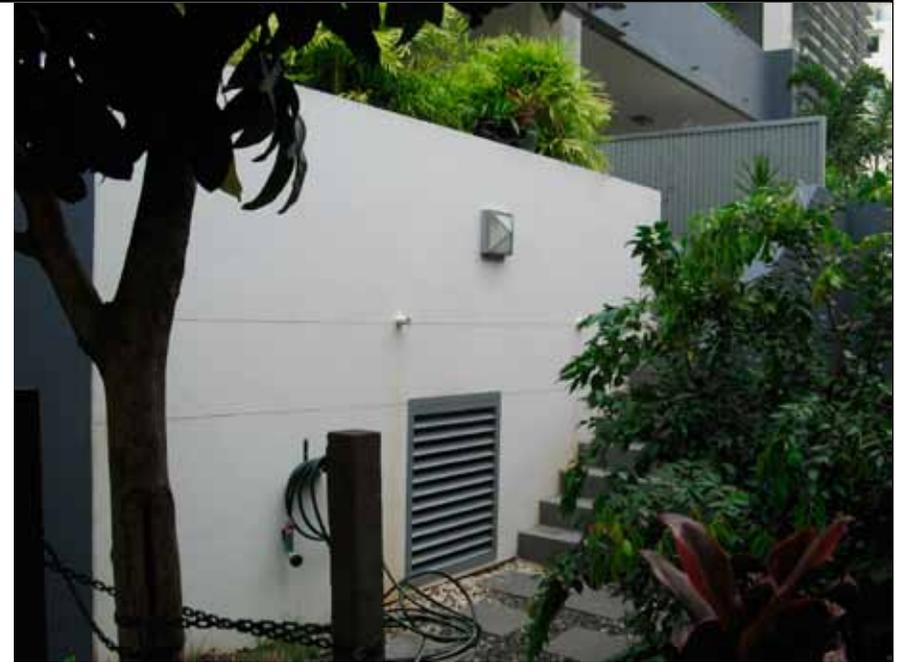
The Council approved building plans for grills for ventilation into the B1 carpark. These grills are well below the ground floor level of the building, and below the design Q100 flood level.

Vents at the back of Aura with the sunken garden below ground level

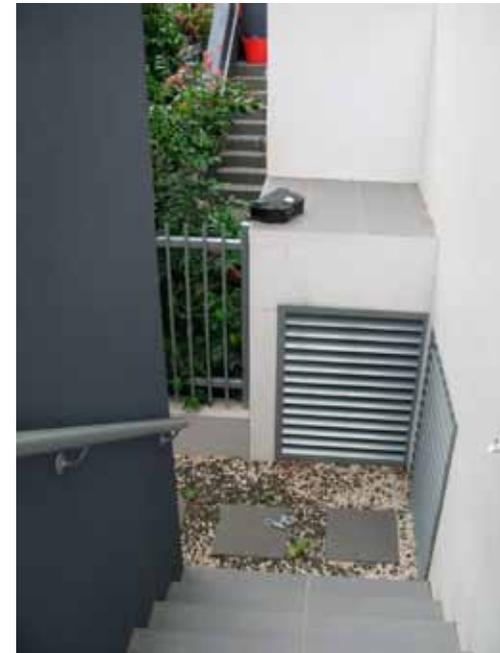
Stairs from ground floor leading to back garden with vents where water spilled into B1 carpark

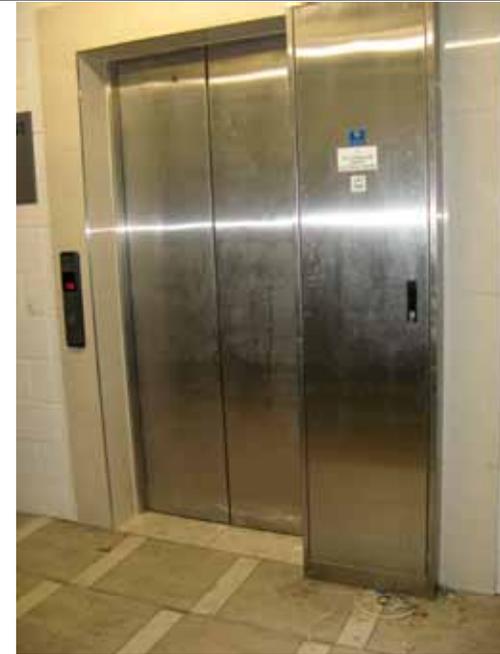
The lift motors and controls are located in the Basement 2, so they were badly affected by flood water and they are very expensive to replace, costing over \$40,000. In Aura there is room for the lift to be placed at the top of the lift shaft, but relocating the motor and controls is very expensive at over \$250,000. Regulations requiring lift motors and controls to be put above flood water levels would have saved residents in Aura many thousands of dollars.

Aura lift doors on Basement 2 with controls on the right

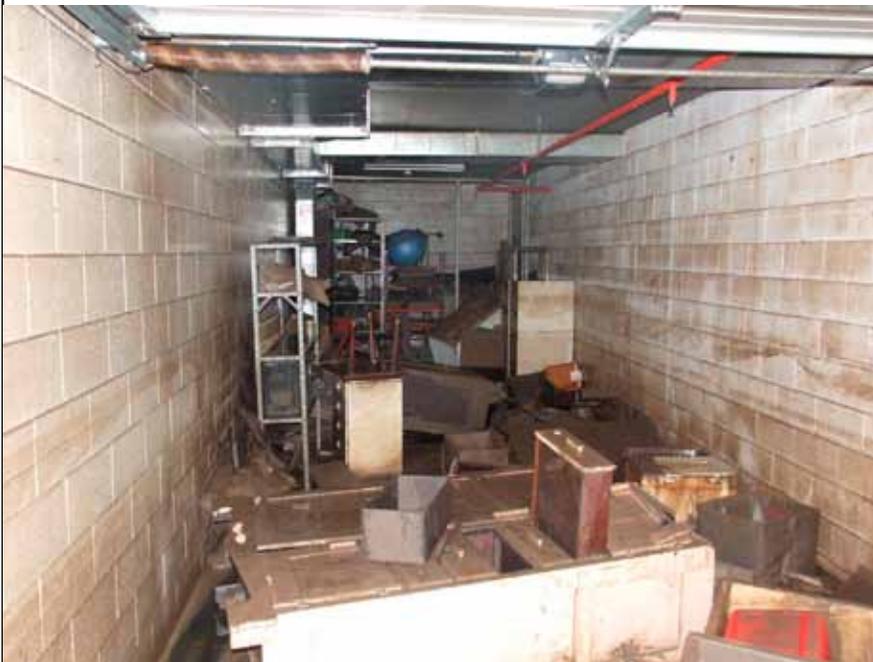
The control panel for the CO₂ ventilation system is located in Basement 1, so this was another expensive service to replace. Repairs will cost over \$20,000. Not all parts of this system can be relocated, but the control panel could be. However, retrofitting this panel is expensive. In flood-prone areas buildings should have the control panel above flood levels.

Metal ducts in the roof are part of the CO2 ventilation system

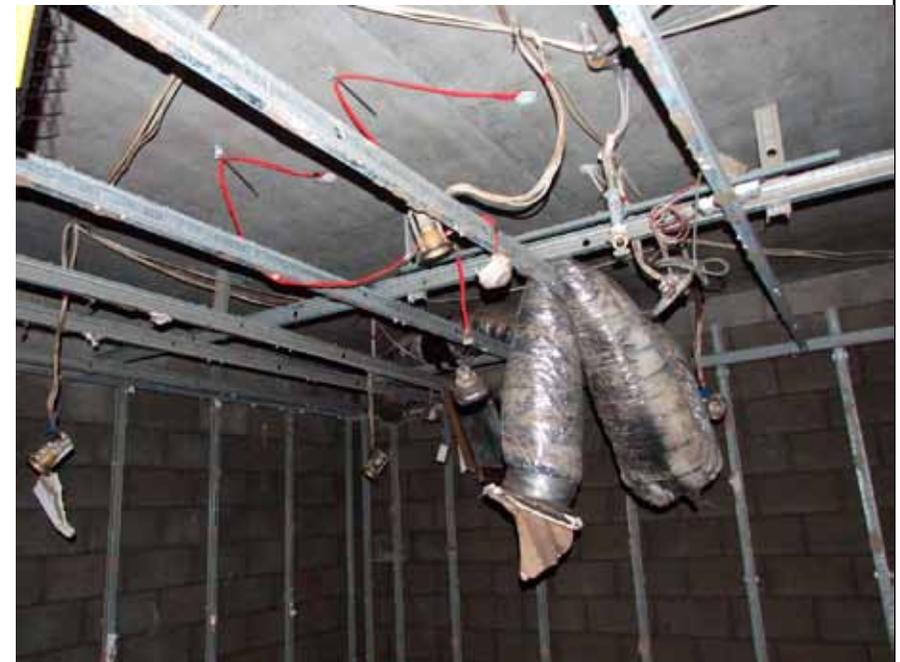
Part of the CO2 ventilation system

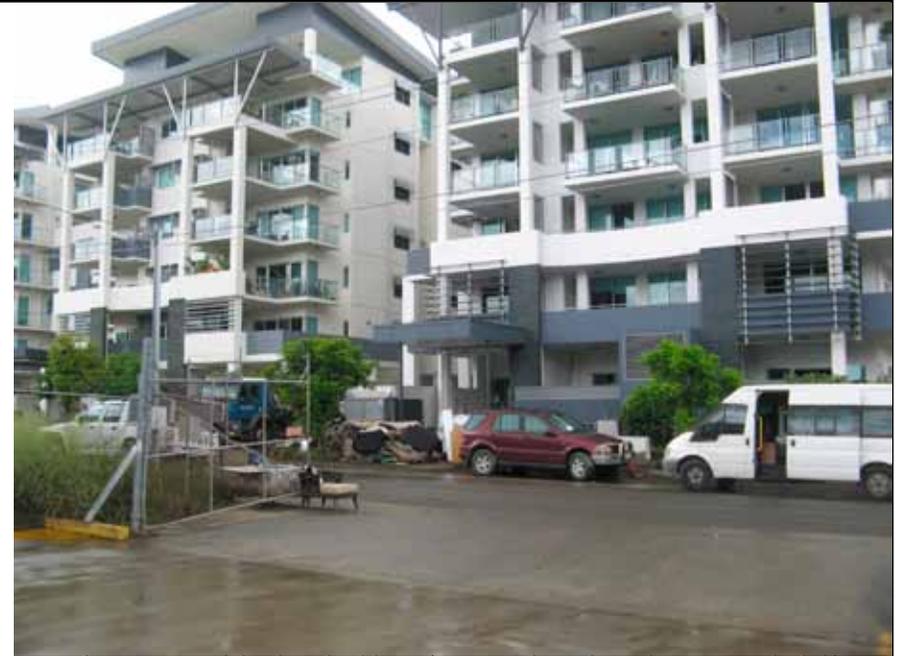
The Energex transformers for the Aura and Arriva Apartments are located in front of Aura's sister building next door and sit at ground floor level, so the transformers were affected by water inundation and had to be turned off when flood waters began rising. That meant that the pumps in the basements stopped working and residents could no longer live in the buildings, even if they were not directly affected by water. The regulations need to stipulate that vital services, such as energy supplies, should be well above any flood levels.

View showing two of the three buildings (Aura on the right and Arriva on the left) serviced by the Energex transformers

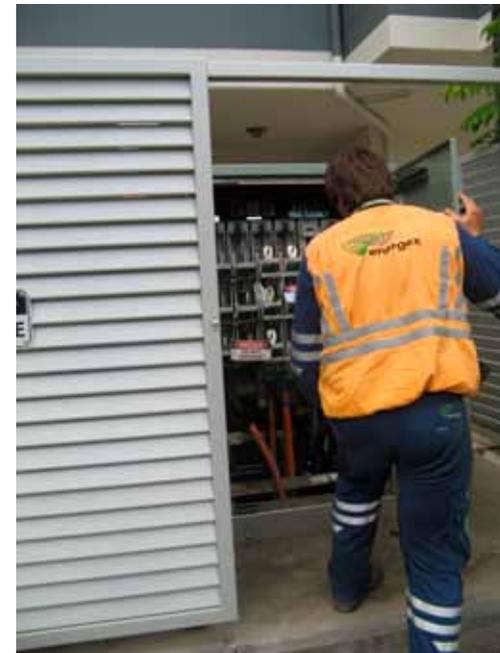
Energex inspecting transformer supplying electricity for Arriva and Aura

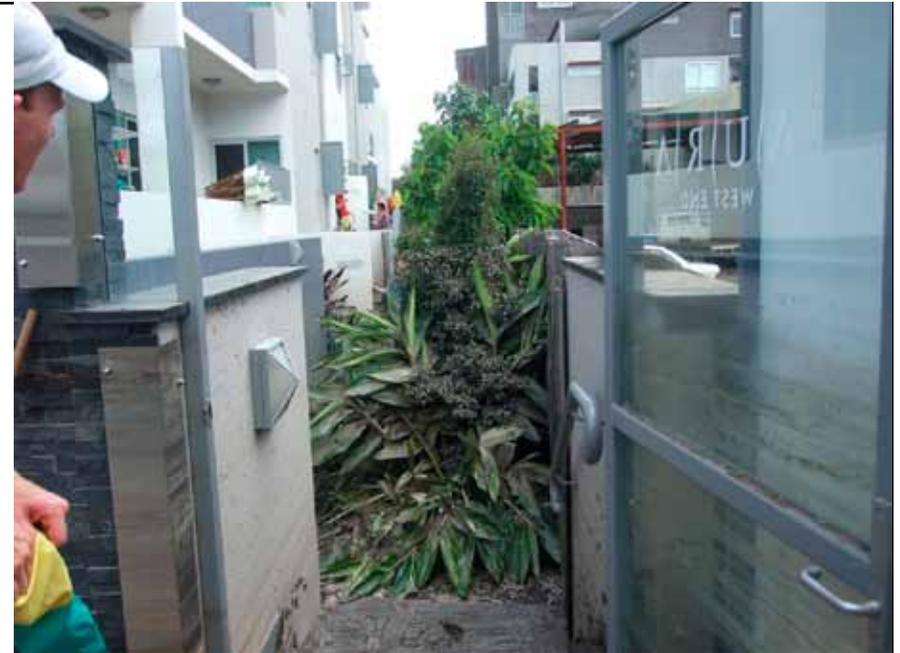
The gas-fired water heaters and electric pumps were completely submerged and needed to be replaced. Residents did not have hot water for some time and then a limited service until units could be replaced. Located in the sunken garden, these heaters are well below the ground floor level of RL5.9.

Street entrance down some steps at the side of the building leading to the fire stairs halfway along and showing the water heater room (white walls) in the middle

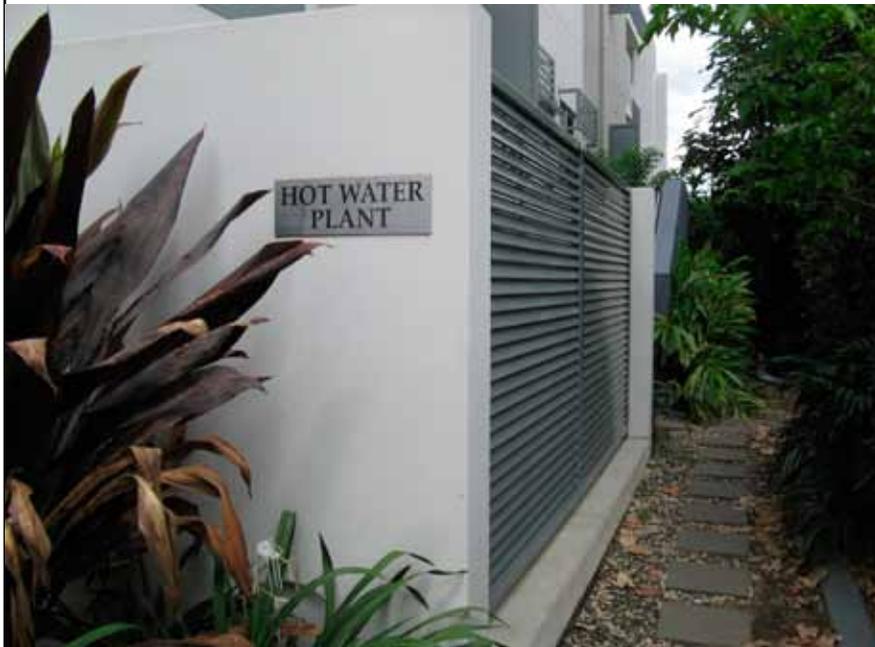
Room housing the water heaters beside the building and well below the building ground floor

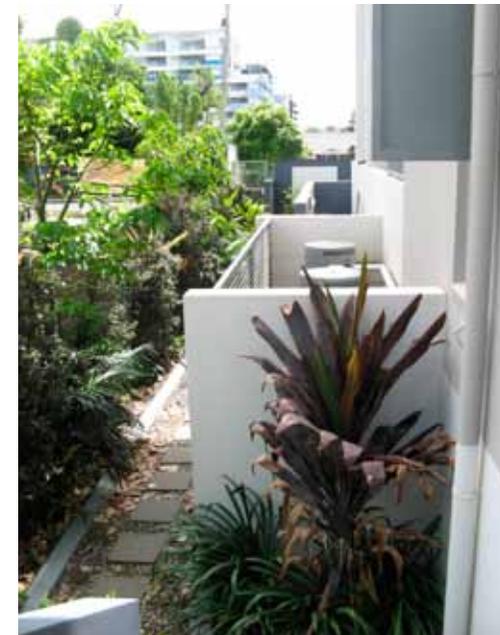
Looking down on the water heaters from the entrance to the fire stairs at ground floor level

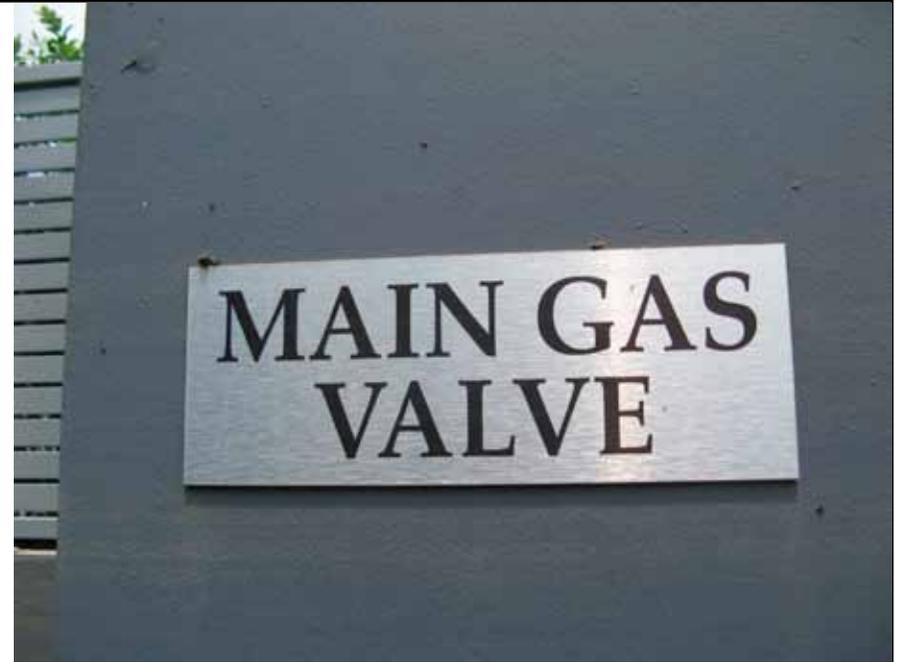
The gas valves in Aura are located in the sunken garden below ground floor level and were completely submerged by water.

Main gas valve sign beside the stairs to the basements

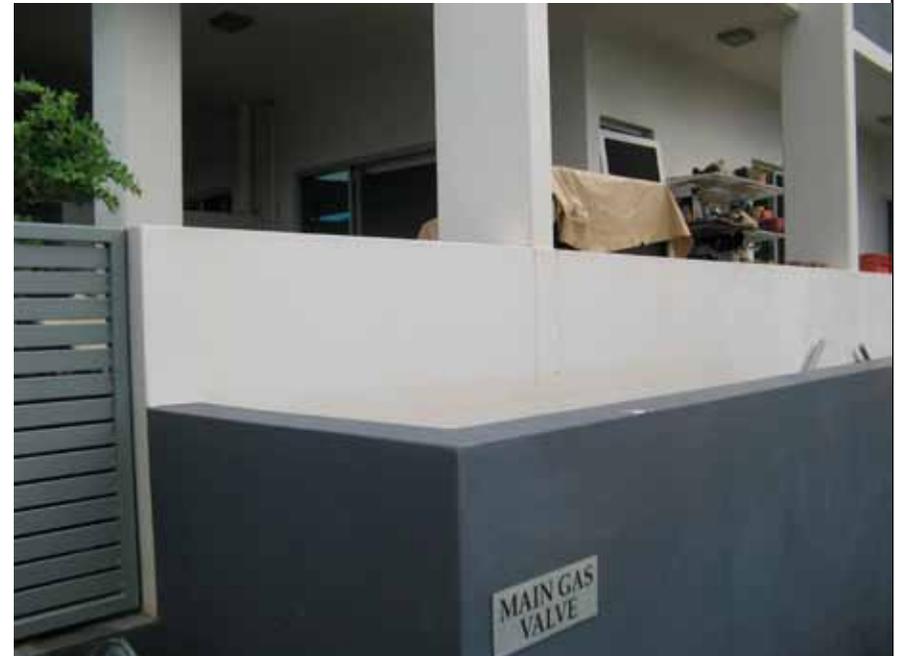
Looking down on the stairs leading to the carpark basements

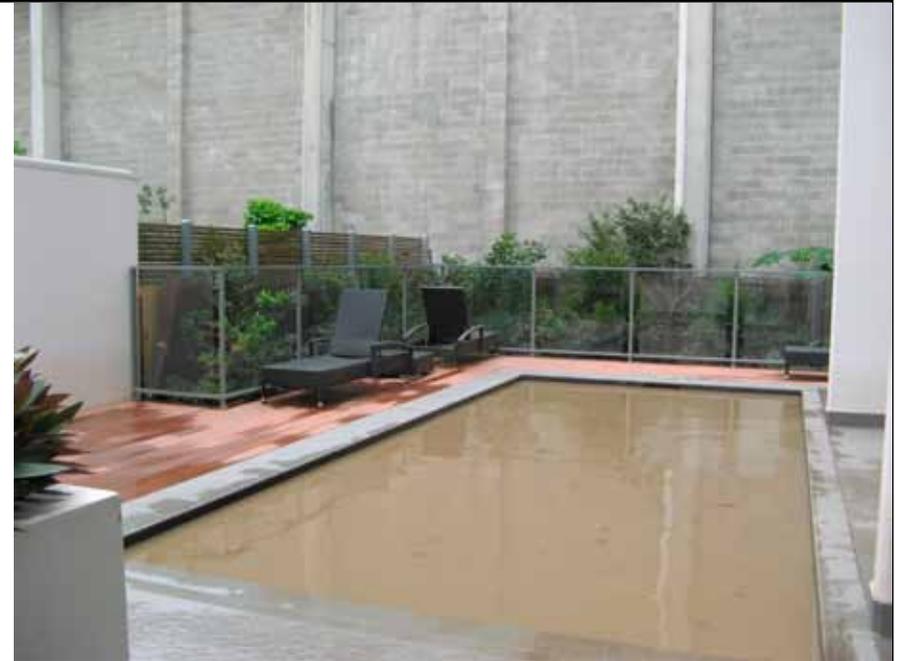
The Aura pool was inundated by flood waters, but the pool pumps and controls located under the pool in the B1 carpark were also damaged and repairs will cost around \$3000.

Aura pool 14/01/11 at 12.12 pm

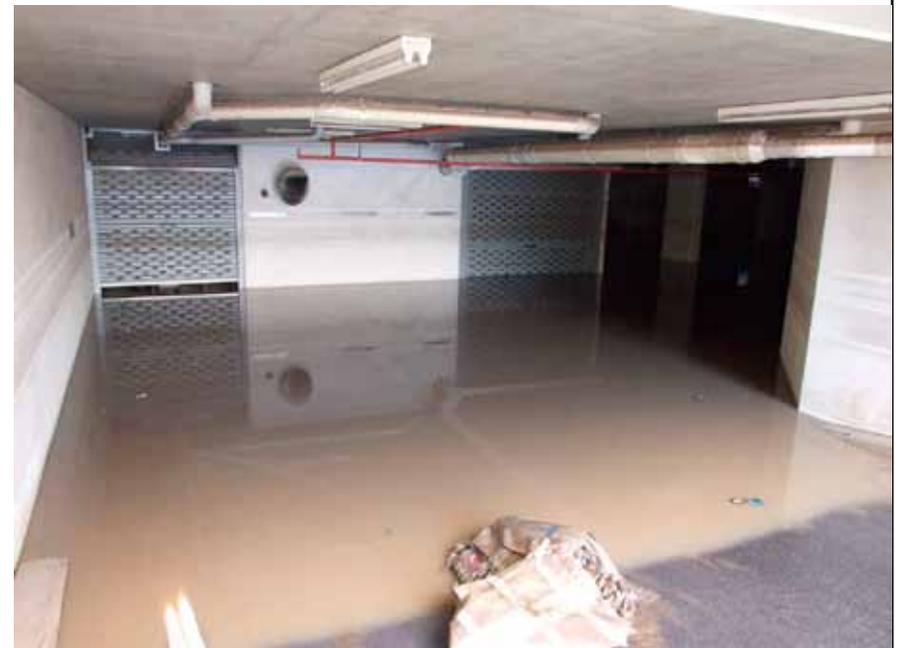
Aura carpark entrance showing room where pool controls are housed in room (left) on Basement 1

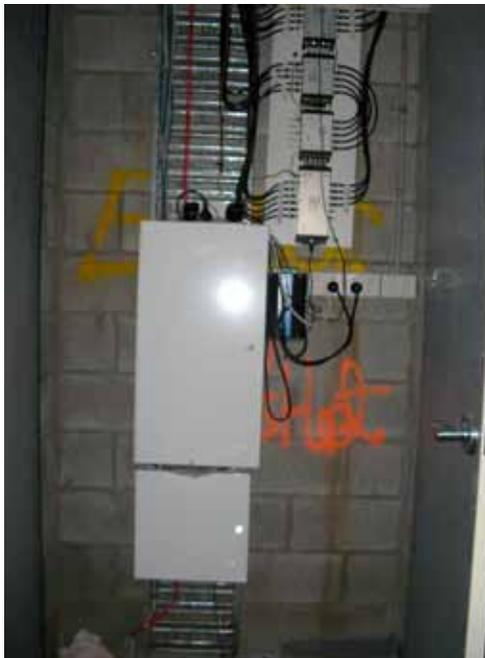
The power, fire alarm, video and telephone cabling control panels in Aura are on the ground floor so they were only partially affected by water, unlike other multi-storey buildings in the West End, which had more major damage because their control panels were located in basements. The control panels in flood-prone areas should be above any flood levels.

Video cabling controls located on ground floor

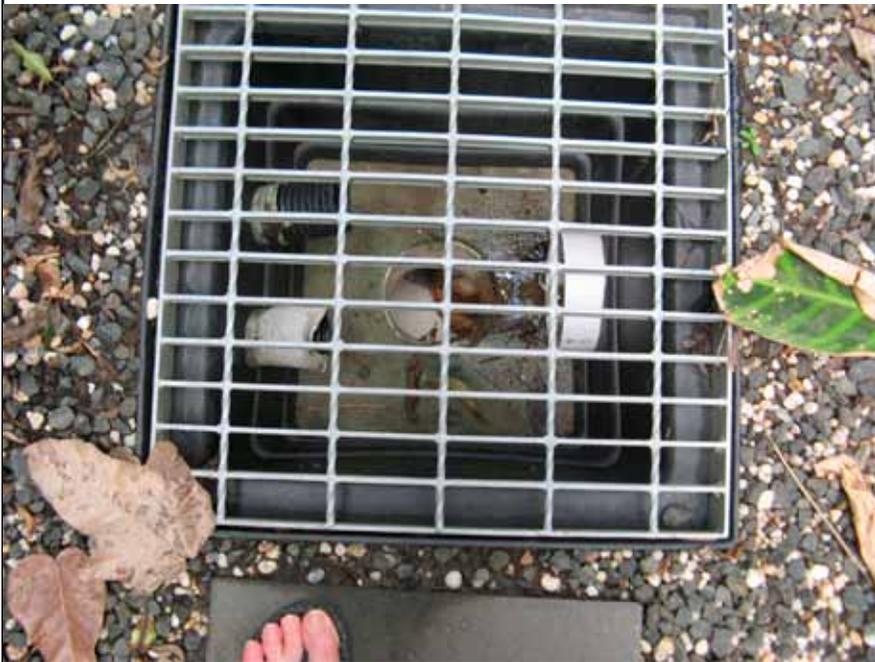
The stormwater drain around Aura could not cope with the volume of water and the first inundation occurred from stormwater, which bubbled up through the drain with such force it lifted one of the grates. One resident then fell down into the open hole, which was under water. The Council needs to better design for stormwater runoff in West End.

One of smaller grates giving access to the stormwater drain around Aura

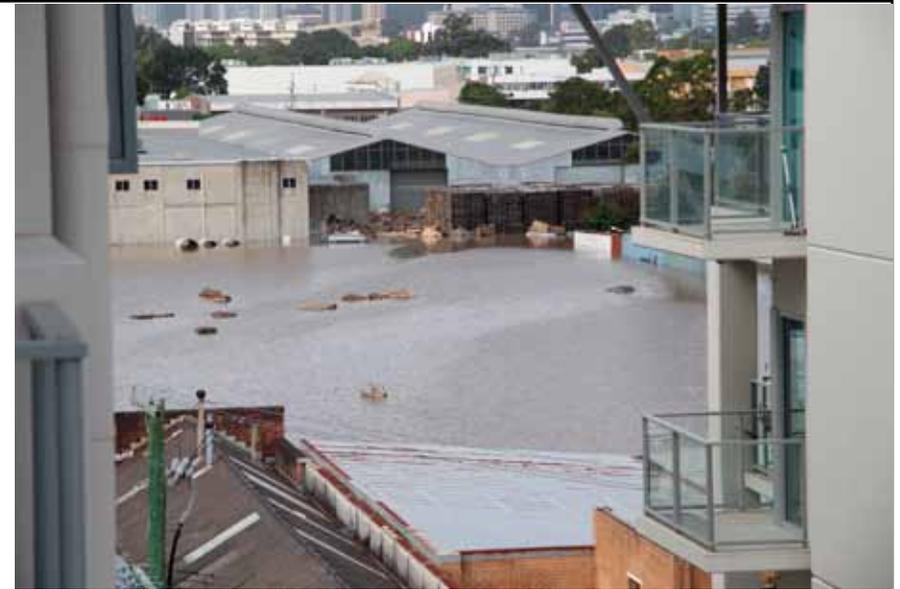
Taken from Unit 32 at Aura on 12/01/11 at 5.13 pm looking towards the city

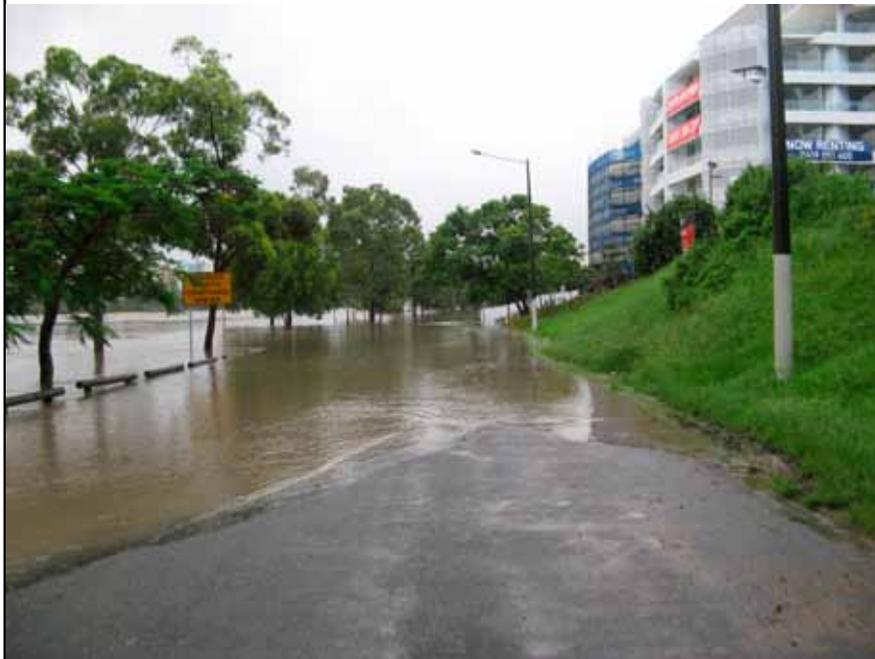
River water flowed over the bank in places along Riverside Drive and entered buildings and, possibly affected Aura. Instead of requiring developers building beside Riverside Drive to raise the bank, the Council allowed the developers of Waters Edge to lower the bank and this was one of the places where river water flowed over the bank.

View of Riverside Drive at 6.33 pm on 11/01/11 showing Waters Edge on the right
