Submission to Queensland Floods Commission of Inquiry Order (No. 1) 2011

Aura Apartments: A Case Study for Reviewing Planning in Flood-prone Areas in Brisbane

36 Units in Ferry Road, West End, Brisbane

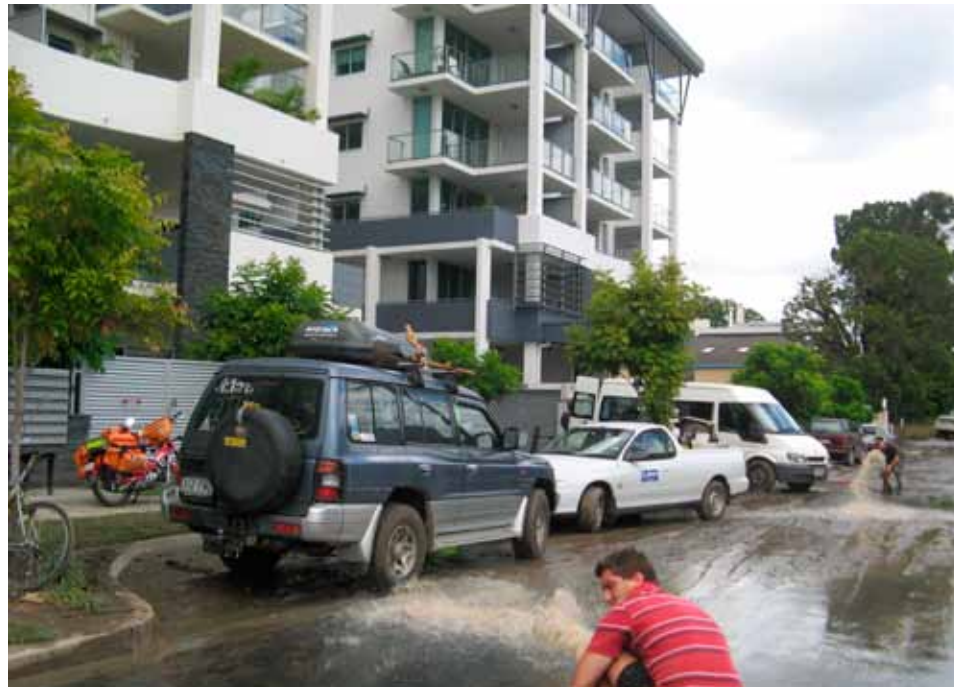
Cleaning the mud outside Aura Apartments on 14/01/11 at 12.04 pm

Aura Apartments were flooded in the January 2011 Brisbane floods up to approximately 0.5 metres above the ground floor level at RL5.9, badly damaging the building, furniture and contents of the common rooms, swimming pool, and four ground floor apartments.

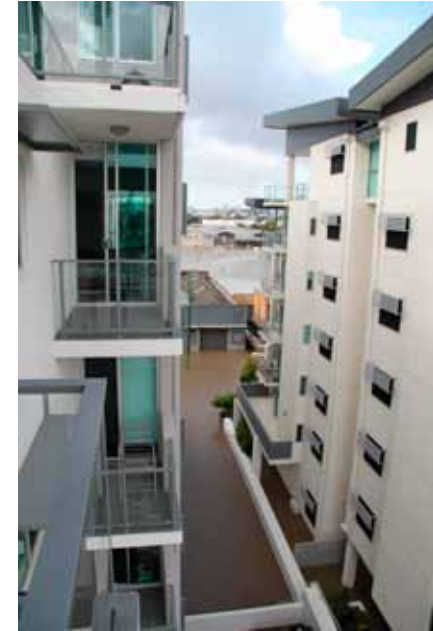
The ground floor was built at RL5.9, a level approved under the existing regulations. This was inadequate for Aura as water rose up to around 6.4 metres in our building and street in the January 2011 floods. This implies a design Q100 flood level of RL5.4. This level was far too low in Riverside South, West End and may even have been below the 1974 flood.

Taken from Unit 32 at Aura on 12/01/11 at 5.13 pm looking towards the city

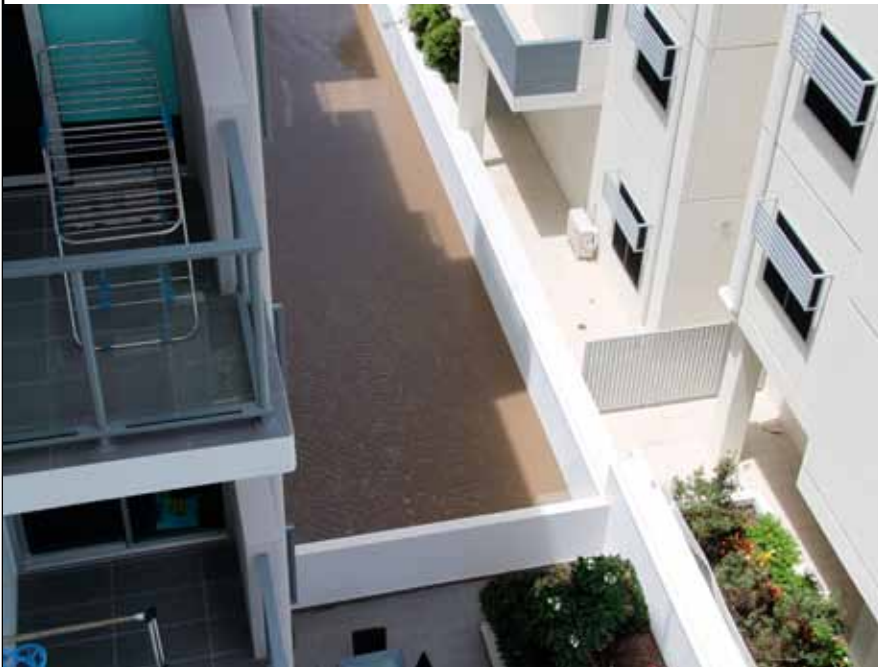
View of the carpark entrance with water still rising at 1.19 pm on 12/01/11

The building has two basement carpark levels. It took 2 days to remove water from the first level, but another 7 days to empty the second level. Regulations need to stipulate building designs with access holes that make it easier to pump water out of second or lower level basements.

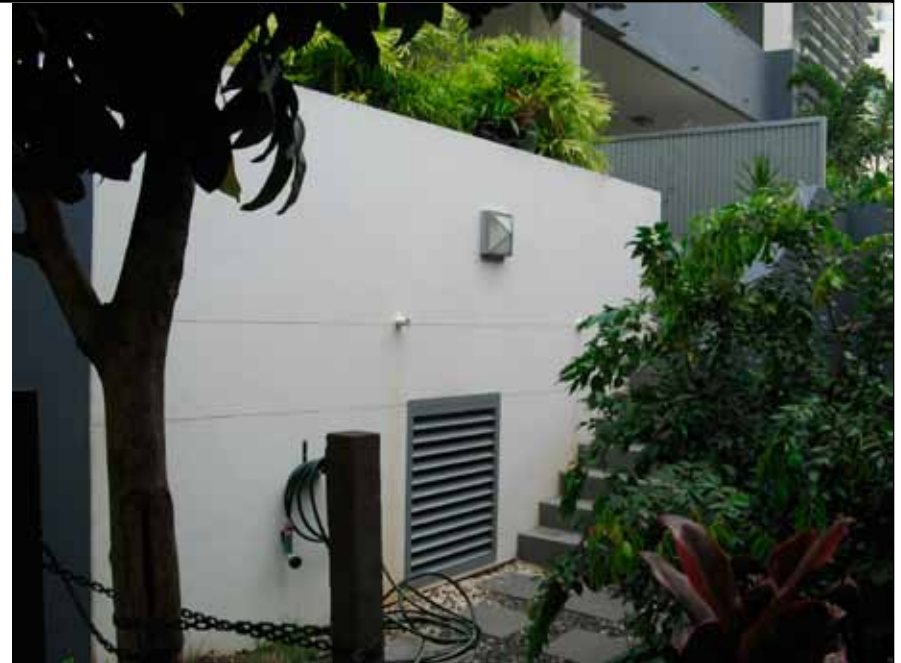
The Council approved building plans for grills for ventilation into the B1 carpark. These grills are well below the ground floor level of the building, and below the design Q100 flood level.

Vents at the back of Aura with the sunken garden below ground level

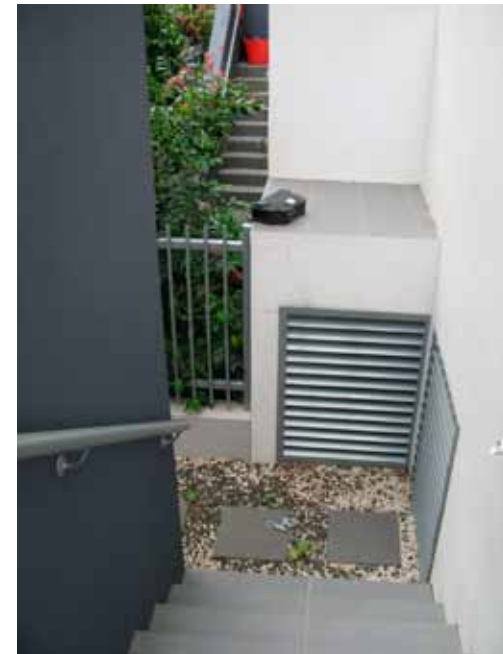
Stairs from ground floor leading to back garden with vents where water spilled into B1 carpark

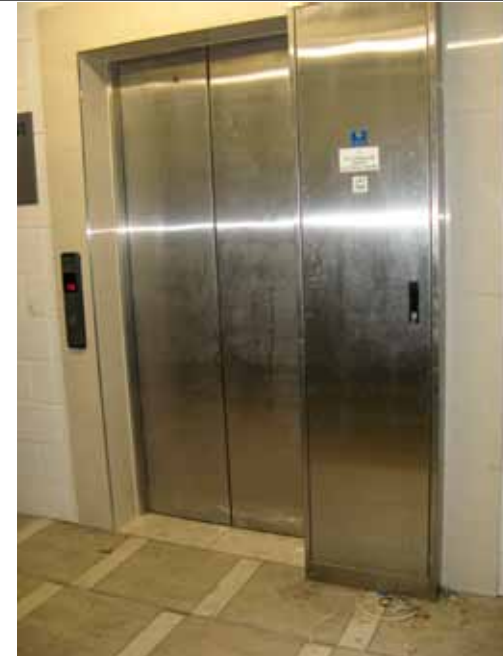
The lift motors and controls are located in the Basement 2, so they were badly affected by flood water and they are very expensive to replace, costing over \$40,000. In Aura there is room for the lift to be placed at the top of the lift shaft, but relocating the motor and controls is very expensive at over \$250,000. Regulations requiring lift motors and controls to be put above flood water levels would have saved residents in Aura many thousands of dollars.

Aura lift doors on Basement 2 with controls on the right

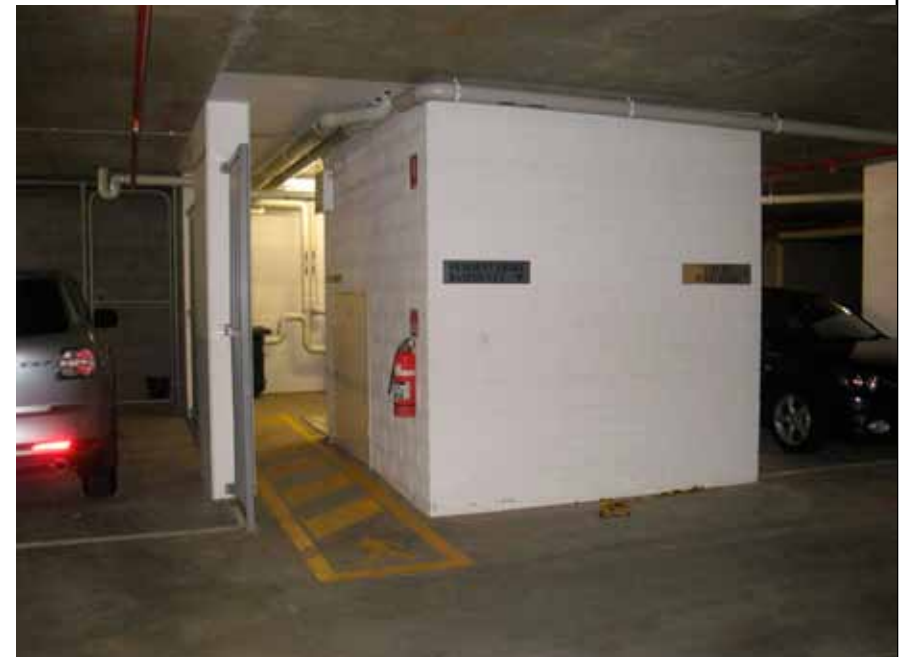
Lift well in Aura in Basement 2 with the main lift motor behind the yellow door in the wall near the fire extinguisher

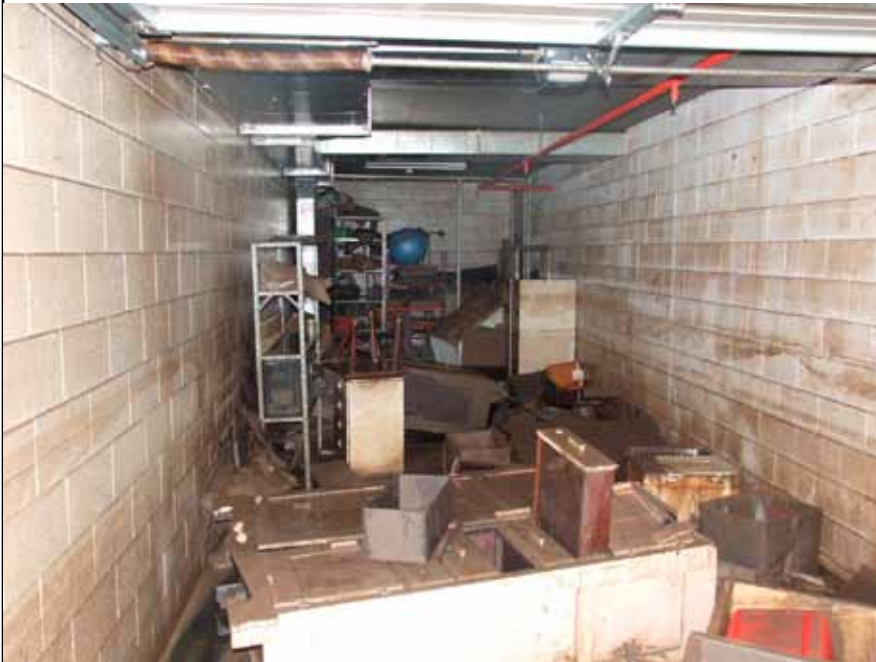
The control panel for the CO₂ ventilation system is located in Basement 1, so this was another expensive service to replace. Repairs will cost over \$20,000. Not all parts of this system can be relocated, but the control panel could be. However, retrofitting this panel is expensive. In flood-prone areas buildings should have the control panel above flood levels.

Metal ducts in the roof are part of the CO2 ventilation system

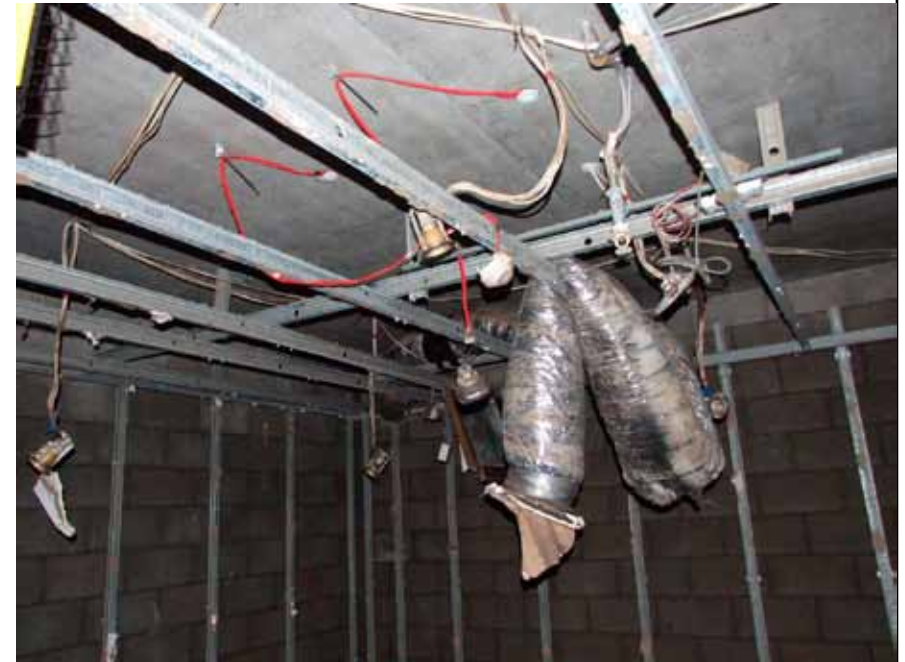
Part of the CO2 ventilation system

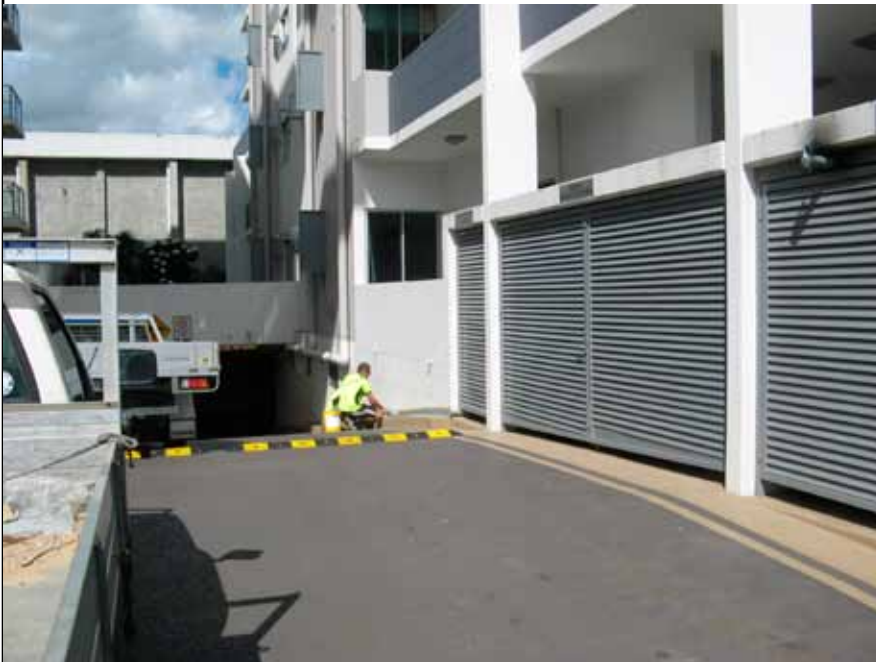
The fire services in Aura were located below the RL5.9 level required for the ground floor. (The roof of the carpark seen in the photo below indicates the ground floor level.) As a result, the sprinkler system, the booster pumps and control board were badly affected by the flood waters and these cost over \$27,000 to replace.

Two rooms either side of refuse room below ground floor beside the carpark entrance housing the fire sprinkler pump (left), the main fire pump and controls (right)

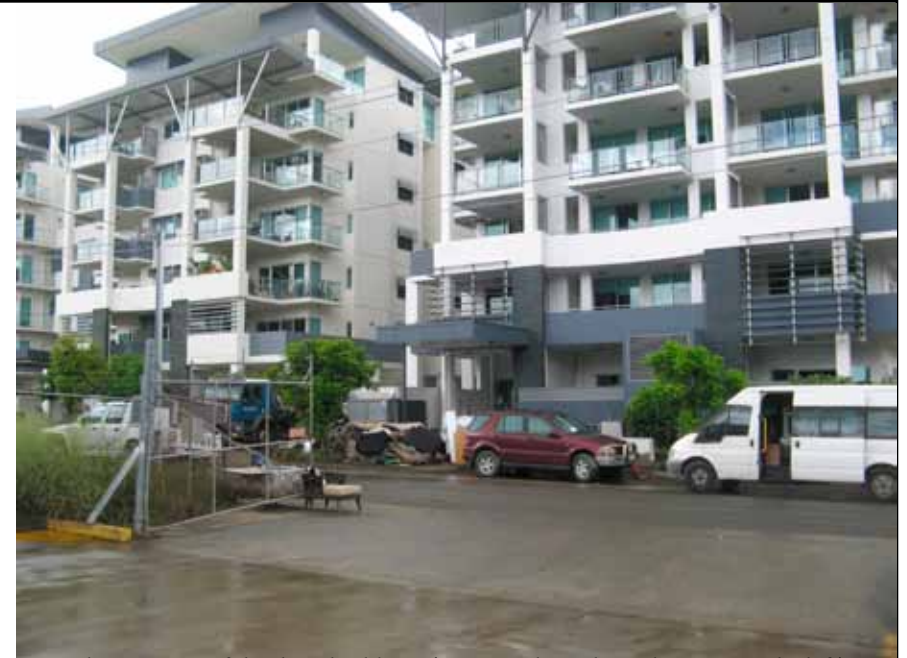
The Energex transformers for the Aura and Arriva Apartments are located in front of Aura's sister building next door and sit at ground floor level, so the transformers were affected by water inundation and had to be turned off when flood waters began rising. That meant that the pumps in the basements stopped working and residents could no longer live in the buildings, even if they were not directly affected by water. The regulations need to stipulate that vital services, such as energy supplies, should be well above any flood levels.

View showing two of the three buildings (Aura on the right and Arriva on the left) serviced by the Energex transformers

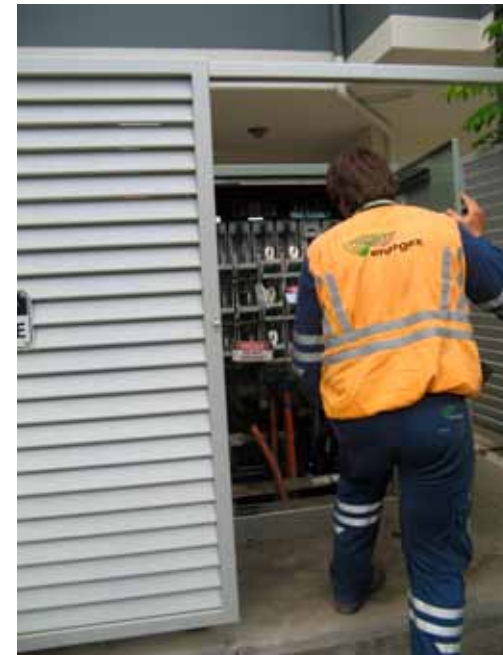
Energex inspecting transformer supplying electricity for Arriva and Aura

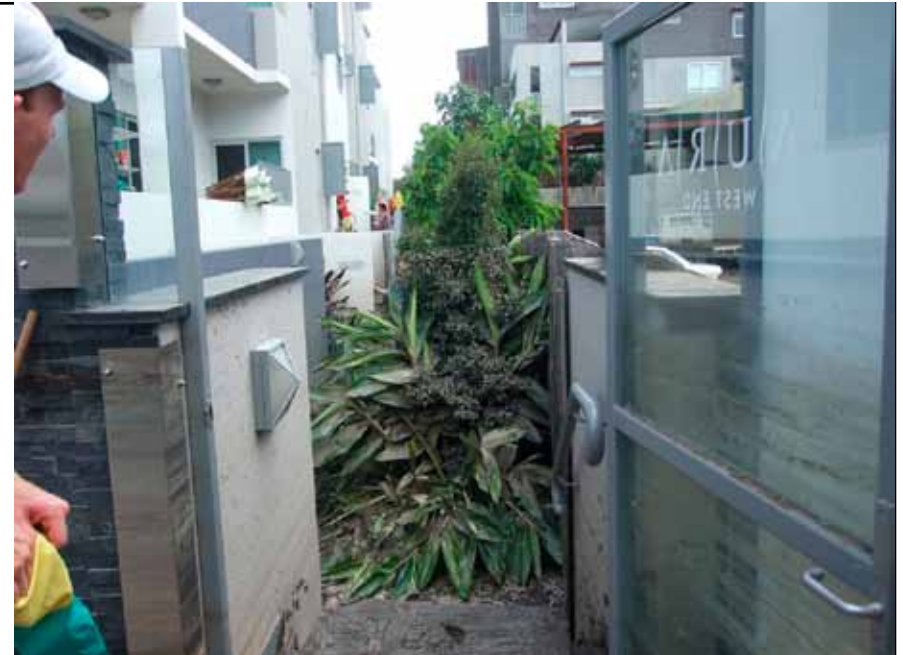
The gas-fired water heaters and electric pumps were completely submerged and needed to be replaced. Residents did not have hot water for some time and then a limited service until units could be replaced. Located in the sunken garden, these heaters are well below the ground floor level of RL5.9.

Street entrance down some steps at the side of the building leading to the fire stairs halfway along and showing the water heater room (white walls) in the middle

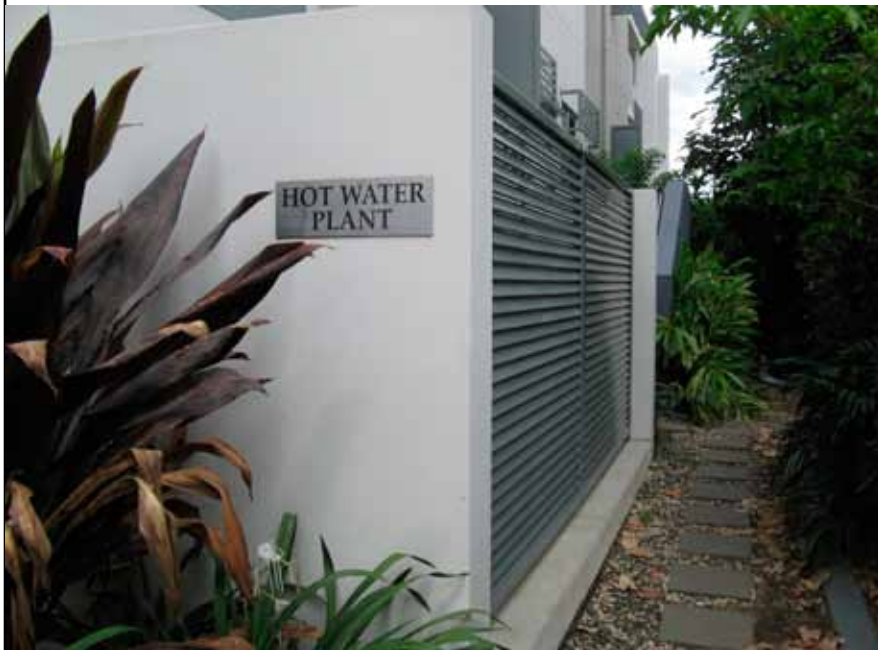
Room housing the water heaters beside the building and well below the building ground floor

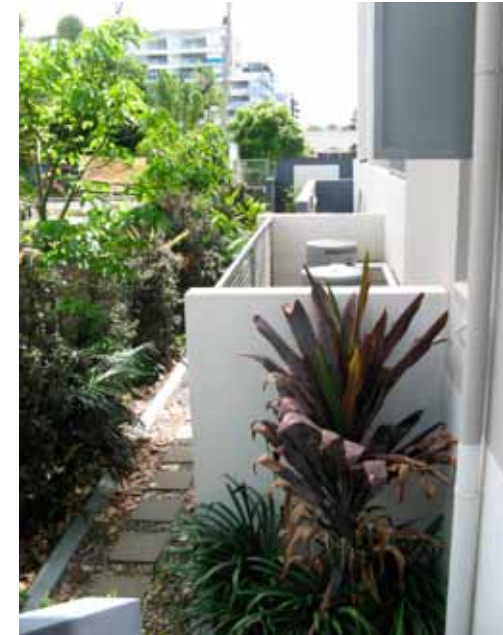
Looking down on the water heaters from the entrance to the fire stairs at ground floor level

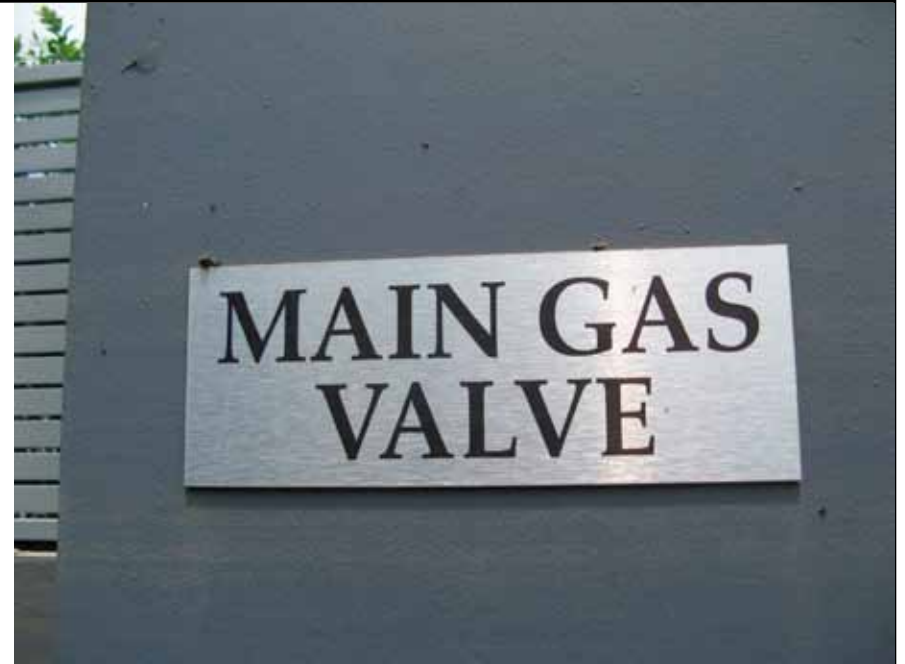
The gas valves in Aura are located in the sunken garden below ground floor level and were completely submerged by water.

Main gas valve sign beside the stairs to the basements

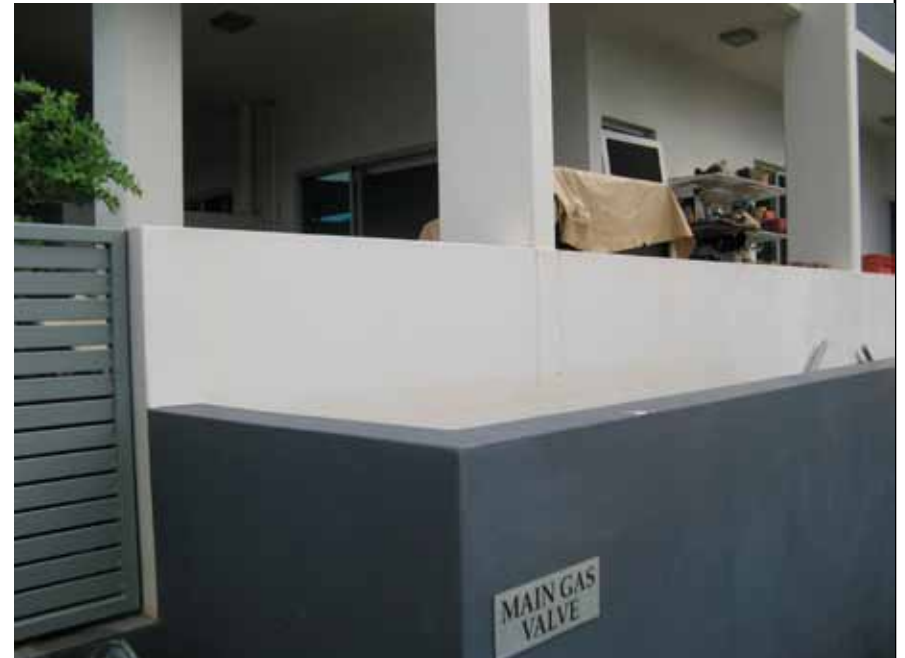
Looking down on the stairs leading to the carpark basements

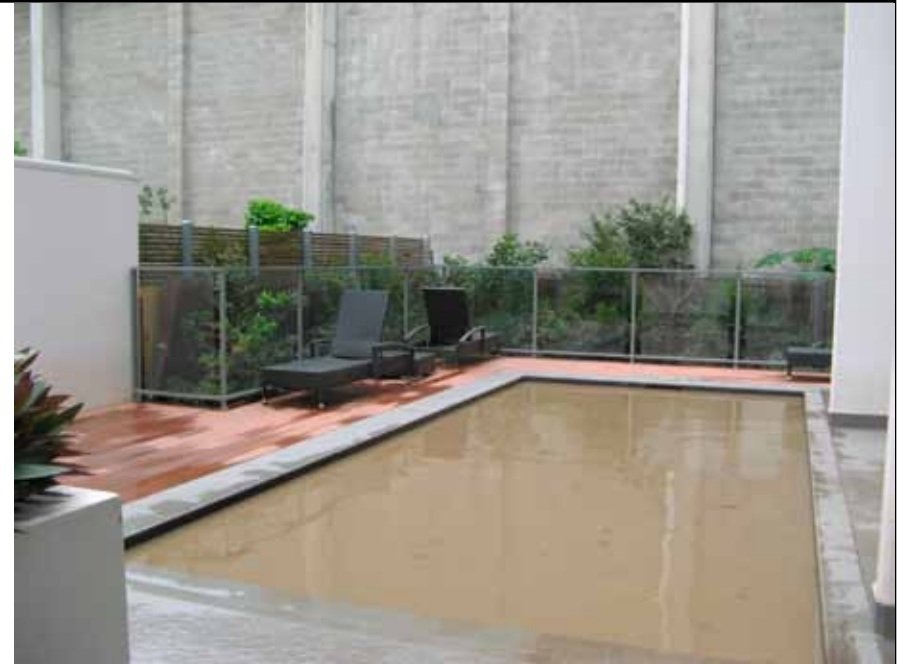
The Aura pool was inundated by flood waters, but the pool pumps and controls located under the pool in the B1 carpark were also damaged and repairs will cost around \$3000.

Aura pool 14/01/11 at 12.12 pm

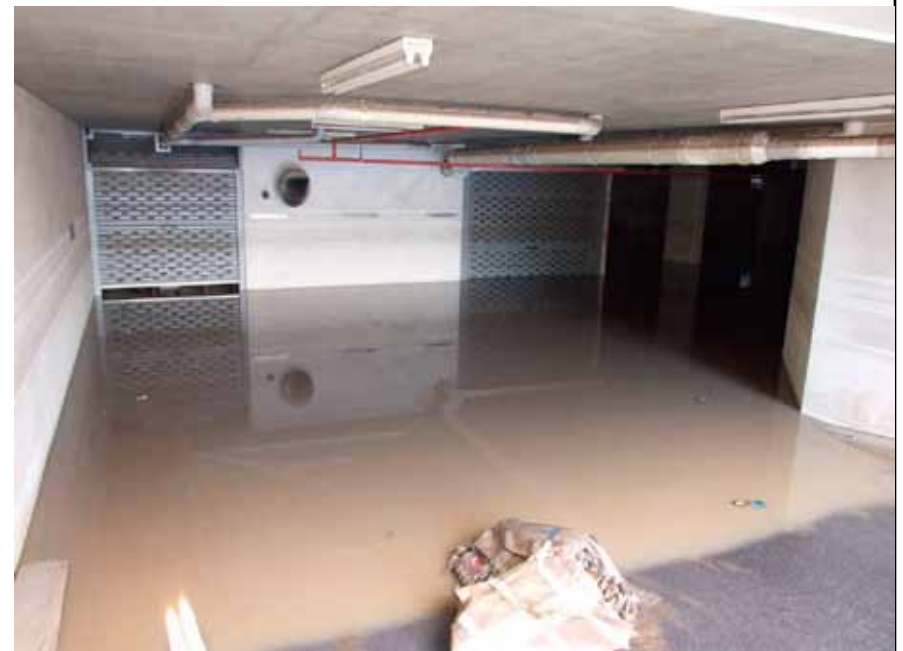
Aura carpark entrance showing room where pool controls are housed in room (left) on Basement 1

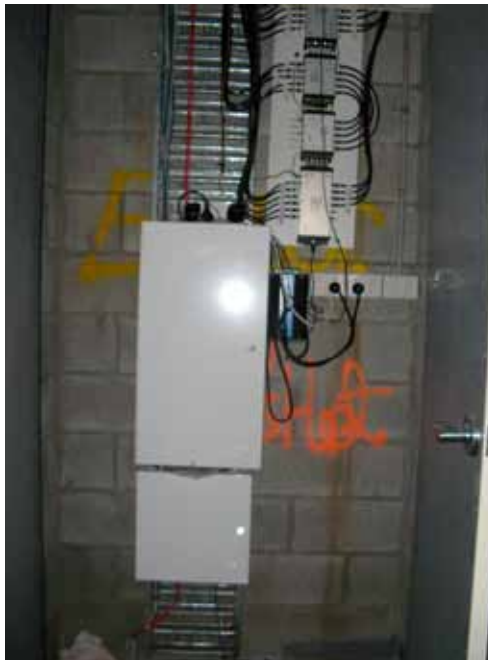
The power, fire alarm, video and telephone cabling control panels in Aura are on the ground floor so they were only partially affected by water, unlike other multi-storey buildings in the West End, which had more major damage because their control panels were located in basements. The control panels in flood-prone areas should be above any flood levels.

Video cabling controls located on ground floor

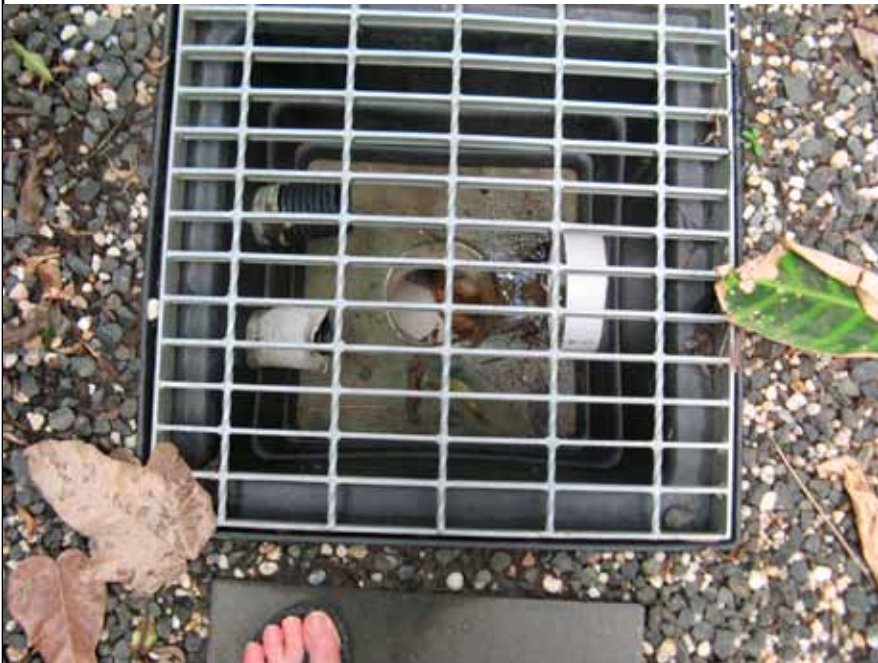
The stormwater drain around Aura could not cope with the volume of water and the first inundation occurred from stormwater, which bubbled up through the drain with such force it lifted one of the grates. One resident then fell down into the open hole, which was under water. The Council needs to better design for stormwater runoff in West End.

One of smaller grates giving access to the stormwater drain around Aura

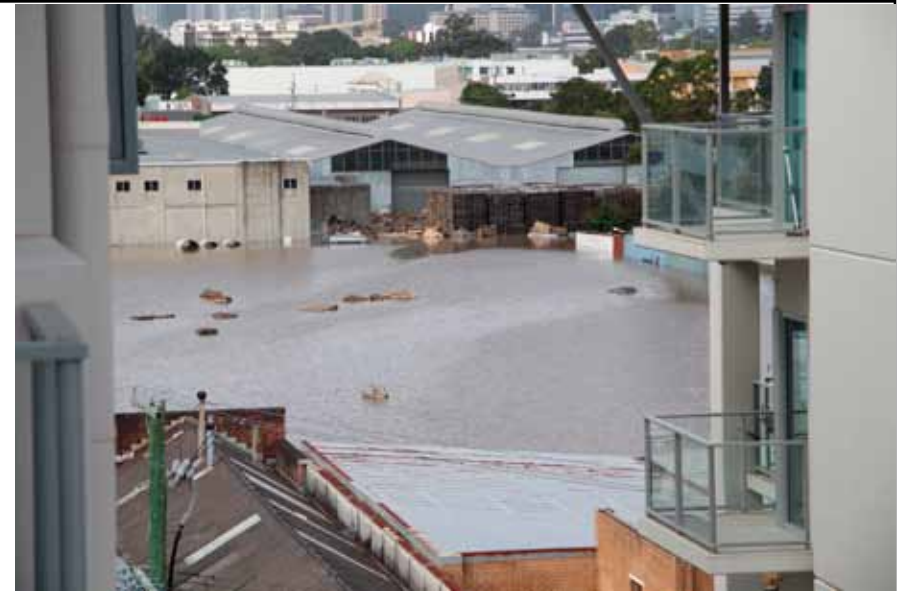
Taken from Unit 32 at Aura on 12/01/11 at 5.13 pm looking towards the city

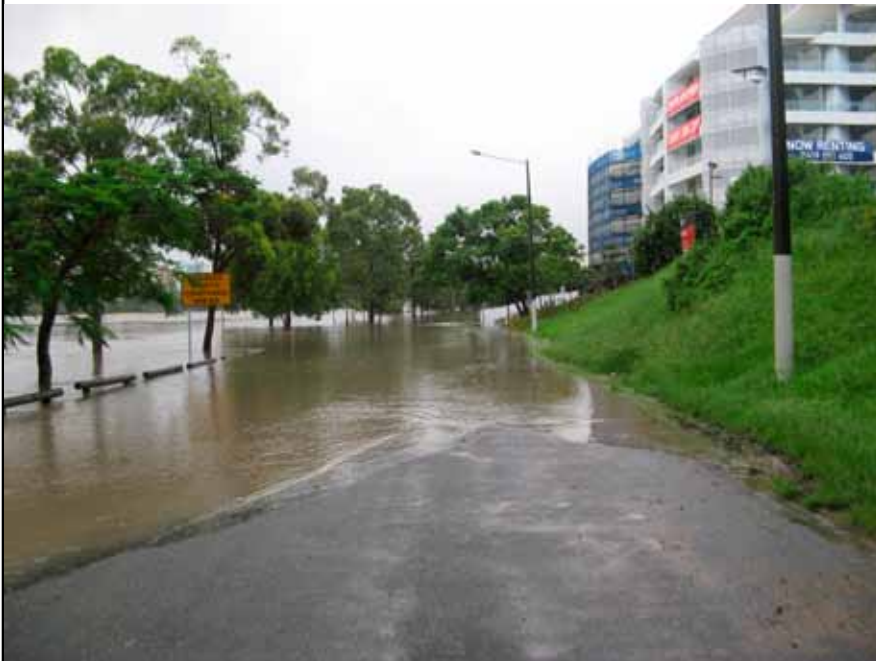
River water flowed over the bank in places along Riverside Drive and entered buildings and, possibly affected Aura. Instead of requiring developers building beside Riverside Drive to raise the bank, the Council allowed the developers of Waters Edge to lower the bank and this was one of the places where river water flowed over the bank.

View of Riverside Drive at 6.33 pm on 11/01/11 showing Waters Edge on the right
