Lynn de Lange

[REDACTED] Basement Water Inundation

This letter confirms the outcomes of our investigations into the source of water inundation into the basement levels of your building located at the corner of [REDACTED] Streets in Brisbane City. The water inundation event occurred over the period 12<sup>th</sup> to 14<sup>th</sup> January 2011.

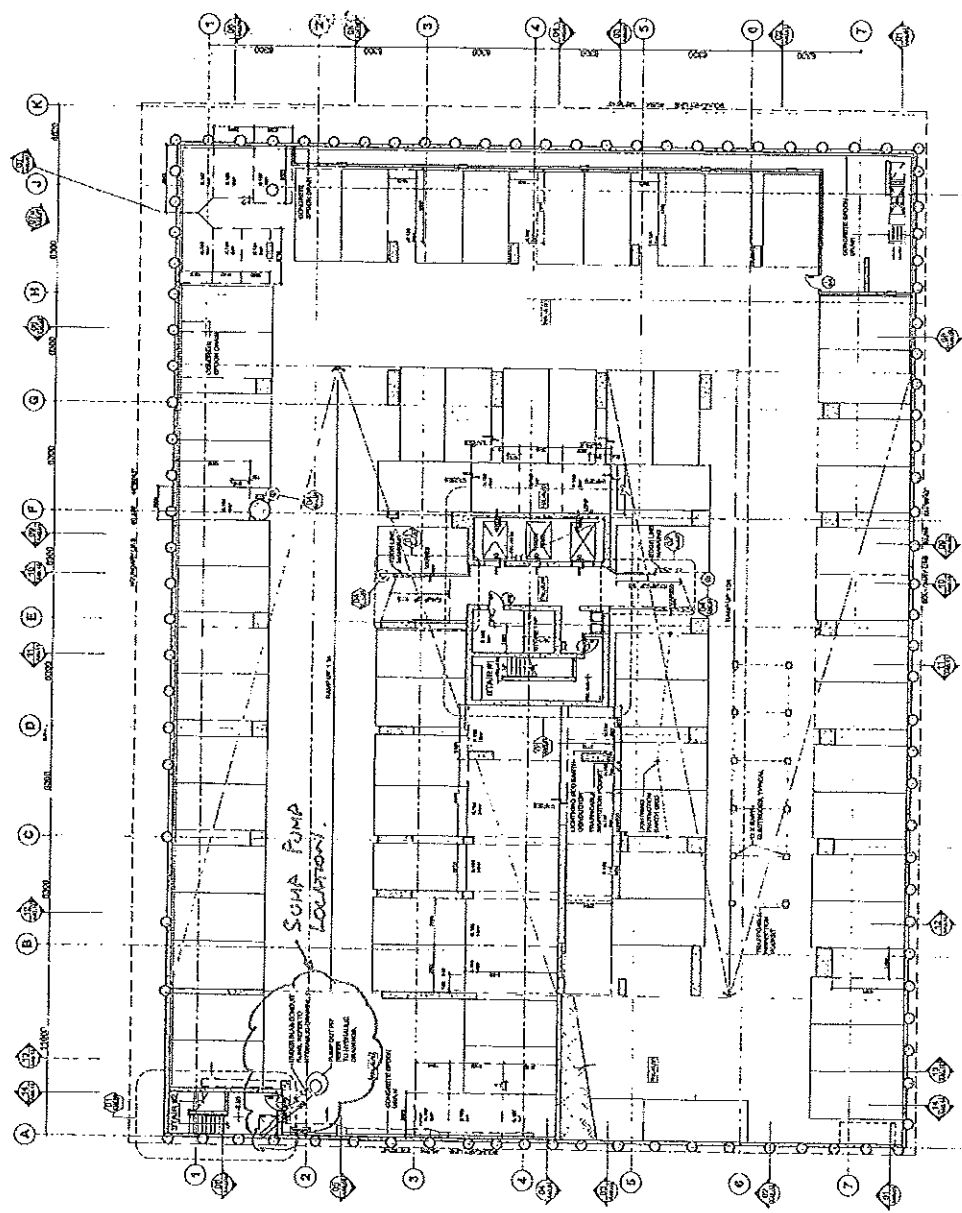
**LEVEL 24 - FLOOR PLAN**

The source of the water inundation is believed to be at the incoming electricity mains to the building on the [REDACTED] Street Frontage. Marked up drawings are attached and photographs follow for identification of this primary water inundation source. A "waterfall" from this location was observed by staff on site during the event. The water staining on the vermiculite encasing of the incoming conduits and failed fire proofing of the entry location boxing soffit also confirm the likelihood of this location being the main source of water entry into the basement.
