Name of Witness	Thomas Paul FISCHER
Date of Birth	[REDACTED]
Address and contact details	[REDACTED]
Occupation	Travel Agent
Officer taking statement	Det/Sgt Anthony VLISMAS
Date taken	7 September 2011

FIRST REPORT – FLOOD DAMAGE CLAIM

Water Technology has been commissioned to inspect the property and undertake a study of the area to determine the source and cause of the inundation and specifically to provide an opinion on whether the inundation would be classified as Stormwater or Flooding.

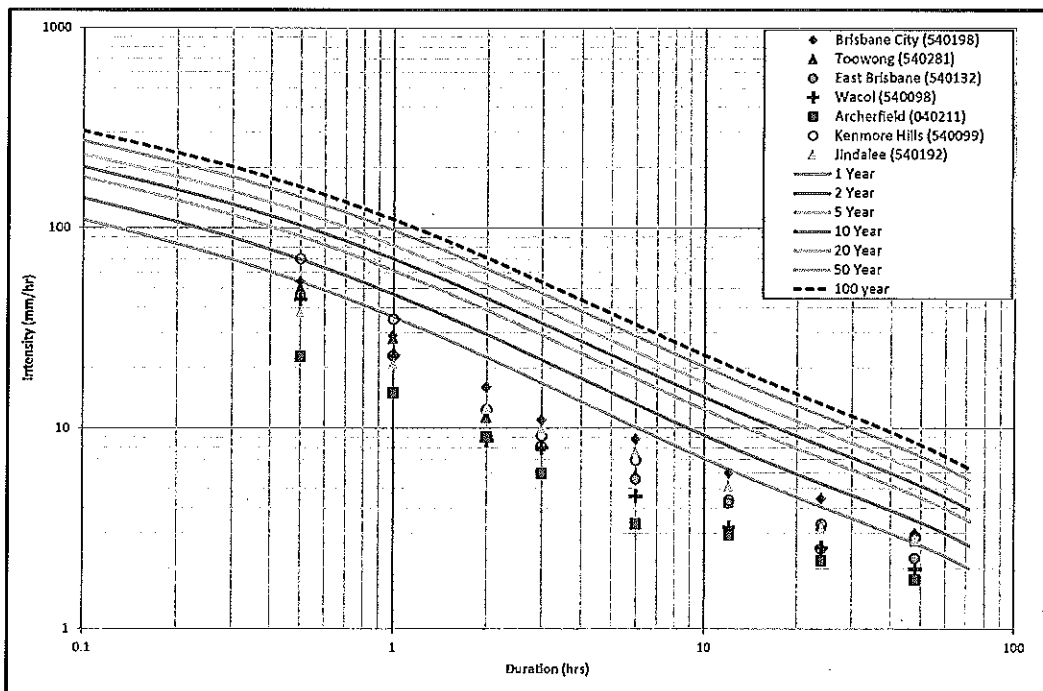
Figure 6-6 Rainfall Intensity Frequency Duration Analysis for Selected Rainfall Stations in Brisbane

Figure 6-6 presents rainfall Intensity Frequency Duration (IFD) analysis for several selected rainfall stations in Brisbane. The Jindalee gauges provide the closest estimate of rainfall occurring in the Middle Park area and Figure 6-6 indicates that the intensity of rainfall in the days leading up to inundation was very low and less than a 1 year ARI event.

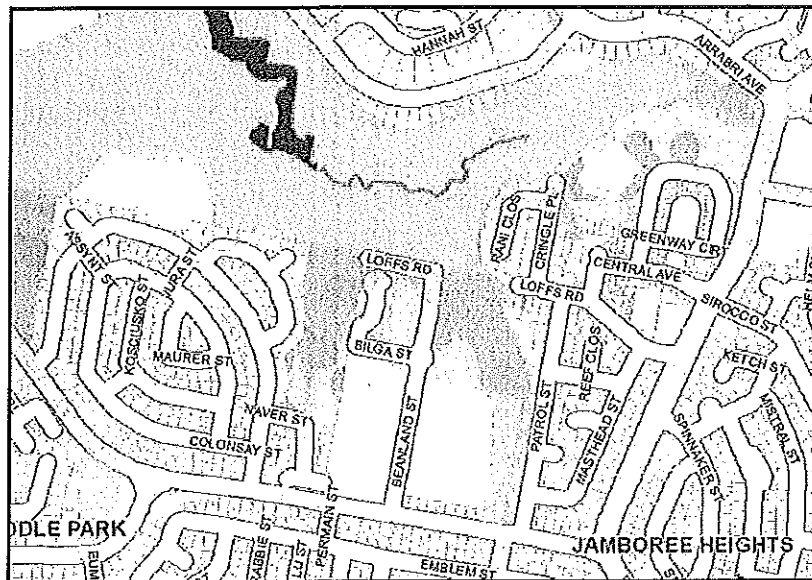
FIGURE 2. BRISBANE CITY COUNCIL, FLOOD FLAG MAP, MIDDLE PARK

- a) The revised flood maps released by Brisbane City Council in 2009 identify those areas potentially influenced by creek, river or tidal flooding in light blue.
- b) The north-western corner of the site is covered by the light blue shading, suggesting that Units 1-5 may be subject to creek, river or tidal flooding.
