Flood Operations of Wivenhoe and Somerset Dams

Notes on the Analysis of the Late December 2010 Flood Event

WIVENHOE DAM

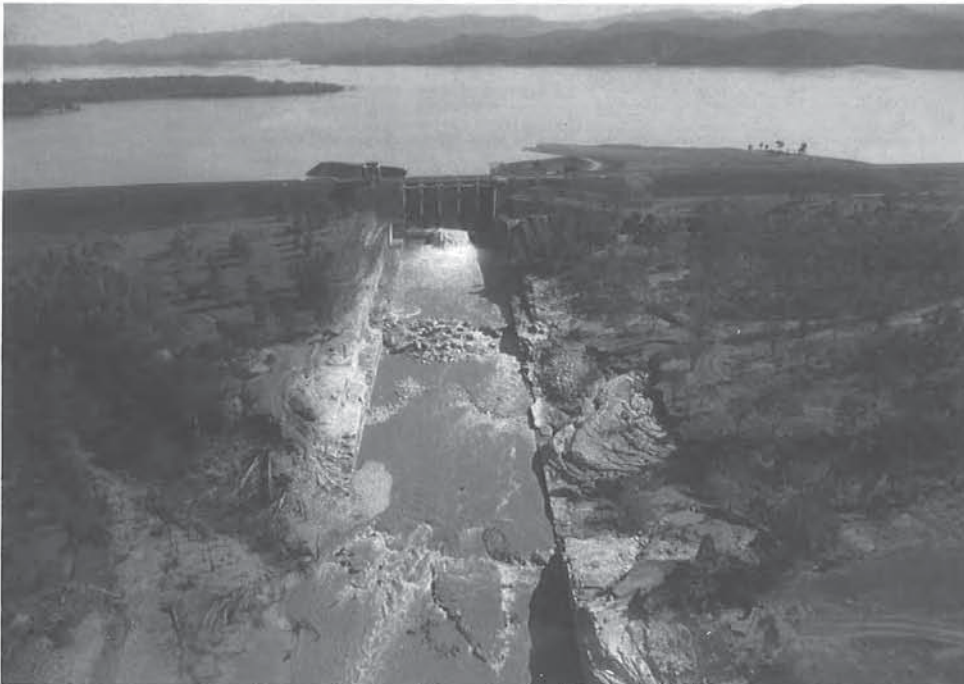
Flows spilling out of the spillway channel at the downstream end of the spillway chute resulted in significant erosion. Material was removed down to moderately weathered rock. Significant damage was found on the left hand side of the channel downstream of the lookout where mudstone joints were washed out and significant amounts of rock removed.

The spillway lookout recreational area had erosion cut down to the underlying rock material, leaving behind near vertical soil slopes up to 3 metres high, as well as damage to the bitumen roads and parking lots. The following photos are representative before and after shots of the January 2011 flood.

Photo 2- Wivenhoe Outlet Channel and Spillway Post January 2011 Flood

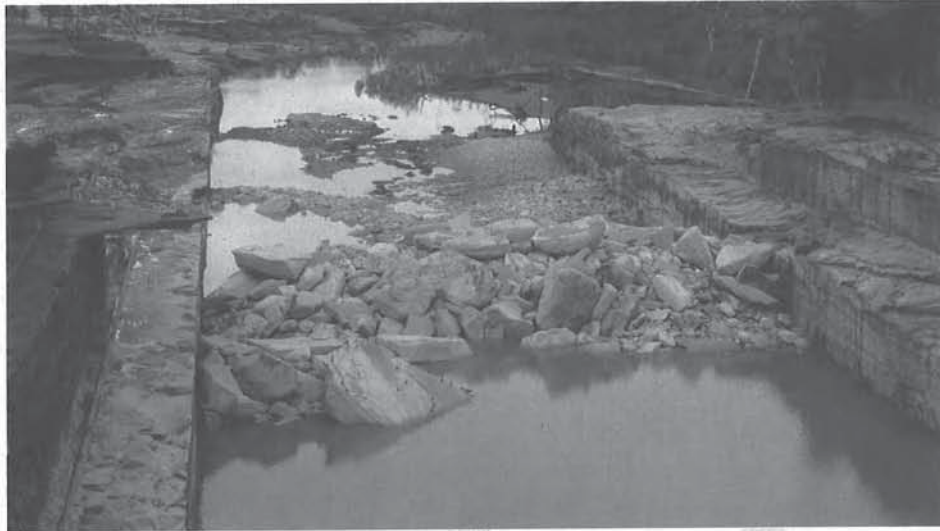
Photo 4- Wivenhoe Outlet Channel and Spillway Post January 2011 Flood

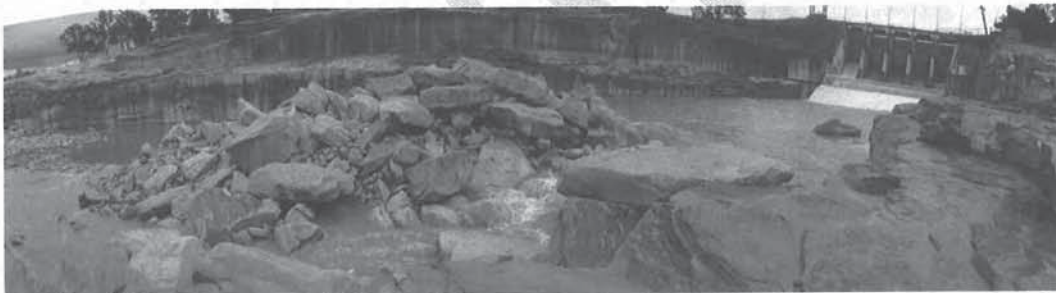
Photo 5- Wivenhoe Outlet Channel and Spillway Post January 2011 Flood

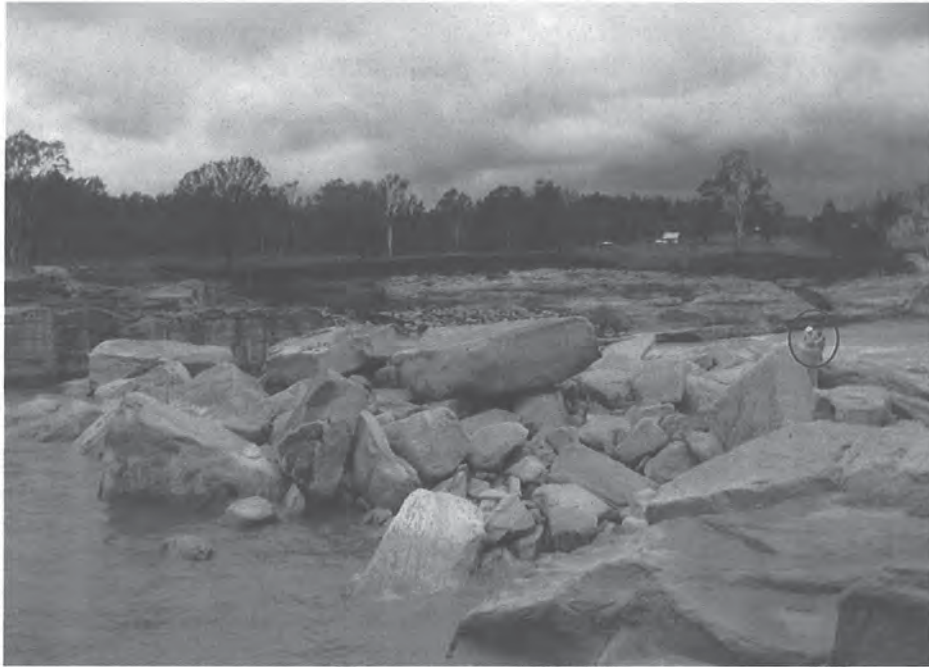
Photo 6- Wivenhoe Outlet Channel and Spillway Post January 2011 Flood

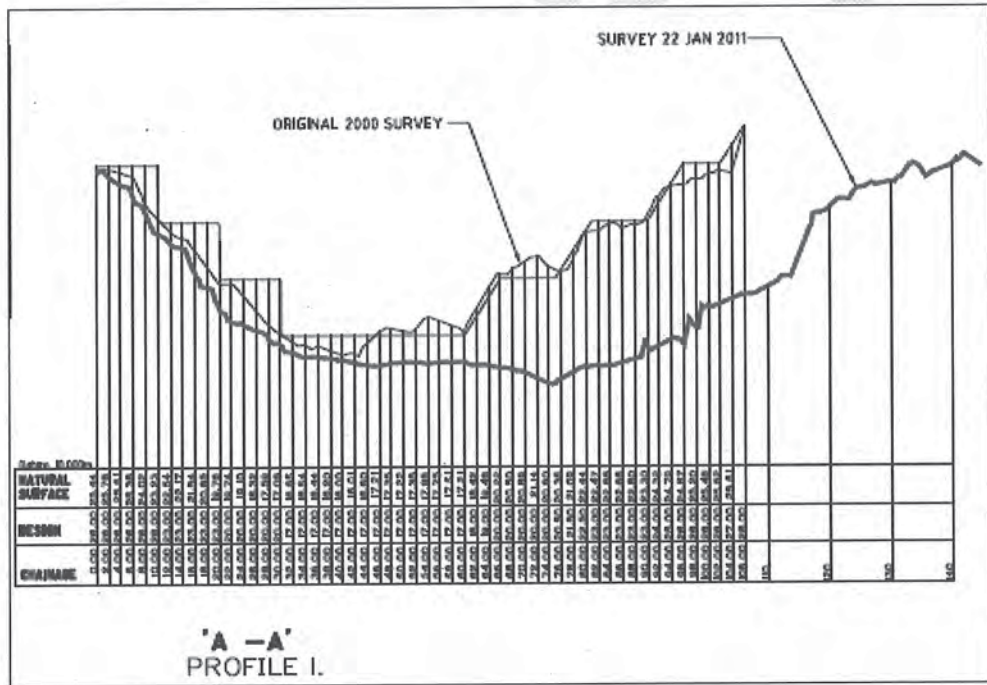
It can be seen from cross section A-A in Figure 4 (left to right represents upstream to downstream) that the majority of material removed from the base of the plunge pool was located at the downstream side of the excavation. The plunge pool depth was decreased to a depth of EL14m and up to 10m of rock was removed from areas of the spillway structure. However, it should be noted that there was minimal head cutting of the upstream side of the plunge pool.

Figure 4 - Survey of Wivenhoe Outlet Channel and Spillway Pre and Post January 2011 Flood

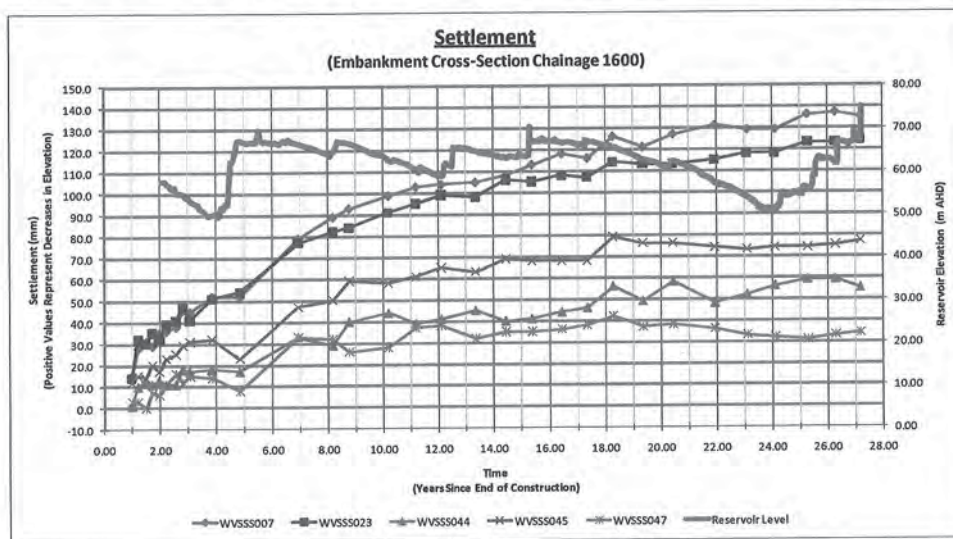
Figure 8 and Figure 9 present the post construction deformation settlement versus time for both of the previously stated chainages. The maximum values of settlement at the two maximum sections are 138 mm, with an average settlement of 53.6 mm at ch. 1,600 and 43.8 mm at ch. 1,800. To note, the maximum settlement at each of the locations occurred on the upstream edge of the dam crest.

Figure 8 - Settlement of monuments analysed for chainages 1,600

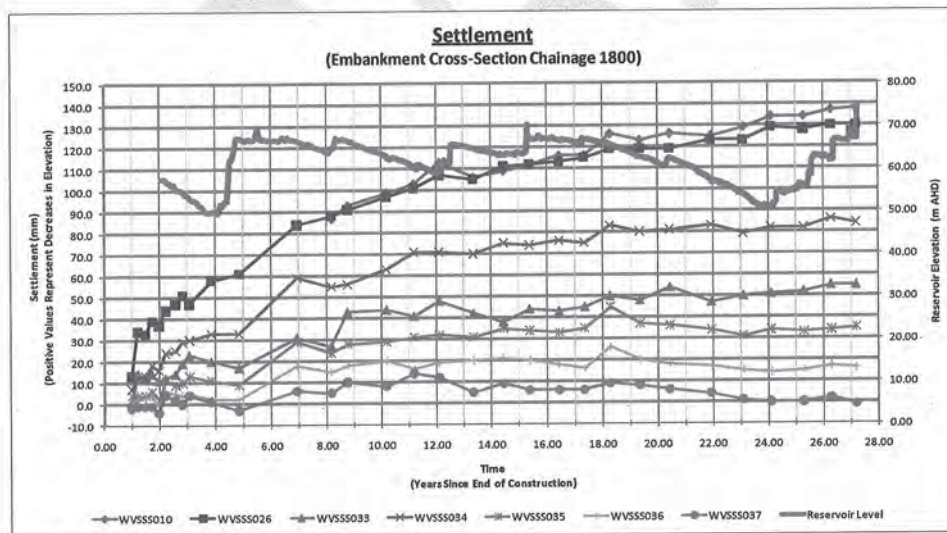
Figure 9 - Settlement of monuments analysed for chainages 1,800

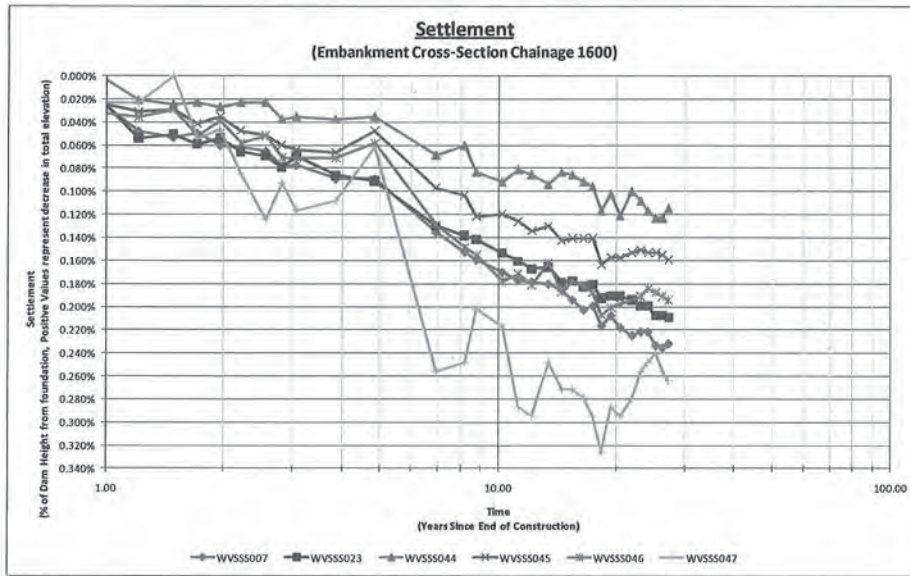
Figure 10 and Figure 11 present the same monument settlement but is displayed as a % of the dam height. This provides an additional tool to analyse the data trending of deformation. This settlement is in line with similar embankment sizes and designs. A point of concern to be noted regarding the settlement monuments WVSS036, WVSS037 at chainage 1,800 and WVSS047 at chainage 1,600. The monuments are located on the downstream slope of the embankment near the dam toe. Within

the last 15 years, these monuments are showing a trending of increasing in elevation. The maximum value of increased elevations of the previous mentioned monuments is 15 mm.

Figure 10 - Settlement of Monuments Analysed for Chainages 1,600

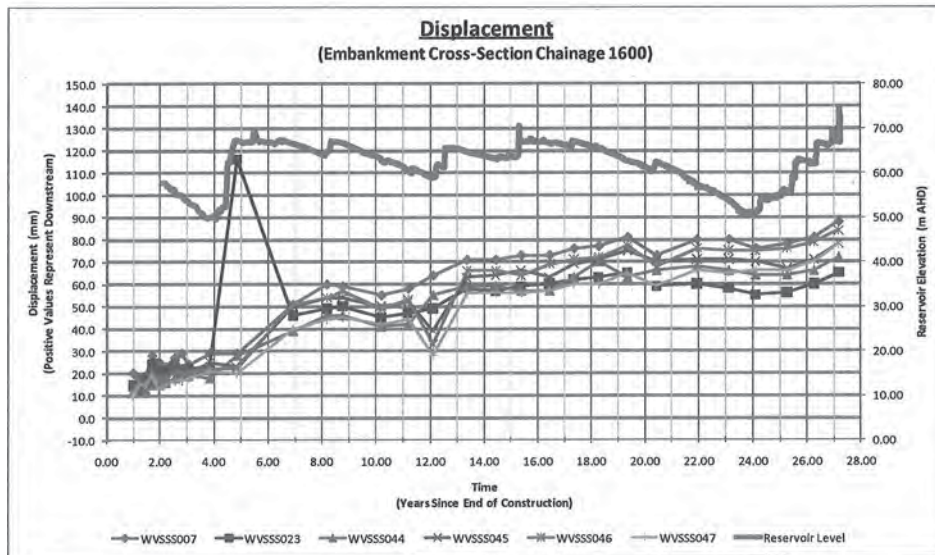
Figure 12 and Figure 13 present the post construction deformation displacement, normal to the dam, versus time for chainages 1,600 and 1,800. The maximum value of displacement, at the two maximum sections is 116 mm, with an average settlement of 25.3 mm at ch. 1,600 and 27.7 mm at ch. 1,800. Similar to the dam settlement, the maximum displacement at each of the chainages occurred at the monuments located on the upstream edge of the dam crest.

Figure 12 - Displacement of Monuments Analysed for Chainages 1,600

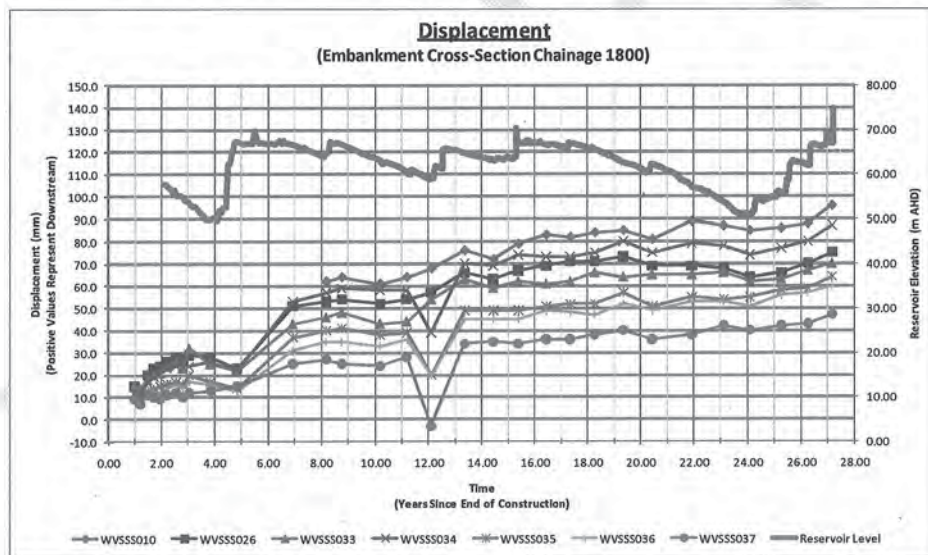
Figure 13 - Displacement of Monuments Analysed for Chainages 1,800

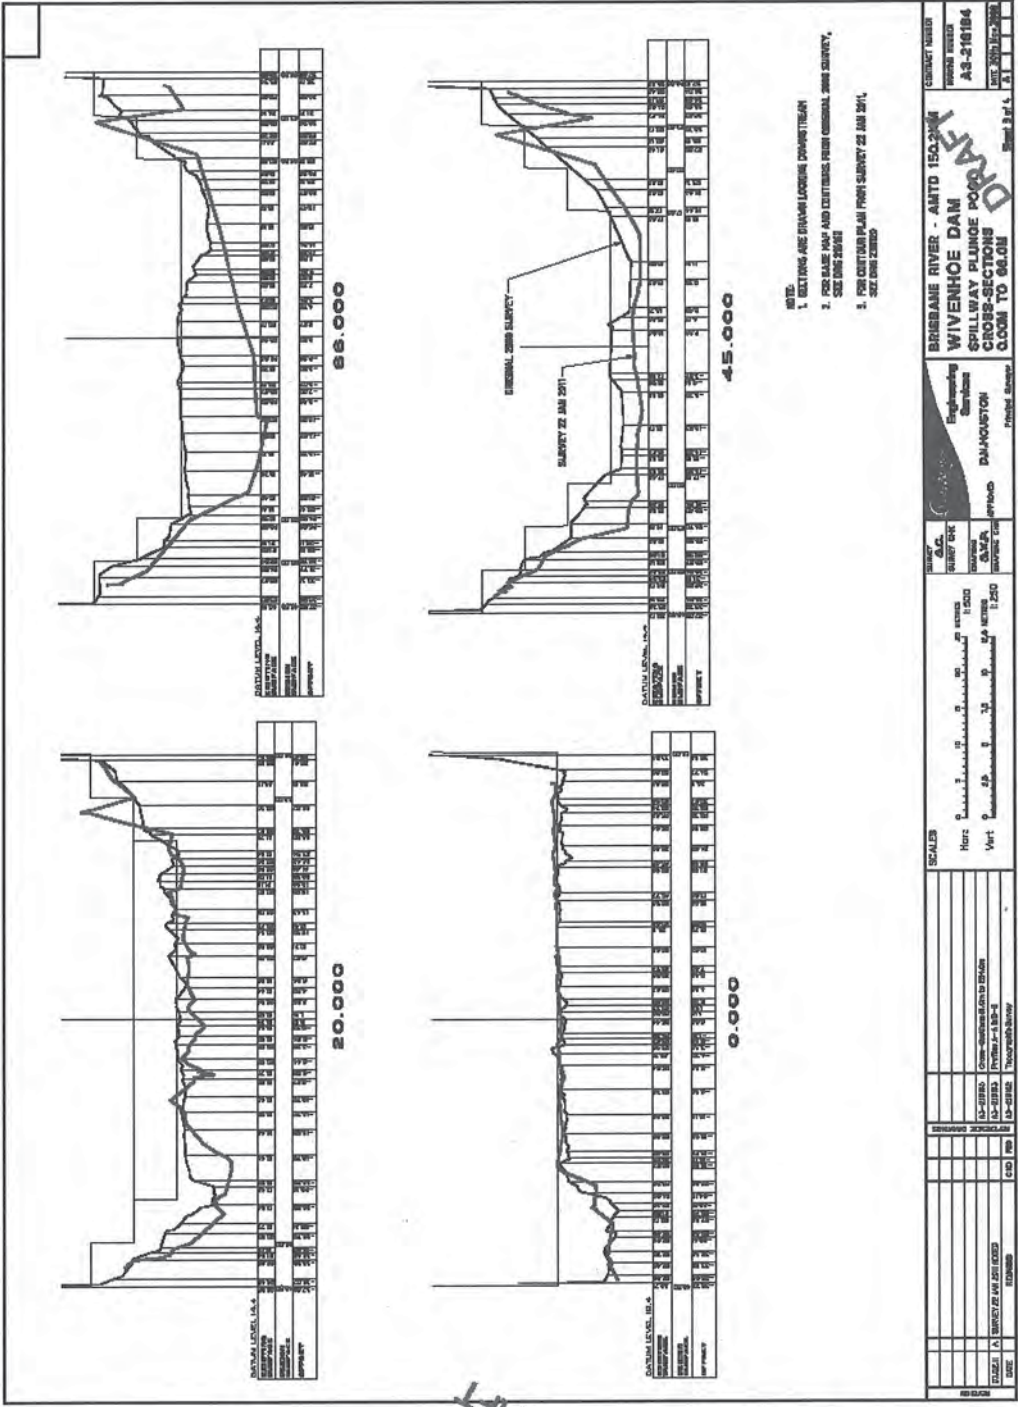
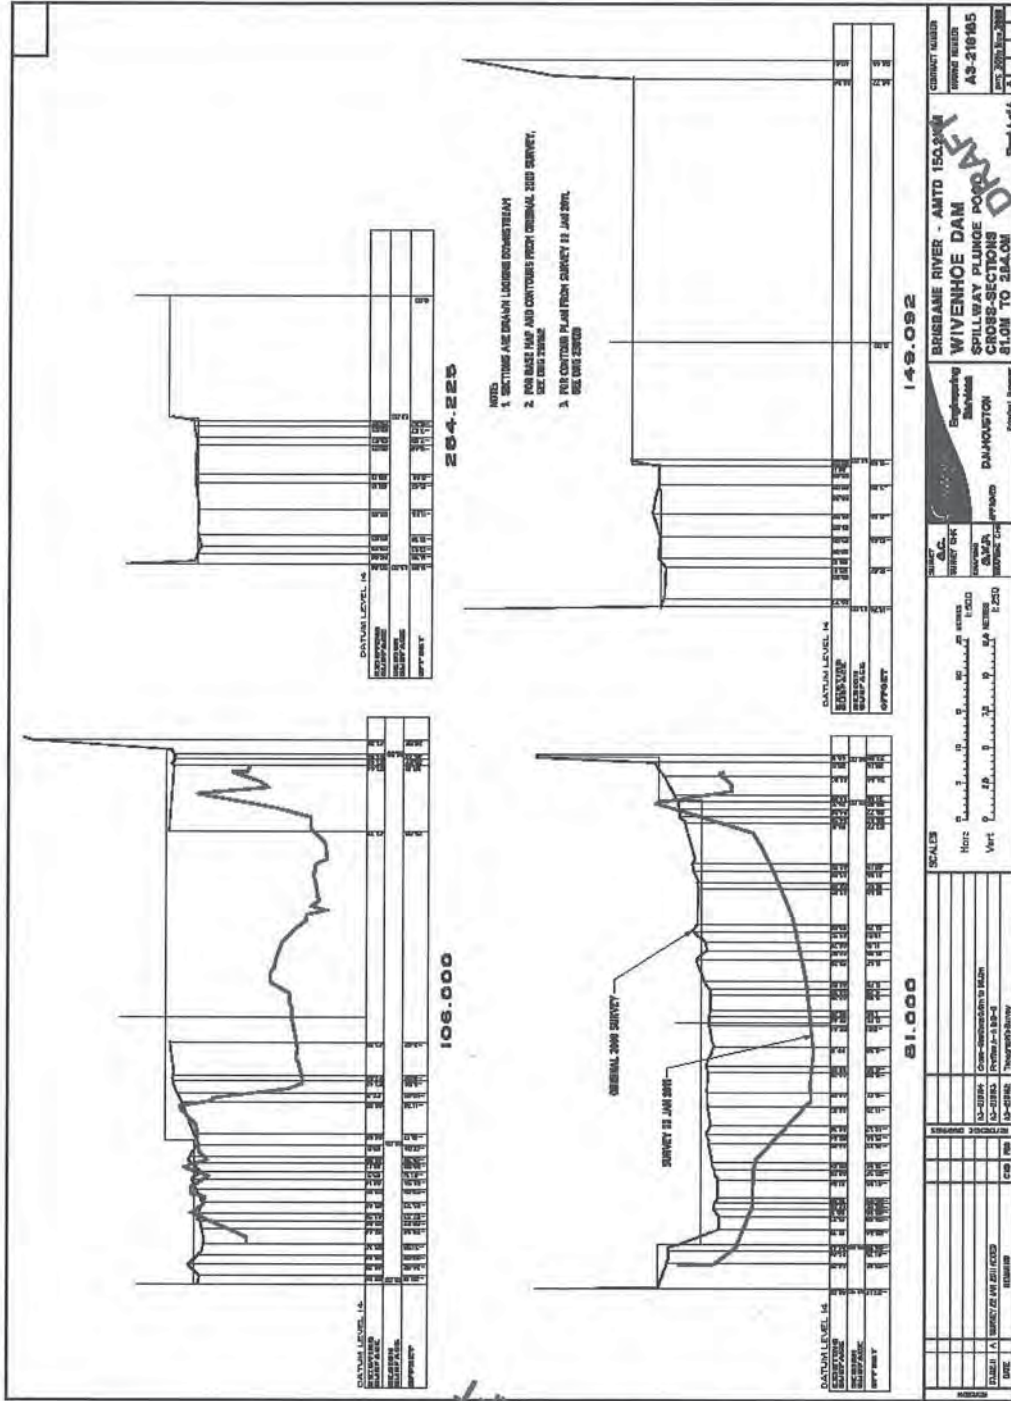
During the flood event, the flow rate released from Wivenhoe Dam Spillway peaked at approximately 7,500 m³/s. The area directly downstream of the Wivenhoe Dam Spillway had significant erosion and scour damage to the plunge pool, outlet discharge channel, lower dam access roads and spillway lookout recreational area. Initial estimates of the volume of the rock eroded from the plunge pool are over 25,000 m³ of material. In particular, several boulders in excess of 700 tons have been displaced and deposited downstream.

4. Although there was significant scour of the pre-excavated plunge pool particularly in downstream sloping face, observations also appear to show that the stability of the valley slopes and the foundation of the dam and spillway have not been compromised and are in a safe condition with rock scouring not resulting in head cutting back to the flip bucket toe and its sloping apron.

<u>Issue</u>	<u>Recommendations</u>
Erosion and scour damage to the plunge pool and downstream spillway chute.	<ol style="list-style-type: none"> 1. Investigate options to open a channel through the rock deposited by the erosion in the spillway outlet channel in order to restore the ability to operate the FDC Valve without cavitation and improve the efficiency of the hydro power station. 2. Investigate the performance of the spillway dissipator following the enlarging of the plunge pool to ensure that safe operation can occur for the full range of flood events. In particular, analyse recirculation flows in the plunge pool which may lead to erosion of the side walls or the head cutting of the upstream rock face. 3. Reestablishment of the water measurement weir to help regulate outflow rates for water delivery purposes.
Damage to the side walls of the spillway outlet channel	<ol style="list-style-type: none"> 4. Carry out a safety assessment of the side wall of the spillway chute and the lookout structure and assess the need for any remedial works where weak joints have been eroded.

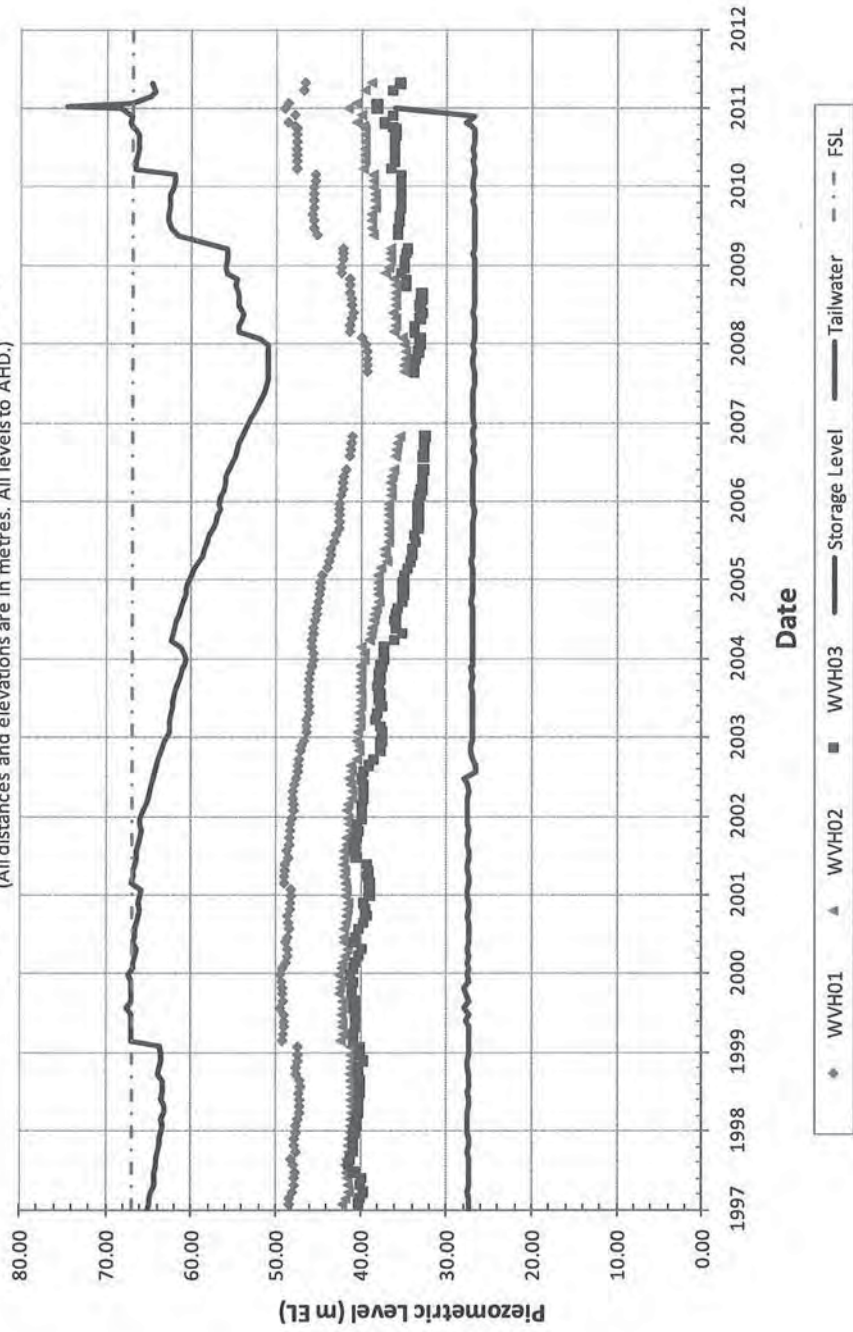
**Wivenhoe Dam Piezo Levels @ CH1600 & EL ~15
(WVH01 @ 11.0 U/S; WVH02 @ 0.0; WVH03 @ 11.0 D/S)**

PIEZOMETERS	DESCRIPTION	COMMENTS	CURRENT TRIGGER
WVH01 WVH02 WVH03	These three piezometers are located within the sandstone foundation at EL 15 metres under the embankment core at Ch 1600. WVH01 is 11 metres upstream of the embankment centreline, WVH02 is on the embankment centreline and WVH03 is 11 metres downstream of the embankment centreline. The grout curtain is located midway between WVH01 and WVH02.	The pressure drop across the grout curtain remains in the order of five metres, indicating some leakage across the curtain. This is in line with historical performance. Due to damages to the piezometer housing, it is possible that WVH02 readings exceed the trigger level of 42 metres during the January 2011 flood event. After the flood, the piezometers levels have receded, as expected, and fall in line with historical trending.	Any reduction in the pressure differential between WVH01 and WVH02 to a value equal to or below 4.5 metres should trigger additional monitoring and investigation. Any increase in the pressure reading for WVH02 in excess of EL 42 metres should trigger additional monitoring and investigation.

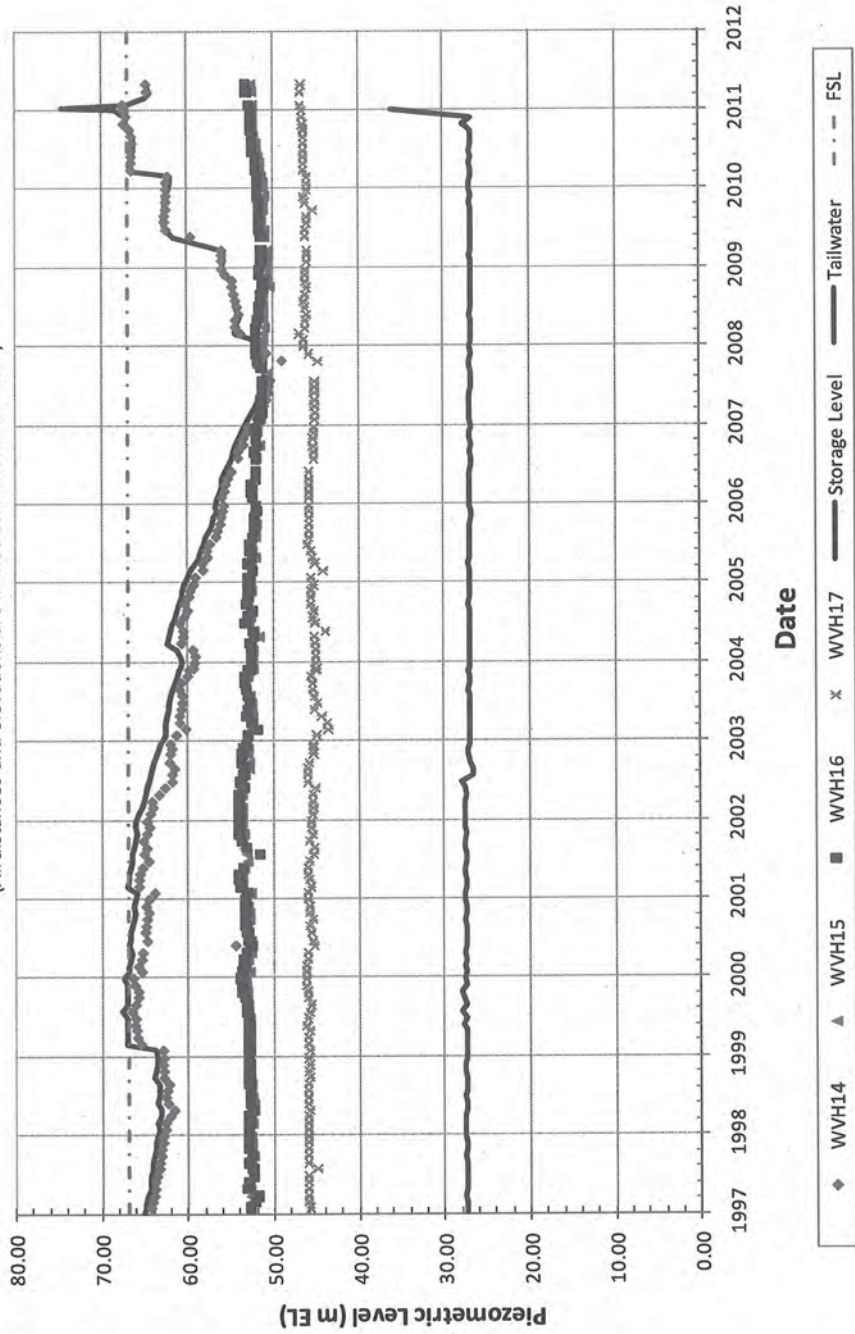
Wivenhoe Dam Piezo Levels @ CH1600 & EL ~45
 (WVH14 @ 7.5 U/S; WVH15 @ 2.5 U/S; WVH16 @ 2.5 D/S; WVH17 @ 6.0 D/S)
 (All distances and elevations are in metres. All levels to AHD.)

WVH14 WVH15 WVH16 WVH17	These four piezometers are located at EL 45 metres within the embankment core at Ch 1600. The piezometers are fairly evenly spaced. WVH14 and WVH15 are 7.5 metres and 2.5 metres respectively, upstream of the embankment centreline. WVH16 and WVH17 are 2.5 metres and 6 metres respectively downstream of the embankment centreline.	The pressure readings from these piezometers are consistent with historical performance dating back to the first filling of the dam in 1988 with the exception of WHV17. Due to damages to the piezometer housing, it is possible that WHV17 readings exceed the trigger level during the January 2011 flood event. After the flood, the piezometers levels have receded, as expected, and fall in line with historical trending.	Any increase in the pressure reading for WHV15 in excess of EL 54 metres should trigger additional monitoring and investigation. Any increase in the pressure reading for WHV17 in excess of EL 47 metres should trigger additional monitoring and investigation.

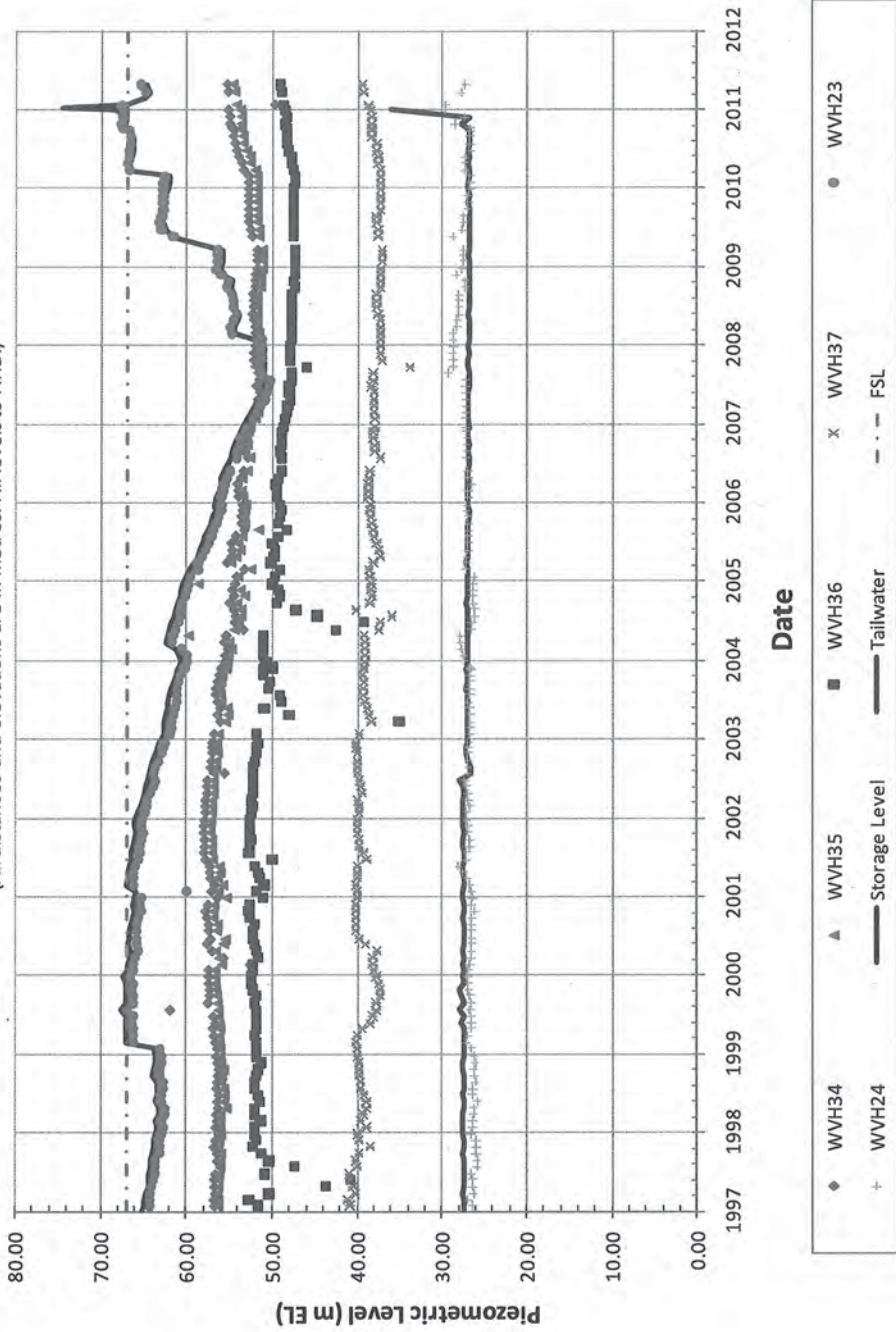
Wivenhoe Dam Piezo Levels @ CH1800 & EL ~35 (CH1600 for WWH23 & WWH24)
 (WWH34 @ 8.0 U/S; WWH35 @ 3 U/S; WWH36 @ 3 D/S; WWH37 @ 8.0 D/S; WWH23 @ 42 U/S; WWH24 @ 42 D/S)
 (All distances and elevations are in metres. All levels to AHD.)

WVH34 WVH35 WVH36 WVH37	These four piezometers are located at EL 35 metres within the embankment core at Ch 1800. The piezometers are fairly evenly spaced. WVH34 and WVH35 are 8 metres and 3 metres respectively, upstream of the embankment centreline. WVH36 and WVH37 are 3 metres and 8 metres respectively downstream of the embankment centreline.	The pressure readings from these piezometers are consistent with historical performance dating back to the first filling of the dam in 1988 with the exception of WHV37. Due to damages to the piezometer housing, it is possible that WHV37 readings exceed the trigger level during the January 2011 flood event. After the flood, the piezometers levels have receded, as expected, and fall in line with historical trending.	Any increase in the pressure reading for WHV36 in excess of EL 53 metres should trigger additional monitoring and investigation. Any increase in the pressure reading for WHV37 in excess of EL 41 metres should trigger additional monitoring and investigation.

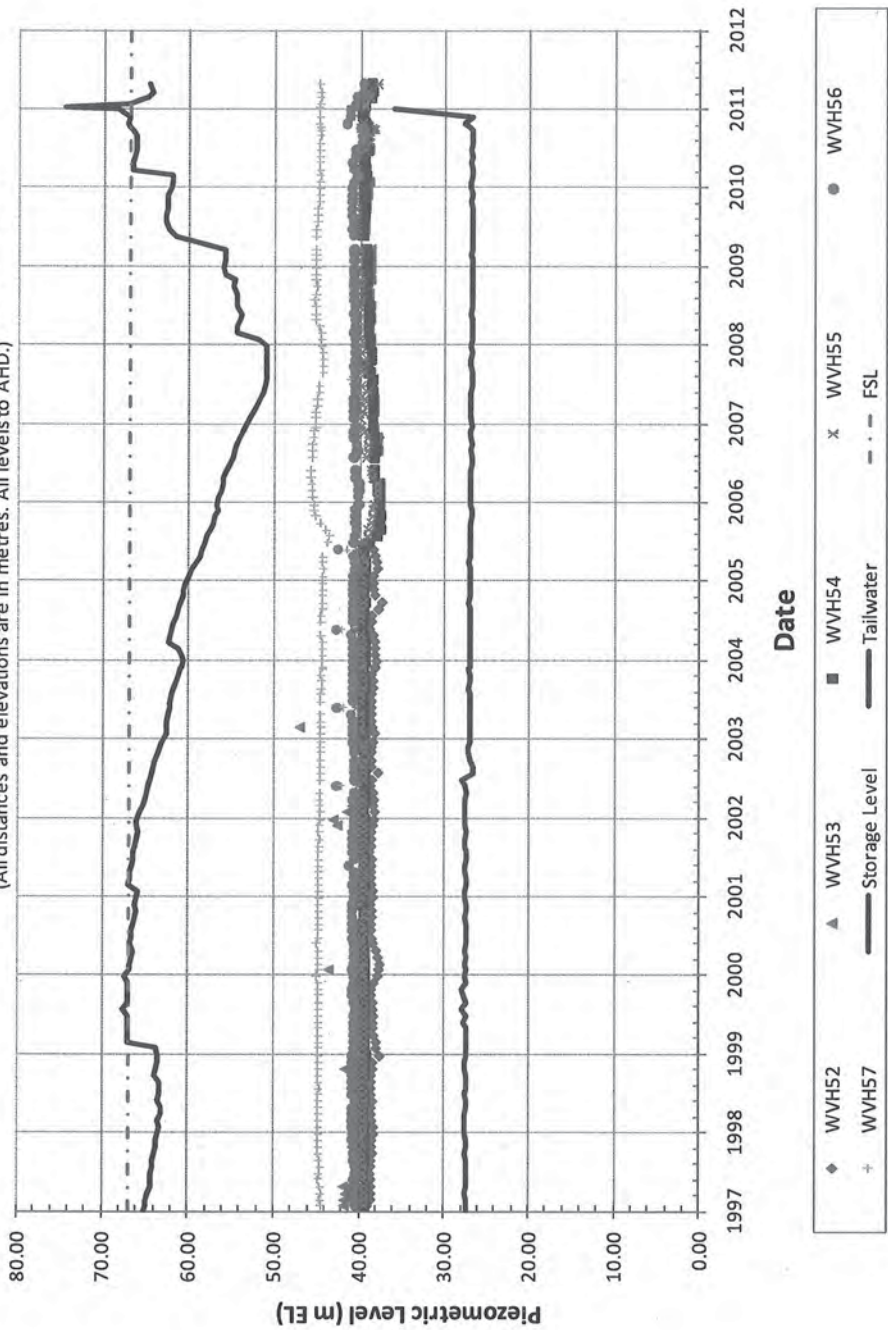
Wivenhoe Dam Piezo Levels @ Mono S2

WVH52 WVH53 WVH54 WVH55 WVH56 WVH57	These six piezometers are located between EL 44 and EL 36 at the interface of spillway monolith 52 and the spillway foundations, at Ch 1170. The piezometers are spaced over a distance of approximately 25 metres, with WVH57 being the most upstream piezometer moving sequentially downstream to WVH52, the most downstream piezometer.	The pressure readings from these piezometers are consistent with historical performance dating back to the first filling of the dam in 1988. There is nothing to indicate that any of the piezometers have approached the trigger levels for this section.	Any trend showing an increase in the pressure reading for any piezometer.
WVH58	This piezometer is located at EL 38 at the interface of spillway monolith 53 and the spillway foundations, at Ch 1185 (spillway centreline). The piezometer is located directly under the lower gallery.	The pressure readings from these piezometers are consistent with historical performance dating back to the first filling of the dam in 1988. There is nothing to indicate that any of the piezometers have approached the trigger levels for this section.	Any trend showing an increase in the pressure reading for the piezometer.

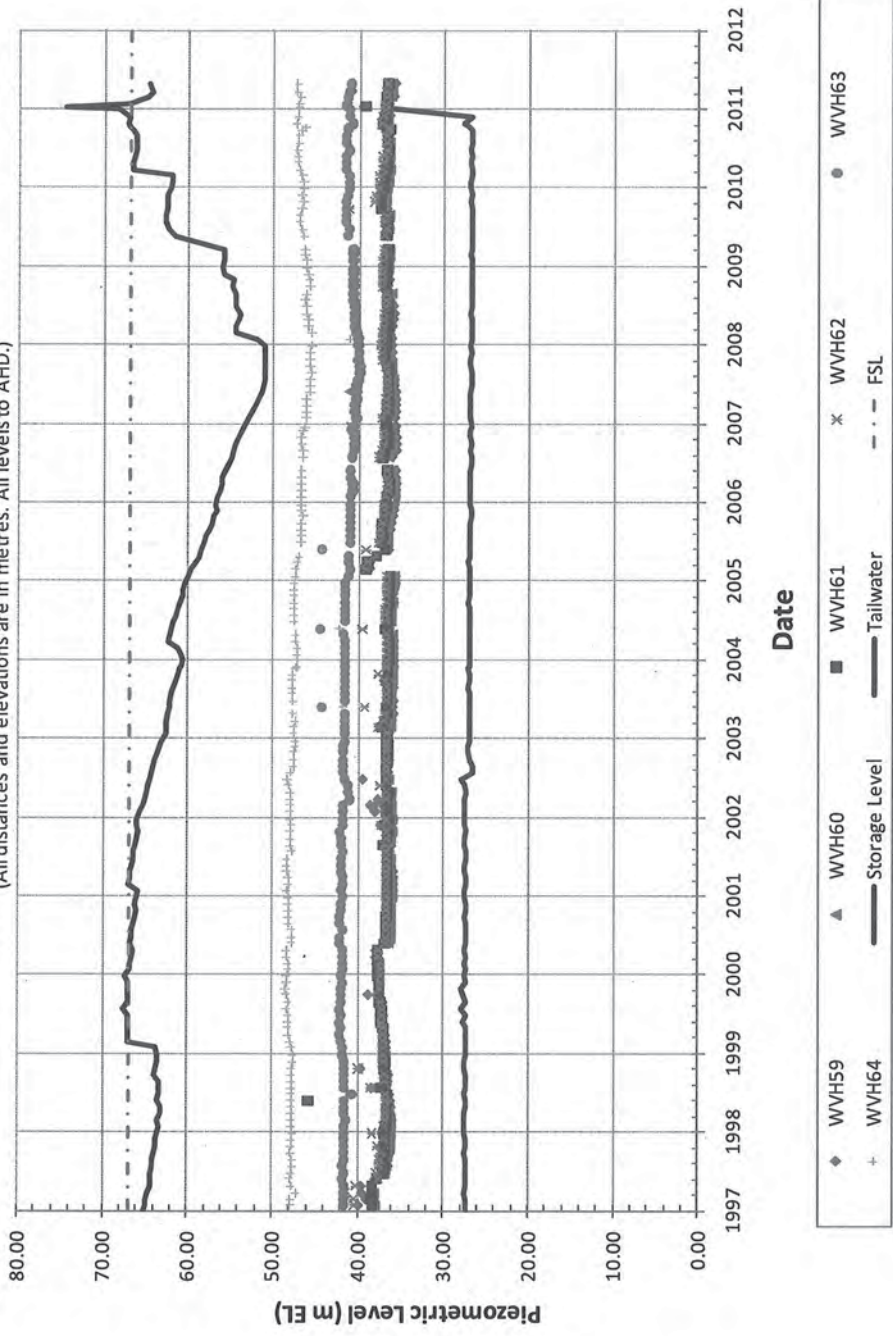
Wivenhoe Dam Piezo Levels @ Mono S4
 WVH59, WVH60, WVH61, WVH62 @ EL ~38; WVH63 @ EL ~44
 (All distances and elevations are in metres. All levels to AHD.)

WVH59 WVH60 WVH61 WVH62 WVH63 WVH64	These six piezometers are located between EL 44 and EL 38 at the interface of spillway monolith 54 and the spillway foundations, at Ch 1200. The piezometers are spaced over a distance of approximately 25 metres, with WVH64 being the most upstream piezometer moving sequentially downstream to WVH59, the most downstream piezometer.	The pressure readings from these piezometers are consistent with historical performance dating back to the first filling of the dam in 1988. There is nothing to indicate that any of the piezometers have approached the trigger levels for this section.	Any trend showing an increase in the pressure reading for any piezometer.
WVH65	This piezometer is located at EL 39 at the interface of spillway monolith 55 and the spillway foundations, at Ch 1215. The piezometer is located directly under the lower gallery.	The pressure readings from these piezometers are consistent with historical performance dating back to the first filling of the dam in 1988. There is nothing to indicate that any of the piezometers have approached the trigger levels for this section.	Any trend showing an increase in the pressure reading for the piezometer.
