QUEENSLAND FLOODS COMMISSION OF INQUIRY

STATEMENT OF ANDREW KROTEWICZ

ATK2-1 Wivenhoe Power Station Geological Inspection Report by SunWater 19 January 2011

Project: P-AEXP-1900-AC-12-03 **File No:** 05-013001/009

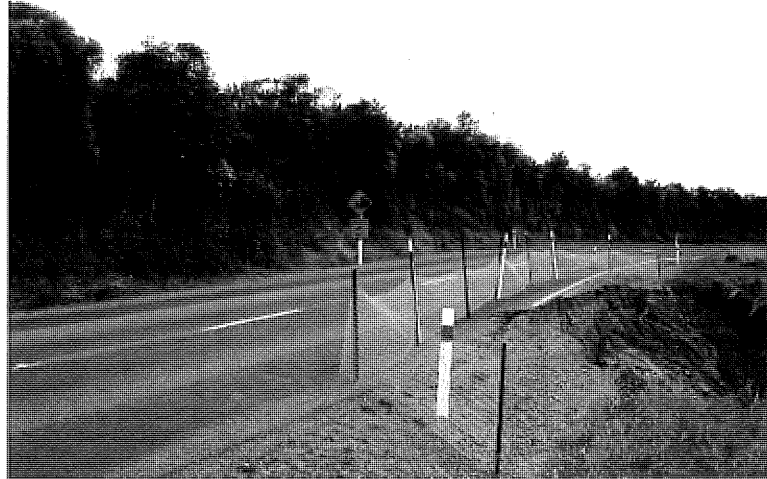
Figure 21: Example of isolation using barricade mesh (New Zealand).

These areas should be isolated with barricade mesh or similar (refer Figure 21).

Tension cracks should be isolated from overland flow by way of the construction of a low, cold mix asphalt bund, which will direct water away from the open crack. Ideally, the crack should be sealed using asphalt or tar to prevent surface water ingress. Grout should not be used as the addition of significant volumes of grout may promote additional movement.

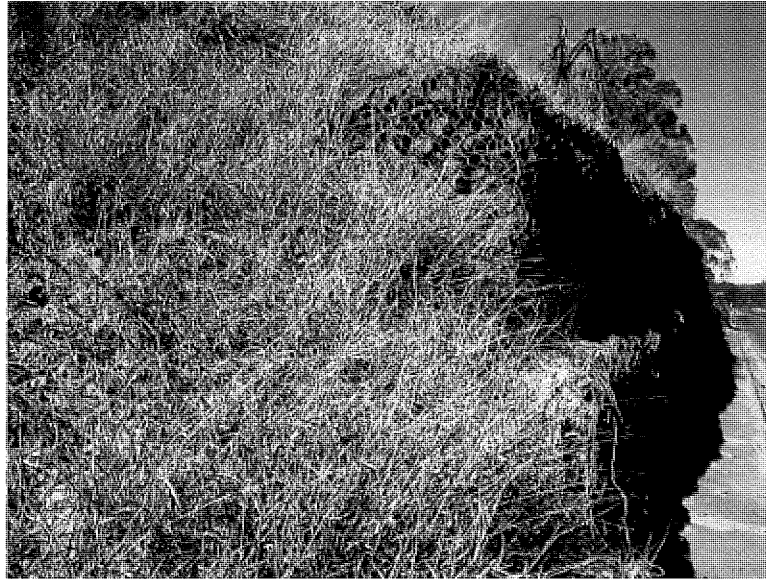
Figure 22: Example of gabions used to stabilise road cutting near Fernvale, Brisbane Valley.

- Remove the material that has suffered failure or disturbance.
- Provide a benched foundation.
- Install geofabric and appropriate drainage.
- Reinstate the slope using a combination of gabions and free draining earth materials.

An example of such a repair is provided below (Figure 22).

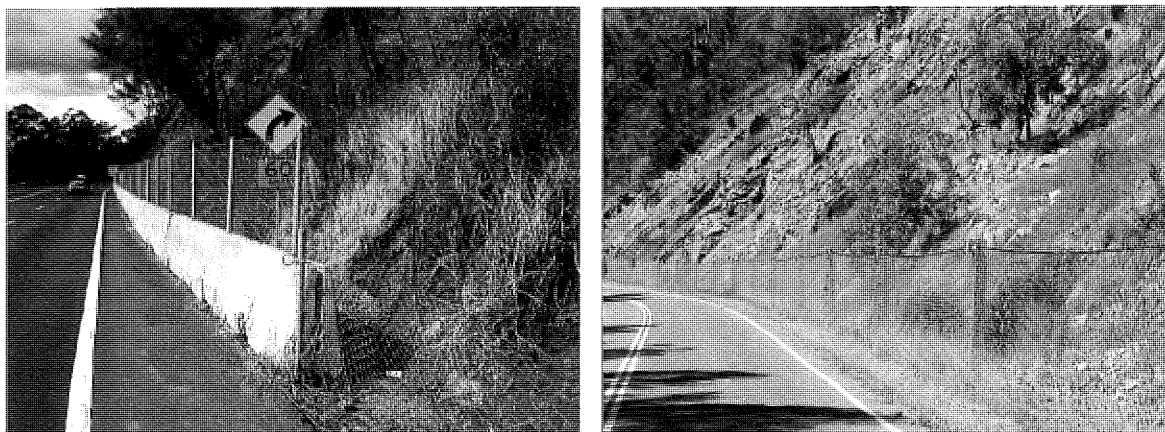
Figure 23: Rock fall protection systems at Left) Cunningham's Gap, and Right) Mount Tamborine.

Where rock falls have and are expected to occur and the adjacent slope is not able to be re-profiled, a system of rock fall protection barriers, similar to those shown in Figure 23 may be suitable. These are engineered systems designed to absorb/protect against specific energy loads.
