Statement of Ian WHITEHEAD

QUEENSLAND FLOODS COMMISSION OF INQUIRY

STATEMENT OF IAN WHITEHEAD

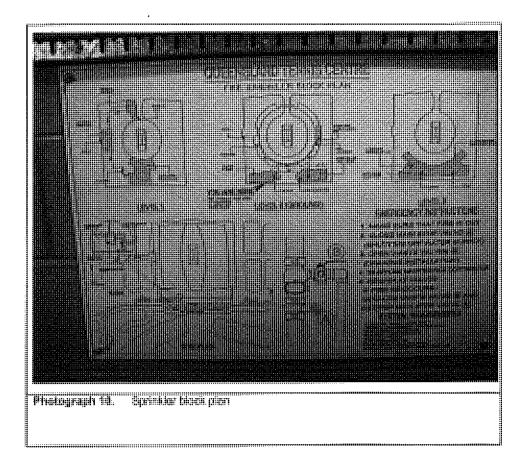
The protected areas can be seen in photograph 10.

The sprinkler system is linked directly to the local fire brigade.
