IN THE MATTER OF
THE QUEENSLAND FLOODS COMMISSION OF INQUIRY 2011

SECOND SUPPLEMENTARY STATEMENT OF BARTON JEFFERAY MAHER

Brief description of the nature of cracking at Somerset Dam

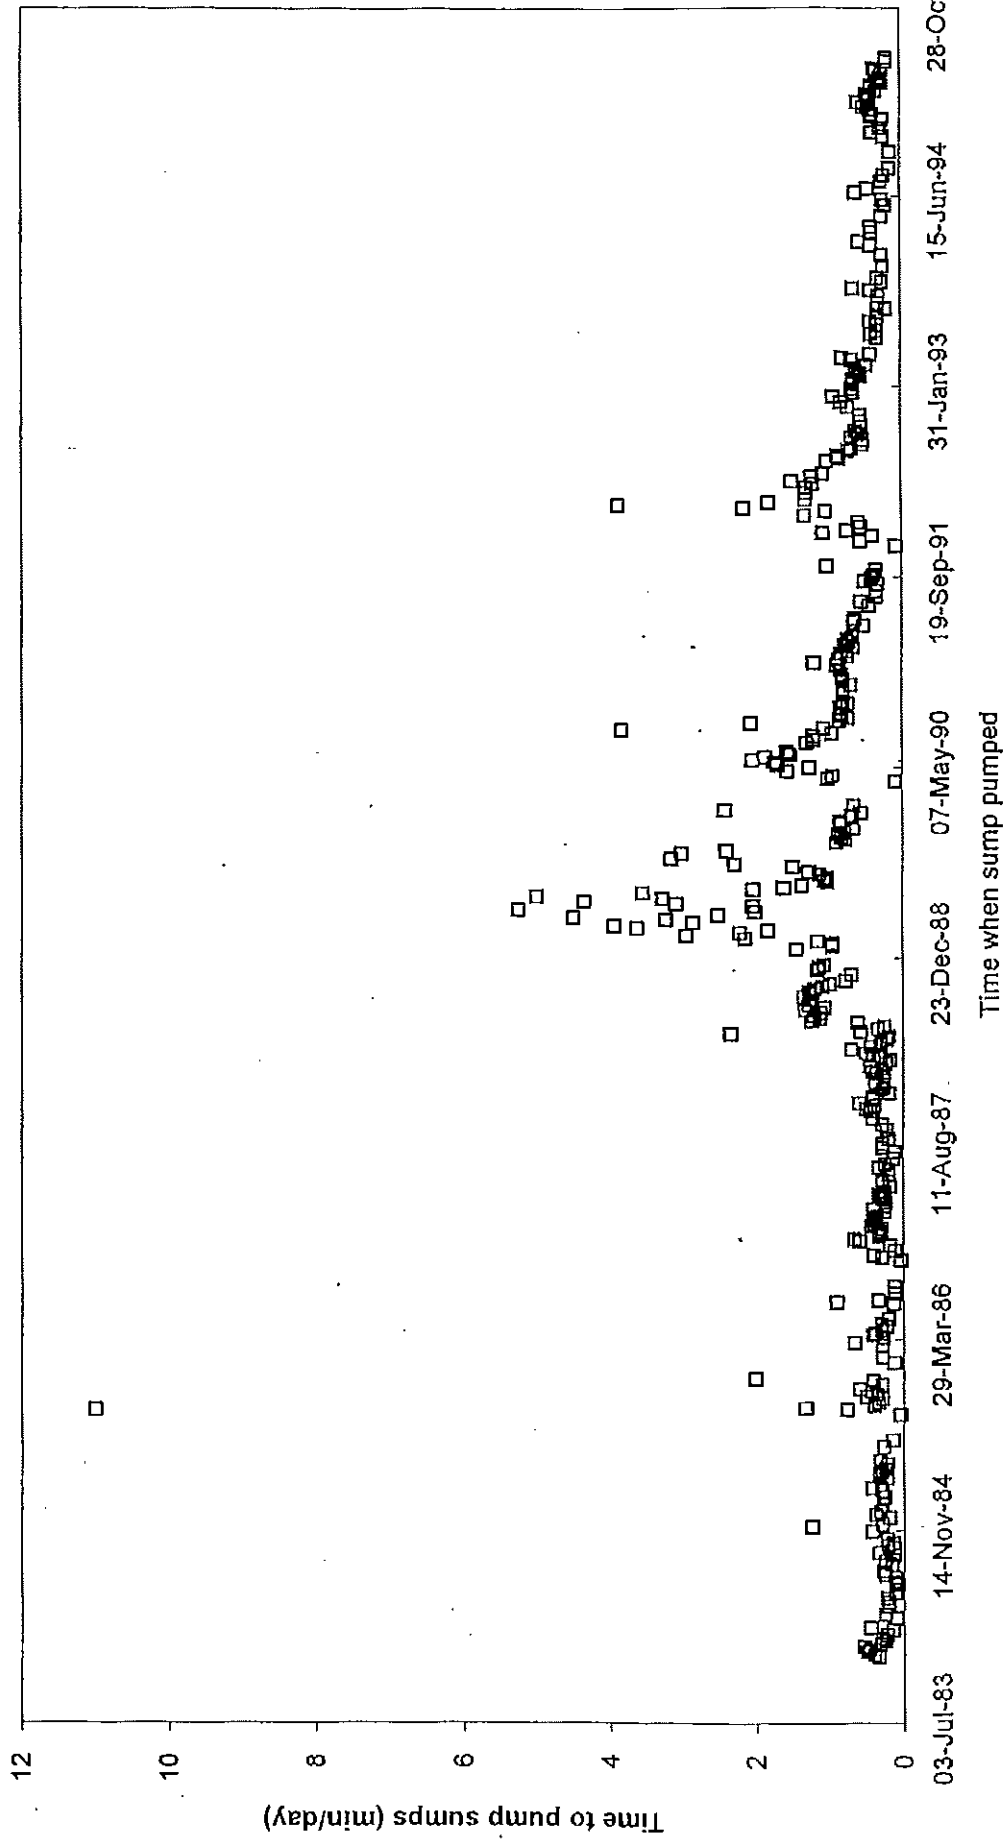
FIGURE 5

From 15 December 1983 to the present, the time taken to pump out water from the sump in monolith Q is measured. Results of this monitoring are plotted in Figure 5 and indicate no clear trends. This could be because the system used to test the pumps each week involves filling the sump to trip the automatic switch on the pumps.

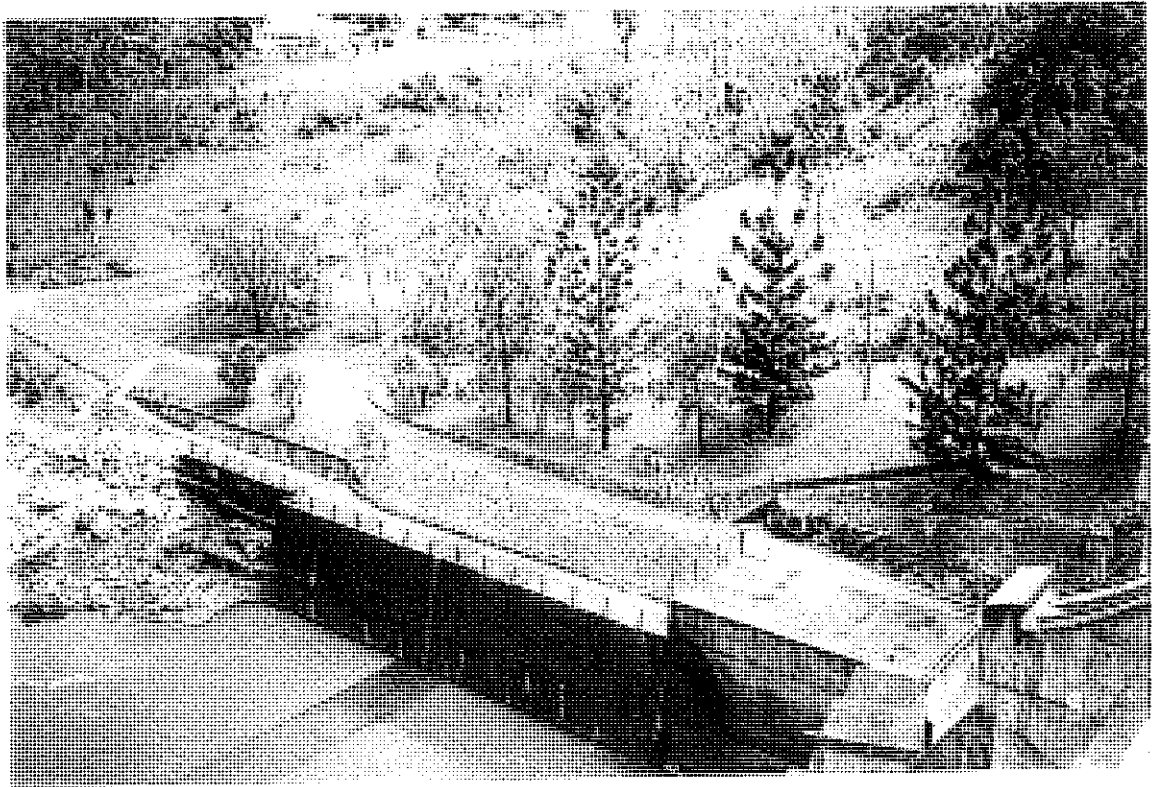
Right Abutment Stilling Basin Walls - Note weep holes, rock outcrops counterweight slides for spillway gates, signs of weathering "alkali; aggregate reactivity" in gate pier, backfilling behind retaining walls, stilling basin baffle, rip-rap downstream of stilling basin.

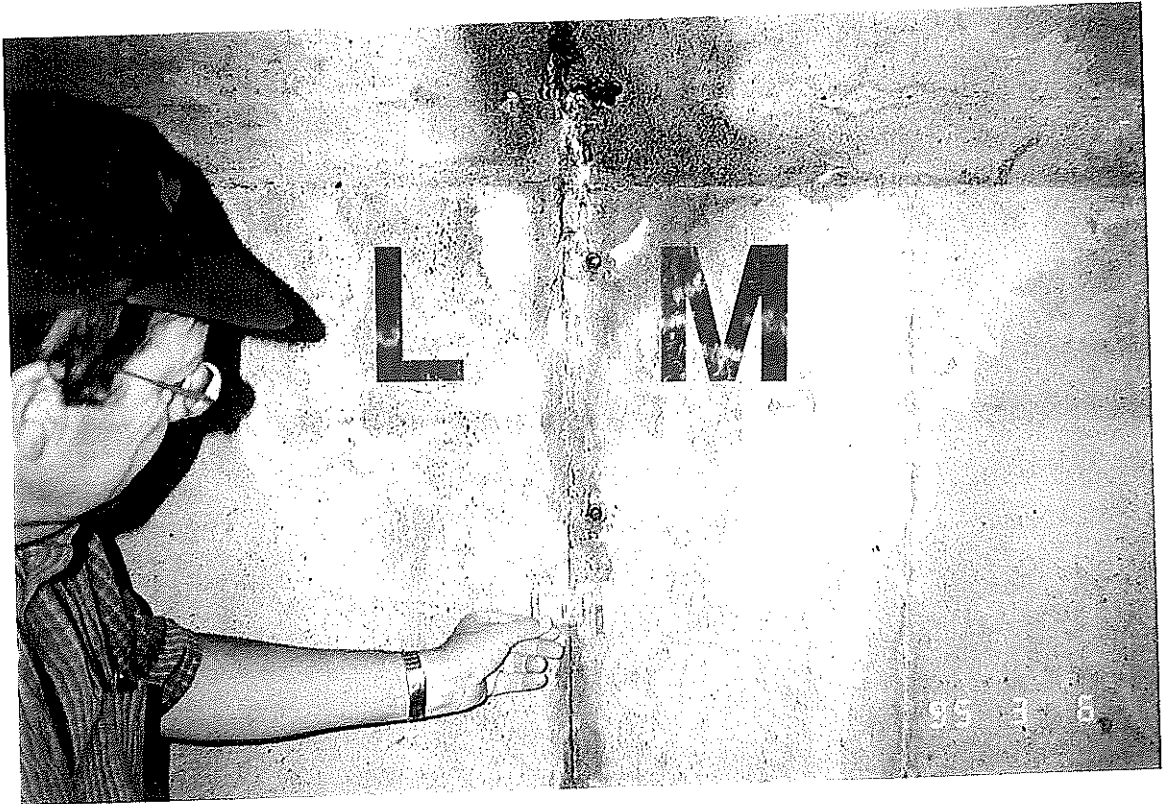
Seepage through Joint L/M - Water entering about 2 m above gallery floor.

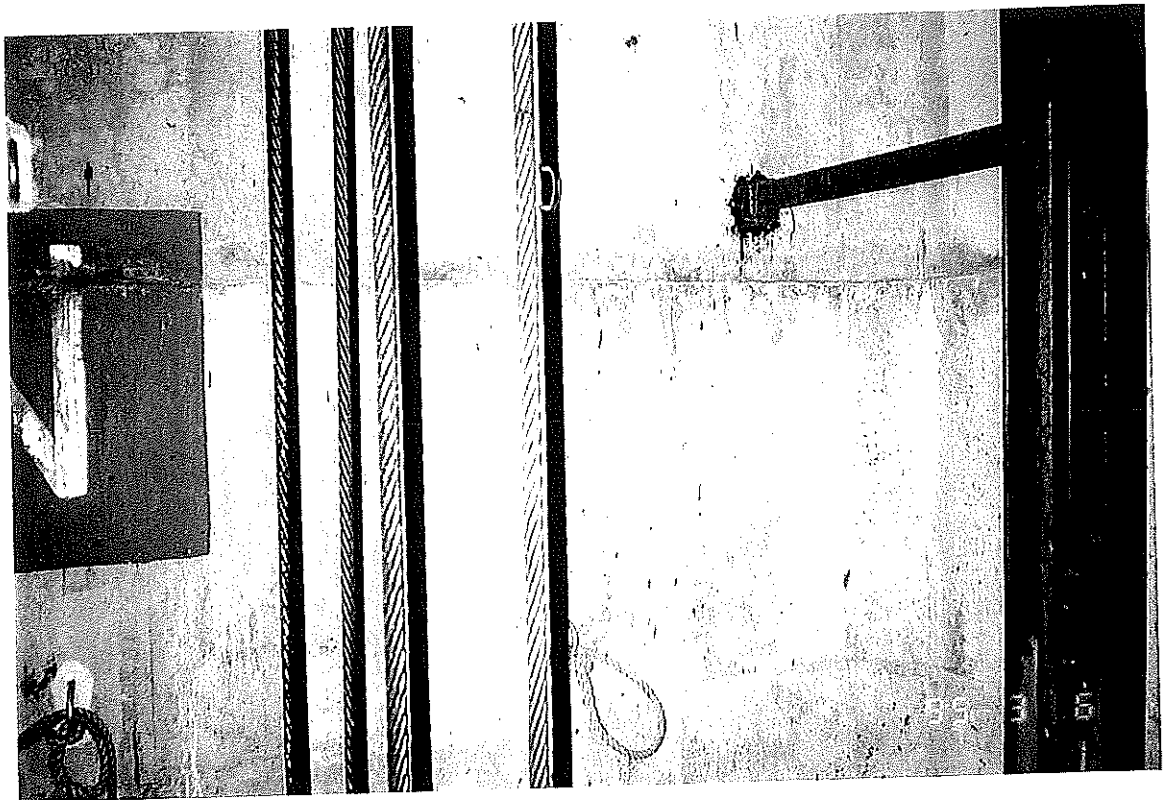
Calcite from old weep in sluice shaft in Monolith N.

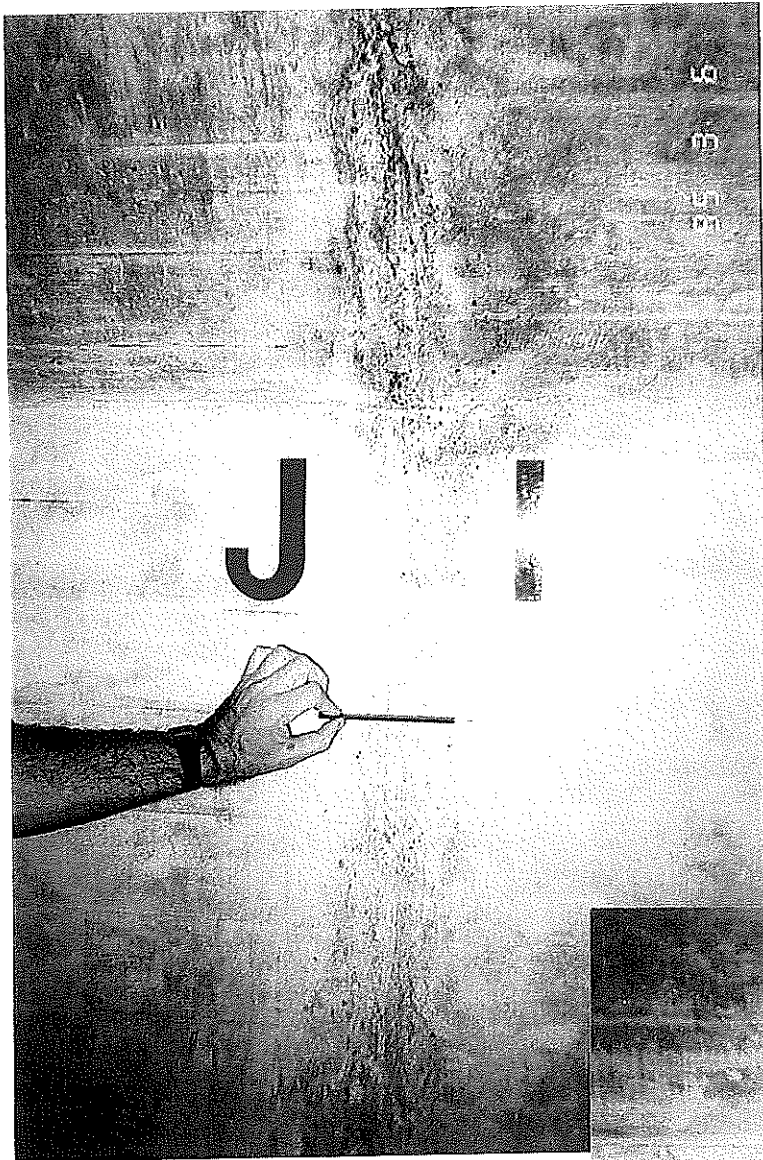
Downstream face of contraction joint between Monoliths L and M in lower gallery. Note that at the crest this joint is open, in the upper gallery the joint indicates a crack has developed and in the lower gallery the joint may show signs of being compressed.

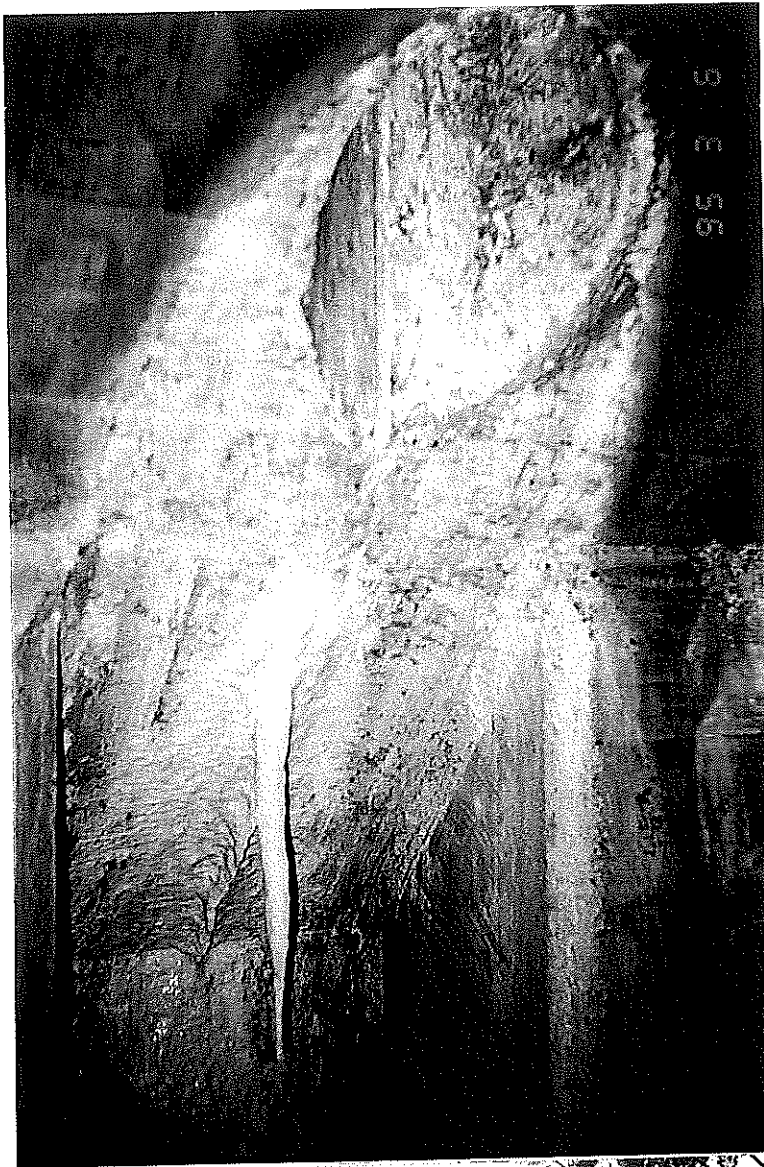
Contraction Joint Drain between Monoliths I and J.

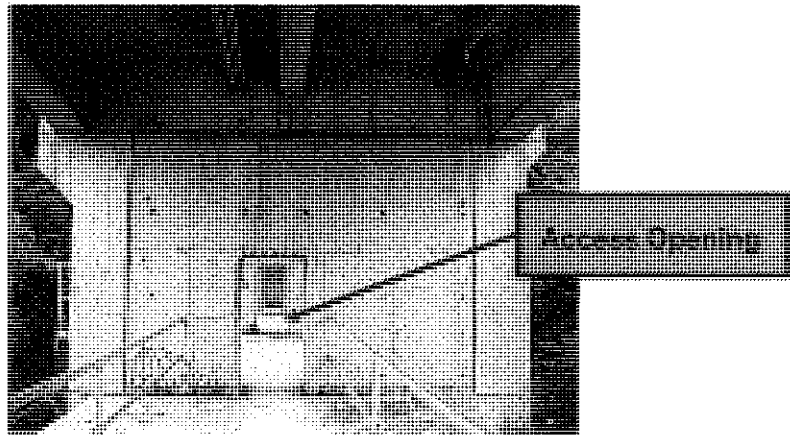
Figure 4. Somerset Dam Crest Level Access

- The existing crack is located at a level well below the road deck and also the dam crest level (located at a level below the road deck);
- The gallery has a small cross section only and limits the size of the equipment that can be used within the gallery and the length of cores that can be extracted;
- Access to the dam crest level is restricted by narrow and relatively low access openings through the piers supporting the road deck.

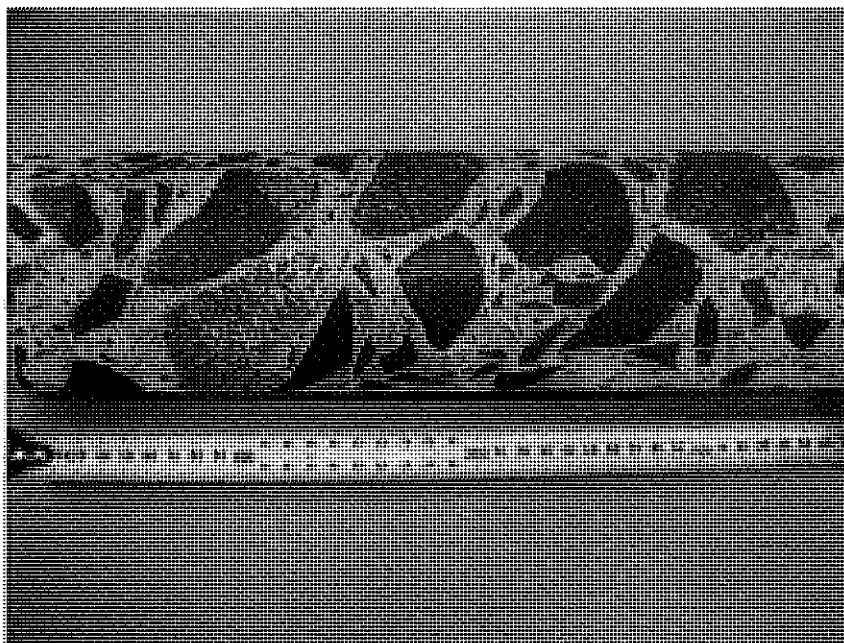
Photo 2. Photograph of 100mm diameter core.

The overall concrete condition appears to be excellent, with the surfaces of lifts difficult to detect from extracted cores and only minor voids visible.

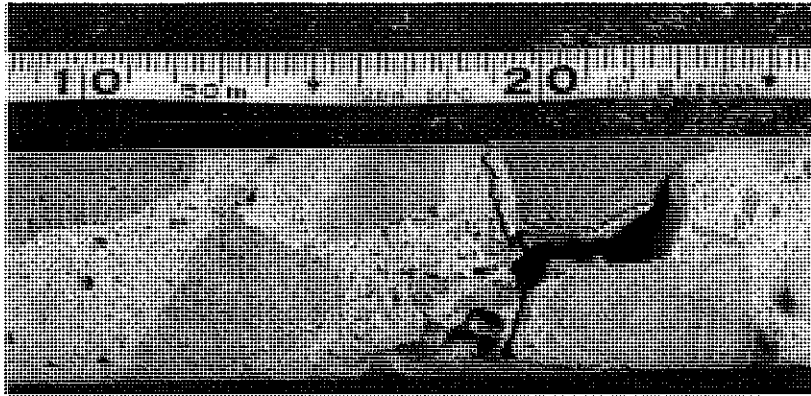
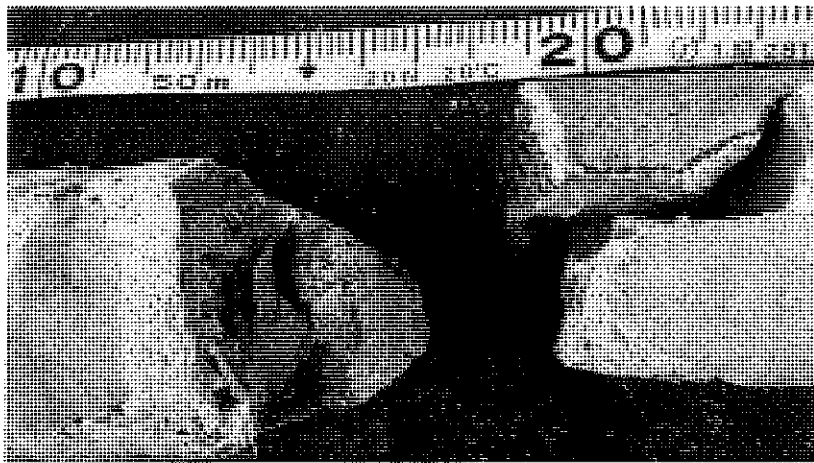
HOLE ID	DEFECT TYPE	DEPTH (m)	CALCITE	WEATHERING	JOINT TIGHTNESS	COMMENTS
CHEA1	Crack/Void	1.90	None	None	Honeycombing	Large loss of water and drill cuttings. Possible crack linking adjacent drain holes between adjacent monoliths. Large amount of cuttings on gallery floor on inspection

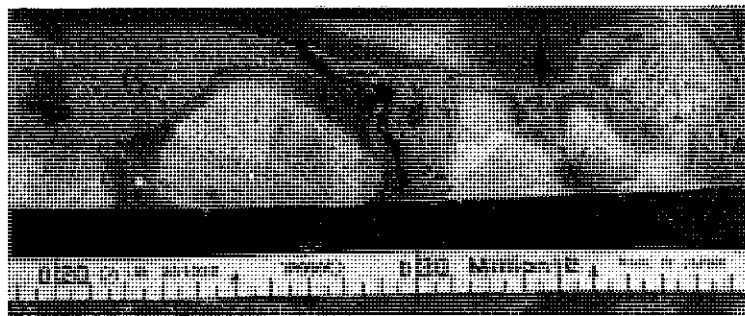
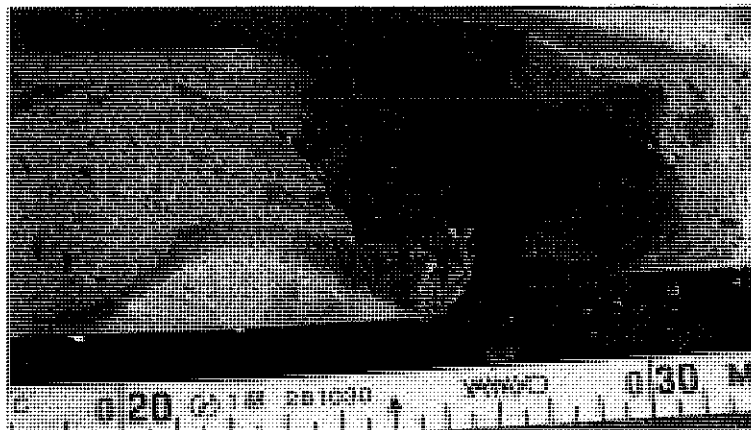
HOLE ID	DEFECT TYPE	DEPTH	CALCITE	WEATHERING	JOINT TIGHTNESS	COMMENTS
CHEV1	Crack	11.70	Moderate	Slight	Tight	Possible lift surface, calcite visible on both surfaces

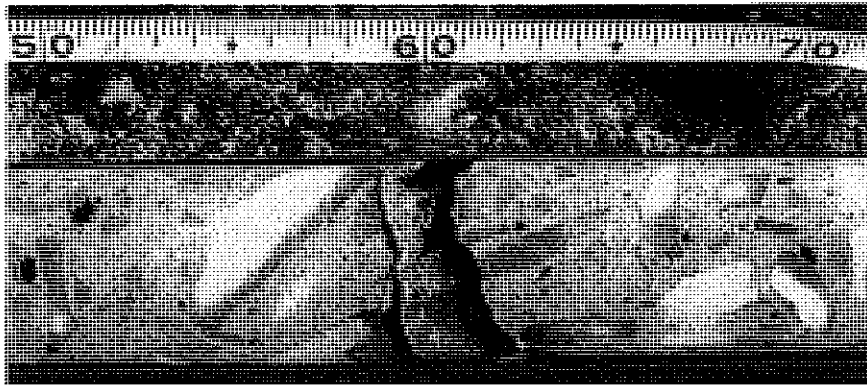
HOLE ID	DEFECT TYPE	DEPTH (m)	CALCITE	WEATHERING	JOINT TIGHTNESS	COMMENTS
CHF A1	Crack	11.10	Slight	Moderate	Loose	10mm at its widest, infilled with weathered cement, slight sandy feel when rubbed, no signs of calcite on surface. loss of water after rods removed.
CHF A1	Crack	12.42	None	moderate	Loose/Fragmented	Possible lift surface, fragmented pieces in joint/crack
CHF A1	Crack/void	14.4	None	Slight	Loose/Fragmented	Possible lift surface, voids/hole showing calcite deposits on surfaces of void. Fragmentation possibly due to drilling.
CHF A1	Crack	18.8	Slight	Slight	Loose-tight	Loss of water on run 18.3 to 19.85, surfaces of joint feel sandy, possibly signs of slight weathering.
CHF A1	Crack	20.10	Slight	None	Fragmented	Possible lift surface, fragmented pieces in crack. Crack approximately 30mm at its widest.

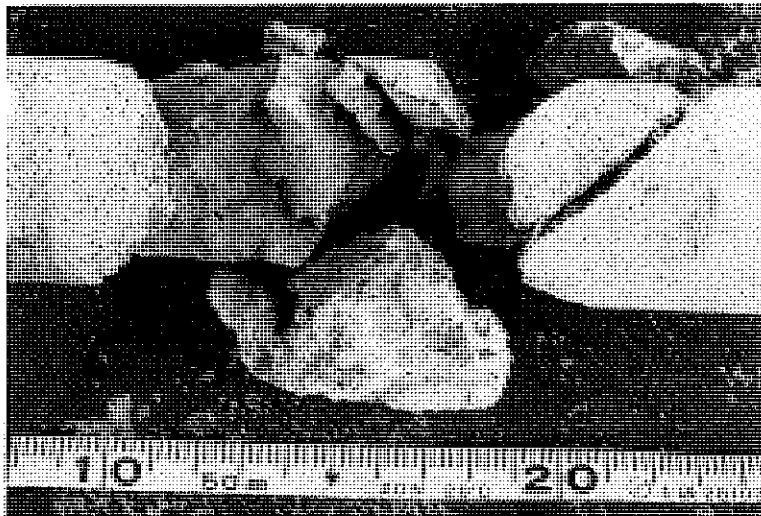
HOLE ID	DEFECT TYPE	DEPTH	CALCITE	WEATHERING	JOINT TIGHTNESS	COMMENTS
CHFV1	Crack/Void	17.30	None	None	Void	Honeycombing/Void from 17.23 to 17.32m, Large loss of water seeping out of 2 vertical drains coming out of the ceiling of the stairwell leading down to the lower observation gallery at the intersection between F and G monoliths.

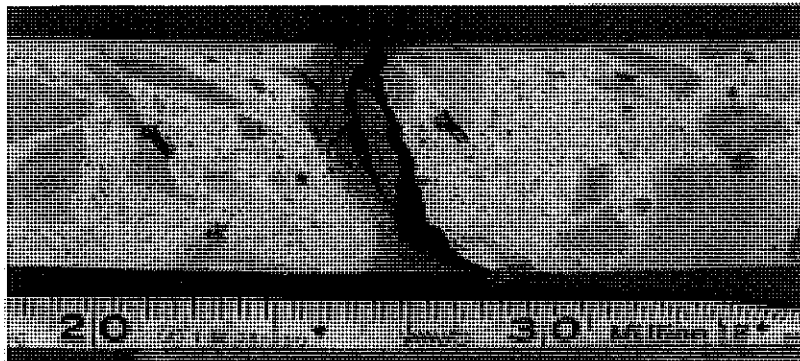
HOLE ID	DEFECT TYPE	DEPTH	CALCITE	WEATHERING	JOINT TIGHTNESS	COMMENTS
CHFA2	Inclusion	11.05	NA	NA	NA	Wood inclusion found embedded in core.
CHFA2	Crack	11.15	None	Moderate	Slightly open	10mm at its widest, infilled with weathered cement, slight sandy feel when rubbed, no signs of calcite on surface. Large loss of water after rods removed. Water seen seeping out of down stream face of dam approximately 5m in width and at same RL as drilling depth.
CHFA2	Crack	14.53	moderate	Slight	Tight	Possible lift surface, signs of calcite of crack surfaces, loose appearance of crack. Loose pieces of cement in split, possibly from drilling.
CHFA2	Crack	20.40	None	Moderate	Slightly open	10mm at it's widest, infilled with weathered cement, slight sandy feel when rubbed, no signs of calcite on surface.

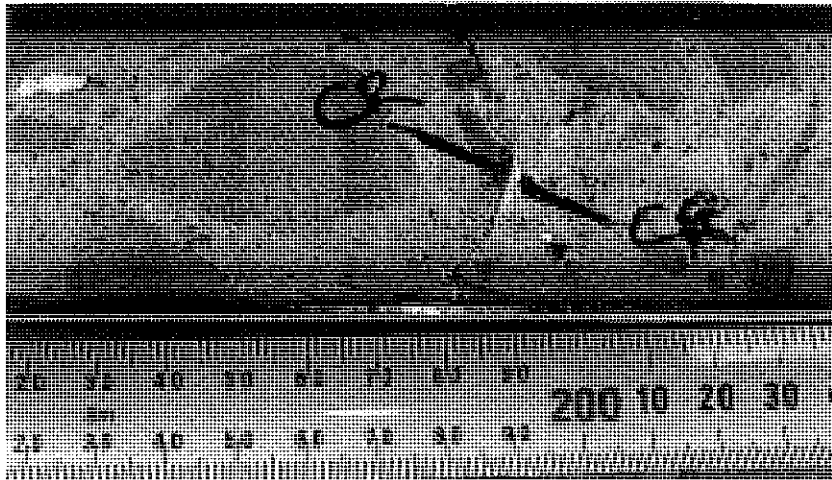
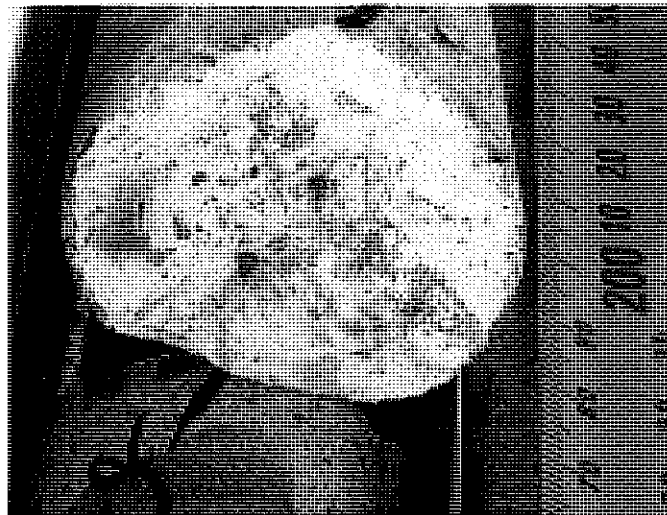
HOLE ID	DEFECT TYPE	DEPTH	CALCITE	WEATHERING	JOINT TIGHTNESS	COMMENTS
CHFV2	Crack	11.73	Moderate	Moderate	Tight	Calcite deposits and powdery feel on both surfaces. Visually tight, undulating, rough crack surface.
CHFV2	Crack	14.45	None	Slight	Tight	No visible calcite on surfaces of crack, slightly weathered.
CHFV2	Crack/Void	15.46	Slight	Slight	Tight	Possible lift surface. Fractured material around crack visible when split placed on ground. Evidence of honeycombing and voids. Hairline crack surrounding void.

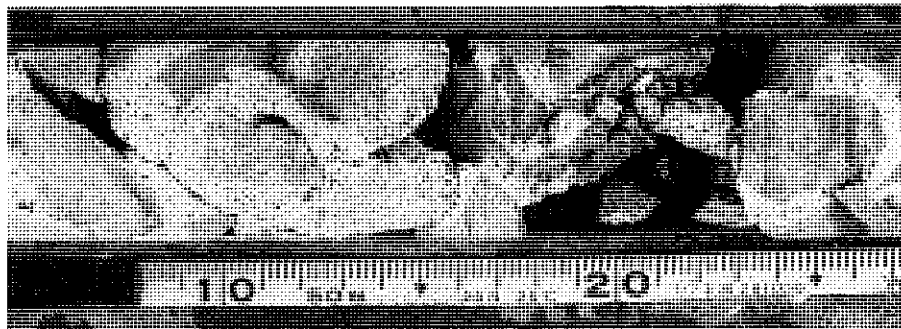
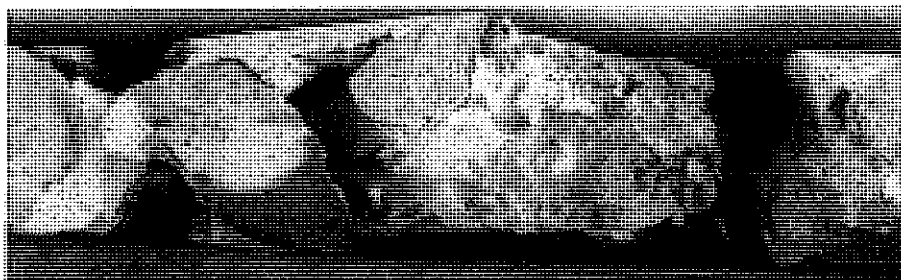
HOLE ID	DEFECT TYPE	DEPTH	CALCITE	WEATHERING	JOINT TIGHTNESS	COMMENTS
CHGA1	Crack/Void	16.0	Slight	Slight	Void	Possible lift surface. Signs of honeycombing/void on crack and fracturing. Loss of smaller pieces. Large loss of water when rods pulled at end of run.
CHGA1	Crack/Void	21.72	Slight	Moderate	Void	Possible lift surface, powdering feel to crack surface. Slight evidence of calcite on lower surface of crack.

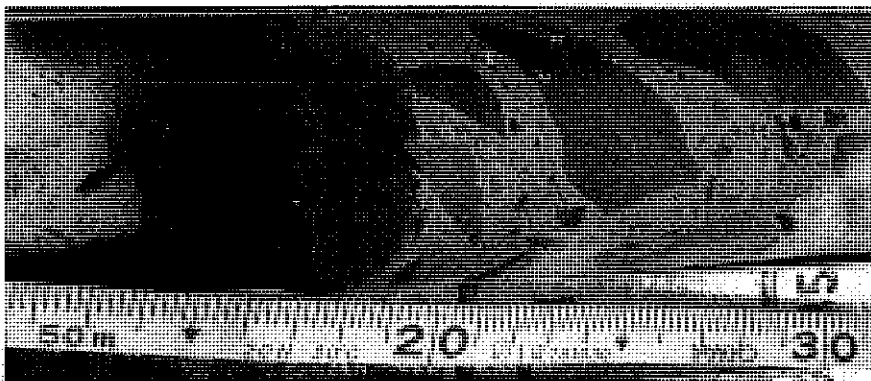
HOLE ID	DEFECT TYPE	DEPTH	CALCITE	WEATHERING	JOINT TIGHTNESS	COMMENTS
CHSA1	Crack	14.85	Moderate	Moderate	open	15cm long in core. Vertical open crack (approximately 20 degrees in core), Calcite on surfaces showing signs of weathering. Identical location and appearance as crack at 14.80 in CHTA1.
CHSA1	Crack/Void	18.3	No	Mod to High	Infilled	Weathered seam of cement. Seepage evident from crack in upper observation gallery. 10-20mm at its widest point in core.
CHSA1	Crack	21.45	Slight	Slight	Tight	Slight evidence of calcite on one side of core sample at crack location.

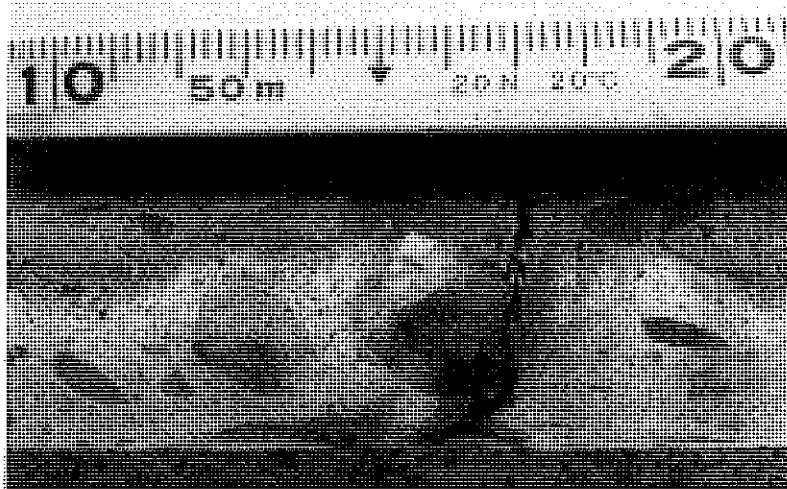
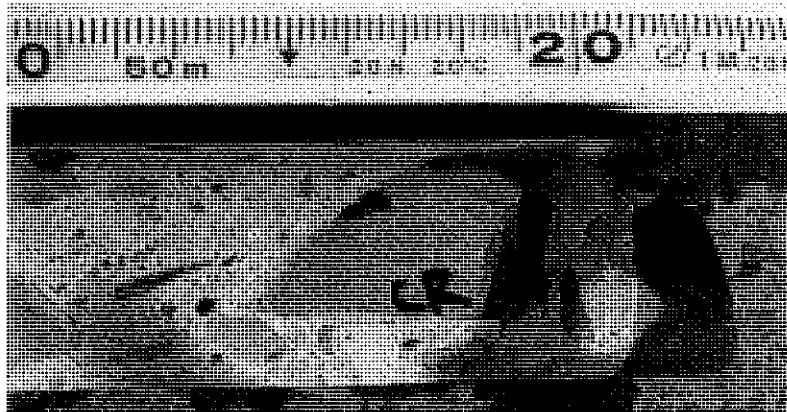
Depth: 6.0m
Machine: Scout

HOLE ID	DEFECT TYPE	DEPTH	CALCITE	WEATHERING	JOINT TIGHTNESS	COMMENTS
CHSA2	Crack	6.0	None	Slight-Moderate	Infilled	Weathered seam of cement 1-5mm at its widest, possible lift surface.
CHSA2	Crack	12.73	Moderate	Slight	Tight	No obvious weathering, signs of calcite on both surfaces of joint.
CHSA2	Crack	18.05	Slight	Slight	Tight	Slight evidence of calcite on surface.
CHSA2	Crack	18.68	No	Mod to High	Infilled	Weathered seam of cement. 5-10mm at its widest point in core. Loose fragments from joint.

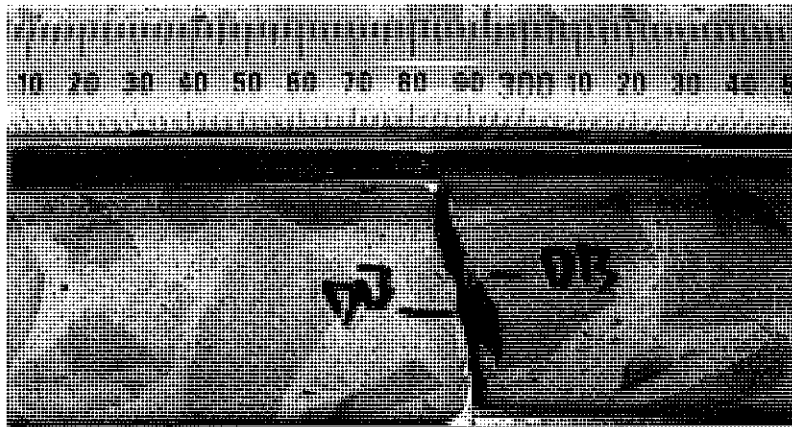
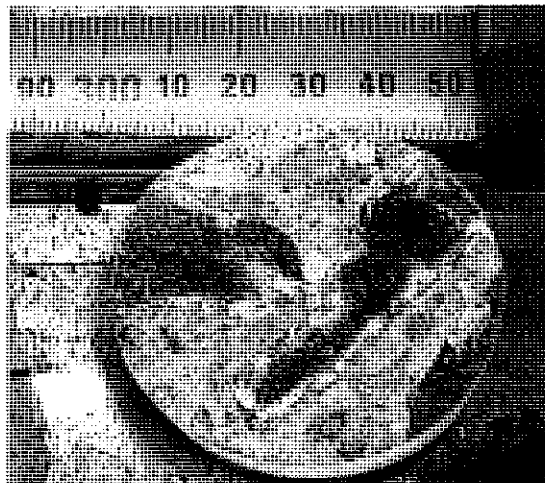
Depth: 19.90m
Machine: Scout

HOLE ID	DEFECT TYPE	DEPTH	CALCITE	WEATHERING	JOINT TIGHTNESS	COMMENTS
CHSV1	Crack	19.90	Slight	Slight	Loose to Tight	Possible lift surface, calcite visible around aggregate.

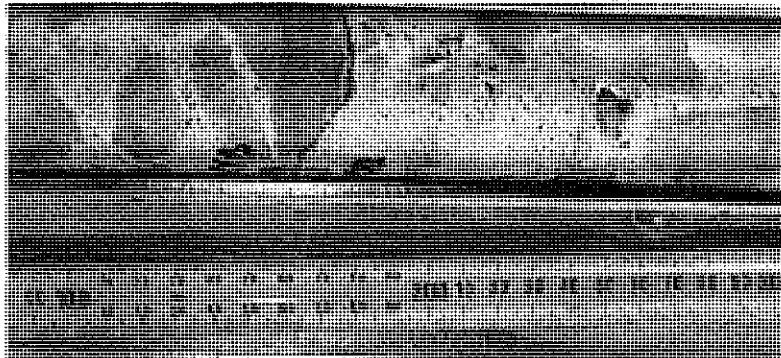
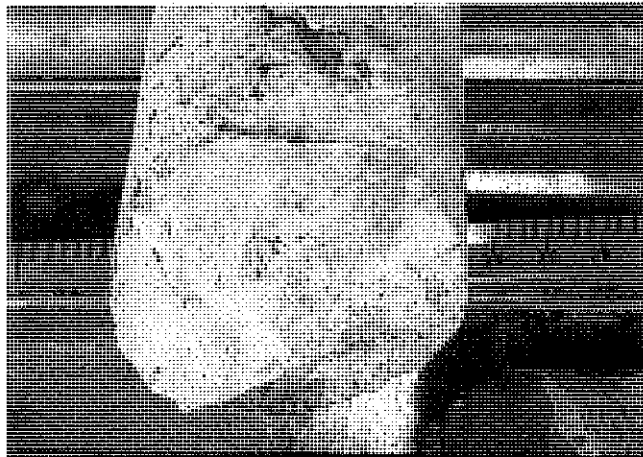
Depth: 20.40m
Machine: Scout

HOLE ID	DEFECT TYPE	DEPTH	CALCITE	WEATHERING	JOINT TIGHTNESS	COMMENTS
CHSV2	Crack	20.40	Slight	Slight	Tight	Possible lift surface, weak cement possibly due to weathering. Slight signs of honey combing.

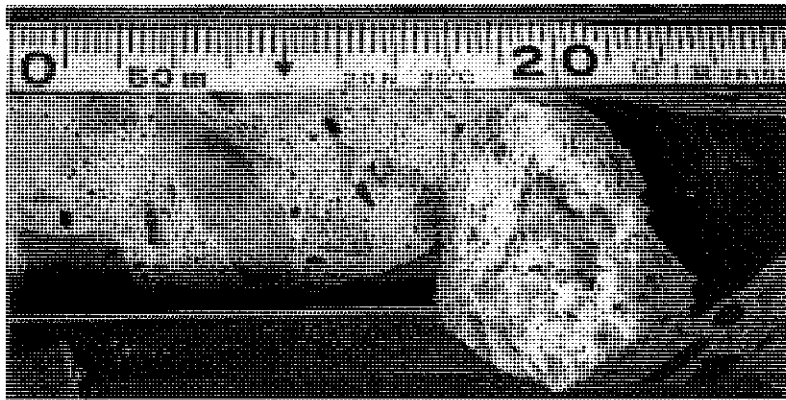
Depth: 12.66m
Machine: Scout

HOLE ID	DEFECT TYPE	DEPTH (m)	CALCITE	WEATHERING	JOINT TIGHTNESS	COMMENTS
CHTA1	Crack	12.66	Moderate	Slight	Tight	Crack appears tight, distinct deposits of calcite on both surfaces.
CHTA1	Crack	14.80	Moderate	Moderate	open	Vertical open crack (approximately 20 degrees in core), Calcified surface showing signs of weathering.

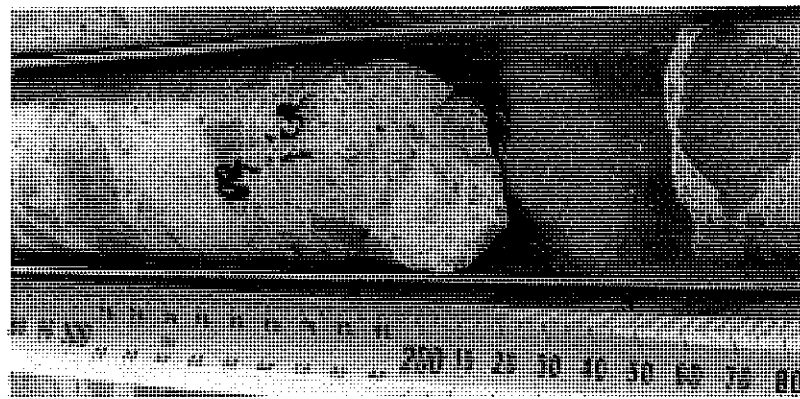
Depth: 12.66m
Machine: Scout

HOLE ID	DEFECT TYPE	DEPTH	CALCITE	WEATHERING	JOINT TIGHTNESS	COMMENTS
CHTA2	Crack	12.66	Slight	None	tight	Slight evidence of calcite on surfaces
CHTA2	Crack	19.1	Slight	Slight	Tight	Slight evidence of calcite and weathering on surfaces

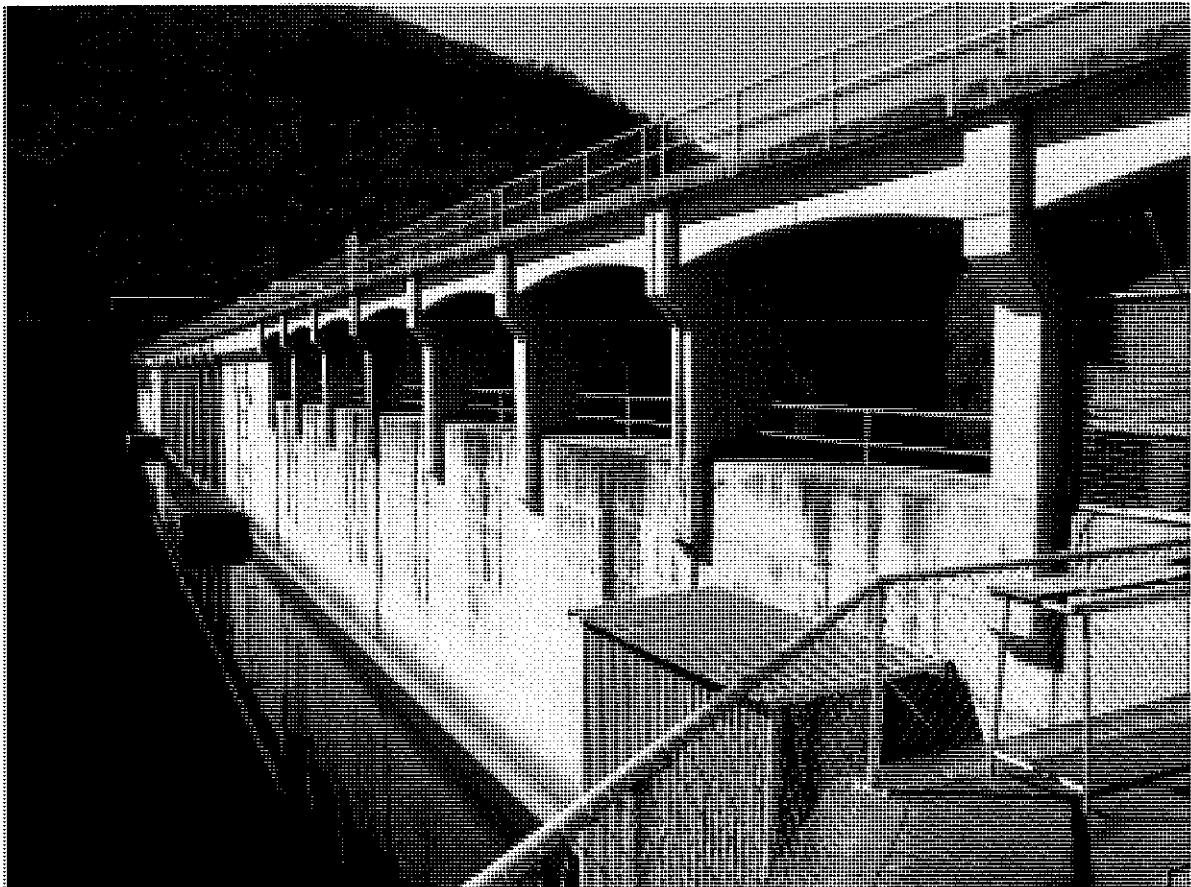
Somerset Dam

The concrete embankment was inspected and was found generally to be in good condition. Some vegetation was observed growing on the embankment and within five metres of the embankment abutments that should be removed. This aspect of the embankment is certainly improved since the 2008 inspection, with several large trees removed from the right bank.

There are a number of galleries within the dam. Concrete cracking has occurred at the Upper Gallery and there is considerable horizontal cracking exposed in the gallery walls. There is no indication that the cracking is worsening over time.

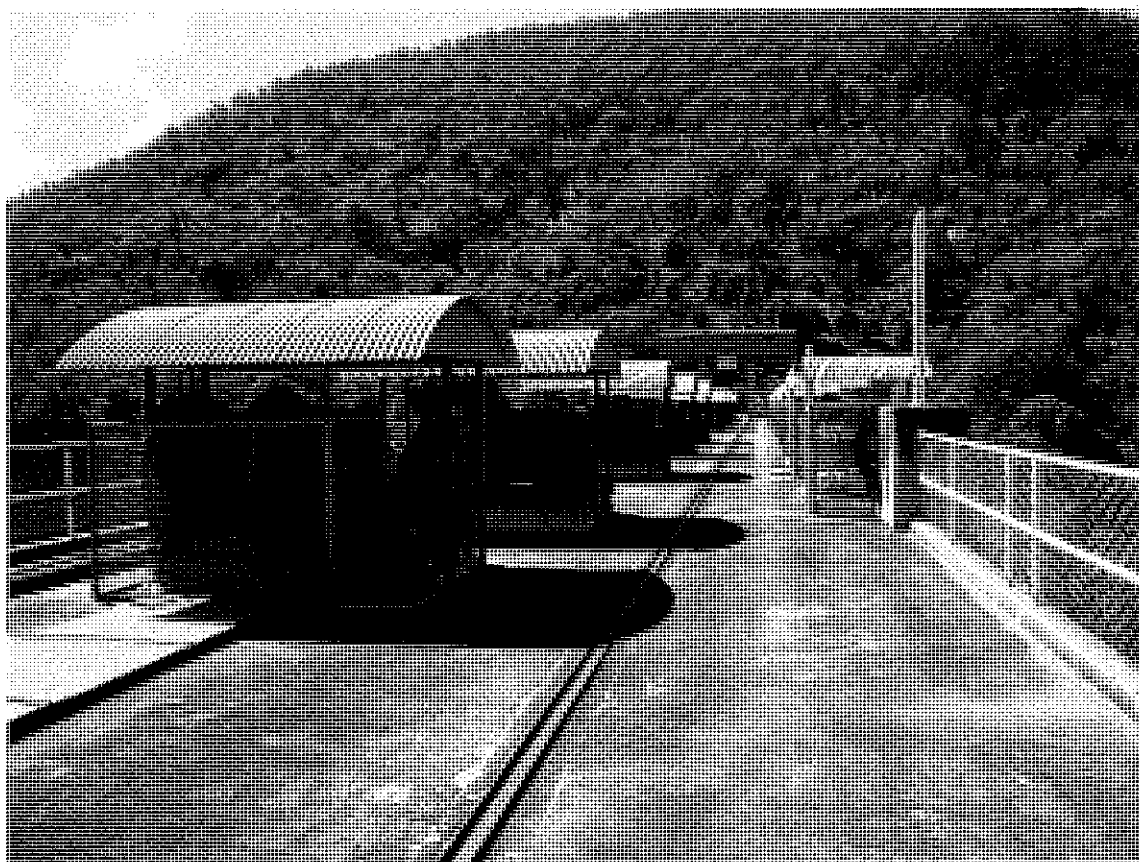
Sluice Gates hoisting gear

The spillway and associated gates, hoisting gear and emergency coaster gate looked to be in good condition, with only some minor issues identified. Undertaking regular routine maintenance in accordance with the dam Operation and Maintenance Manuals appears to be producing good results and it is important that this program is continued. However, it was noted that the electrical condition monitoring program seems to have been discontinued and this is of concern. Replacement of the Radial gate counter weight buffers remains outstanding from the 2008 inspection.

- ***Vegetation growing on the spillway is to be removed and/or sprayed with a suitable herbicide.***
- ***The rotten wooden buffers associated with the radial gate counter weights are to be replaced.***
- ***Recommence the electrical condition monitoring program associated with the radial gates, gantry crane and standby diesel generator.***

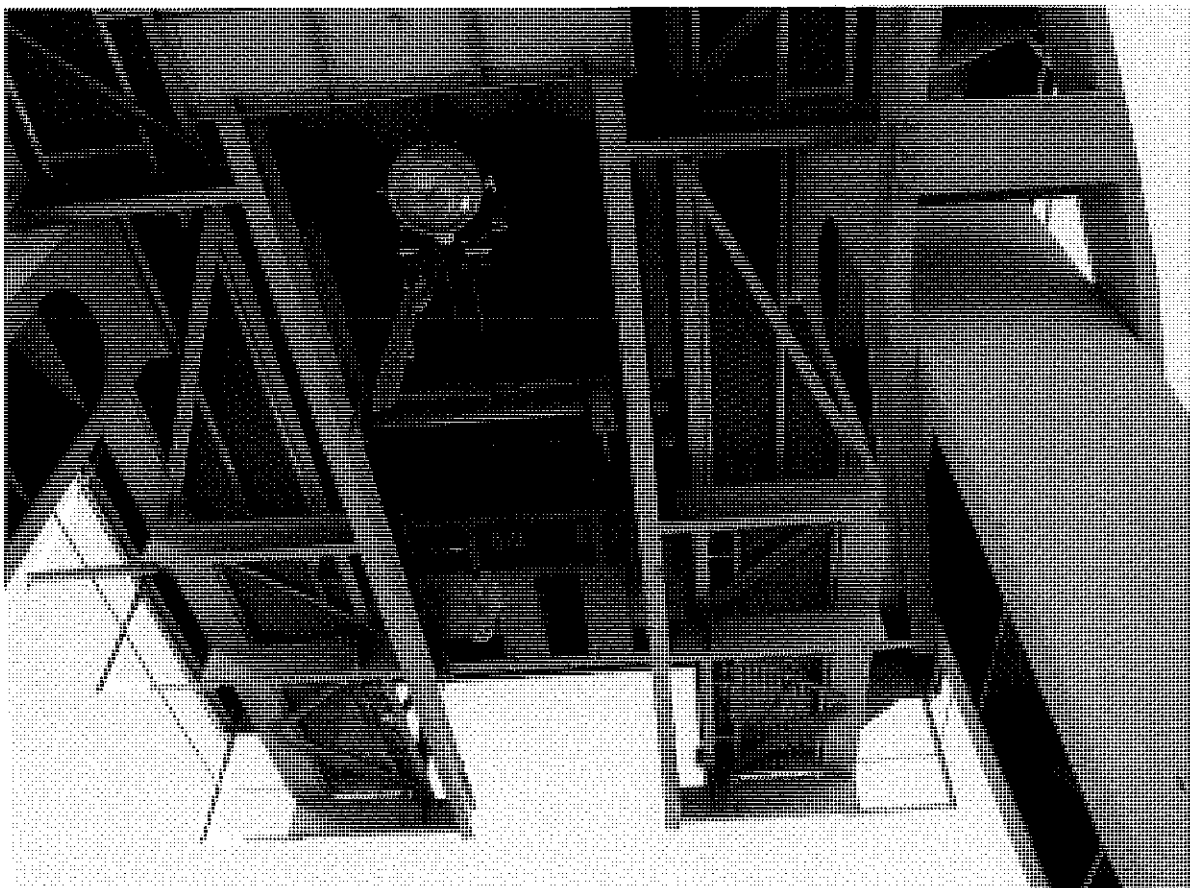
Gantry Crane

A 100 tonne travelling gantry crane on the dam deck serves to handle the emergency coaster gate used for maintenance of the sluice gates. This crane appeared to be in good condition, however it was noted that some recommendations from the 2008 mechanical inspection of the crane remain outstanding.

- ***Recommence the electrical condition monitoring program associated with the sluice gates, radial gates, regulators, gantry crane and standby diesel generator.***
- ***The electric brakes on the sluice gates are to be repaired in accordance with the recommendations made during the last round of condition monitoring.***
- ***An underwater inspection of the coaster gate guides is to be undertaken as soon as possible.***
- ***The works recommendations arising from the August 2008 crane inspection are to be completed as soon as possible.***

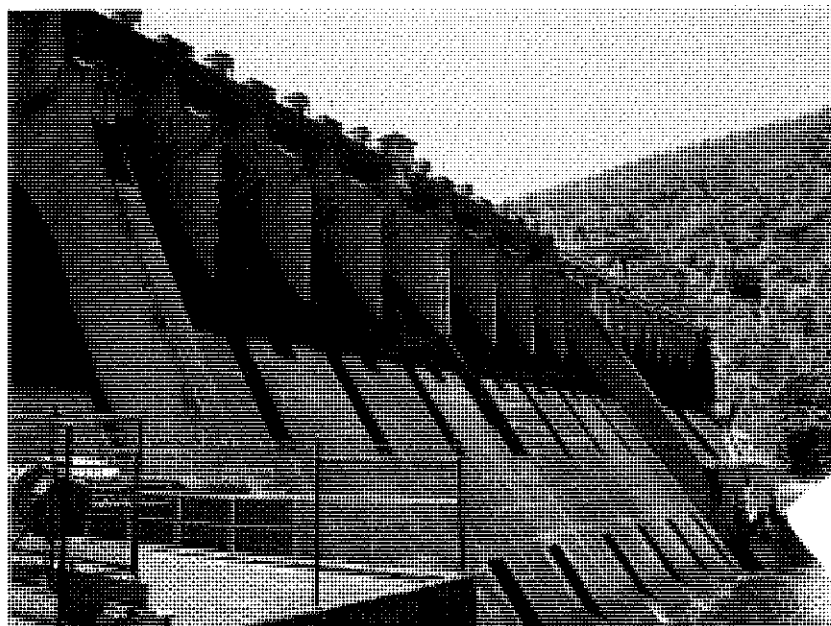
Somerset Dam

The concrete embankment was inspected and was found generally to be in good condition. Some vegetation was observed growing on the embankment that should be removed.

- **Vegetation growing on the embankment is to be removed and/or sprayed with a suitable herbicide.**

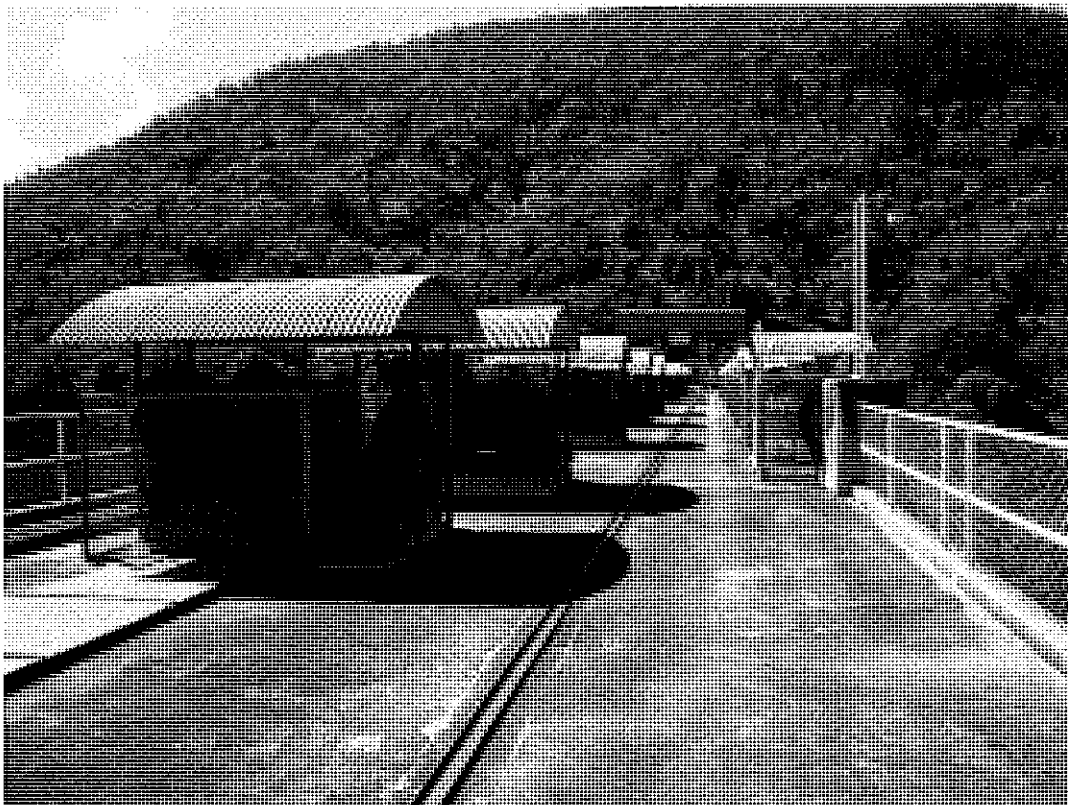
Sluice Gates hoisting gear

The spillway and associated gates and associated hoisting gear looked to be in good condition. All equipment was operated under full flow conditions in the recent flood event in

October and no operational issues with the equipment were identified. Undertaking regular routine maintenance in accordance with the dam Operation and Maintenance Manuals appears to be producing good results and it is important that this program is continued. It was noted that recent structural reports calculate that the dam is over stressed if the radial gates are closed when the dam lake level exceeds 105.7 metres AHD and this issue should be noted in the flood operations procedures.

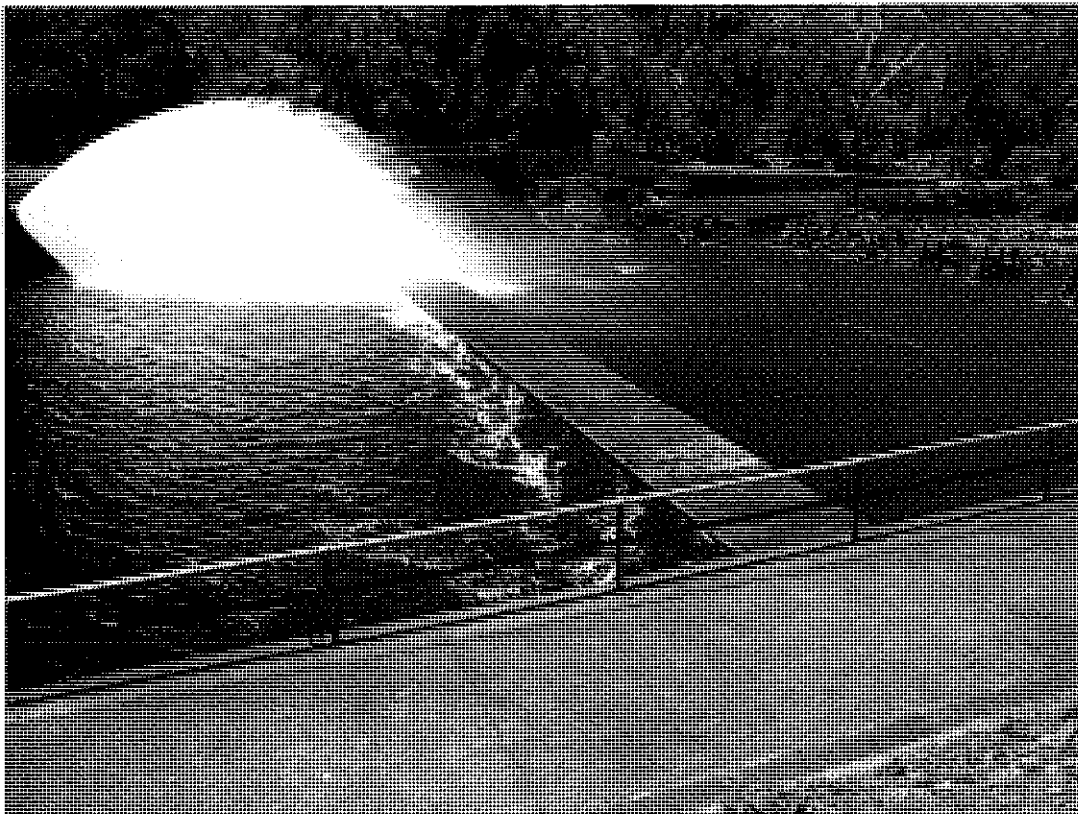
Dissipater

Recent comprehensive inspections have raised concerns with the ability of the dissipater to withstand high outflow conditions and although no damage is apparent, an underwater inspection should be undertaken to confirm that the dissipater is structurally sound.
