IN THE MATTER OF
THE QUEENSLAND FLOODS COMMISSION OF INQUIRY 2011

SECOND SUPPLEMENTARY STATEMENT OF BARTON JEFFERAY MAHER

Brief description of the nature of cracking at Somerset Dam

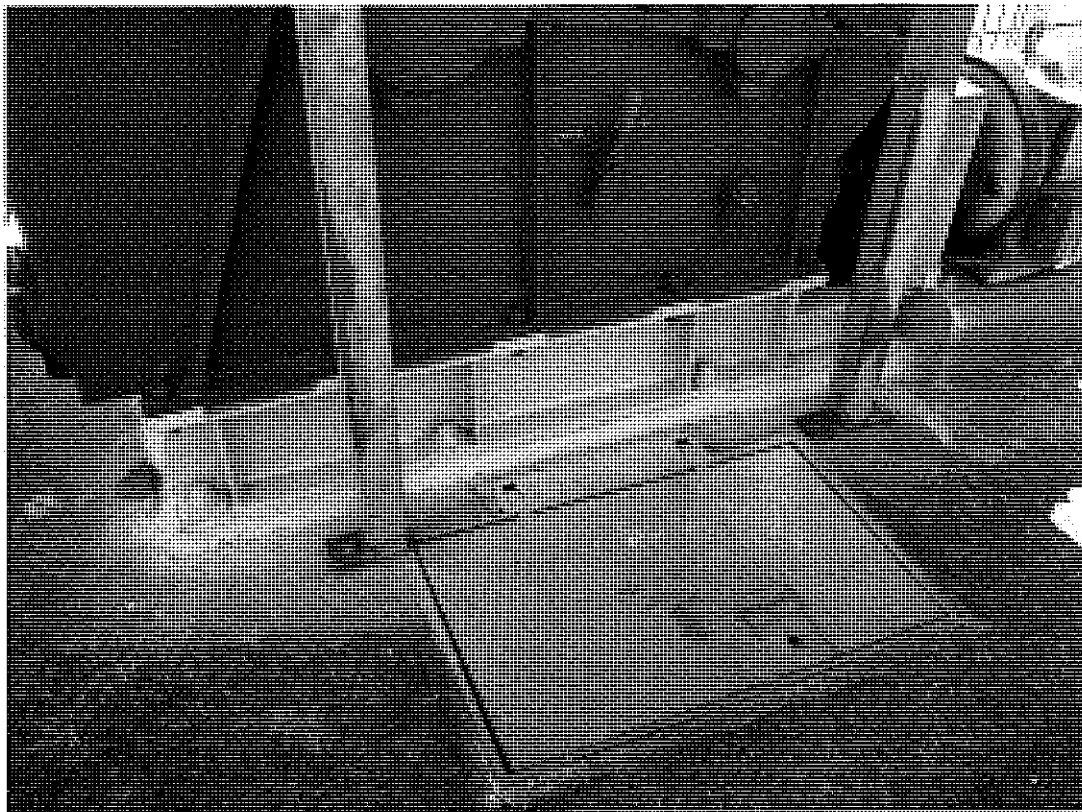
Sluice Hoisting Gear

It is understood that a roller chain from a sluice gate came apart during an operation of a gate in either the 1980s or the early 1990s. No official records relating to the incident can be found, but since that time the circlips holding individual rollers in place on the roller chains on each sluice gate have been welded closed to prevent a another incident of this nature.
