Lenthalls Dam (QLD), Dam Gate Failure to Operate as Designed Increased Flood Risk, gates faulty since 2007 inaction by State Government / Local Government and Wide Bay Water Corporation (WBWC).

LENTHALS DAM GATES FAILURE 2008 – A CASE STUDY IN GATE RELIABILITY AND HUMAN FACTORS, FAILURE TO IMPLEMENT RISK MANAGEMENT PROCEDURE.

PROJECT
ALLAN FARM HOUSE
 ASSESSMENT OF INCREASED FLOOD HAZARDS AND RISKS
 LENTHALLS DAM, DOONGUL CREEK
 CROSS SECTION OF FLOOD HEIGHTS

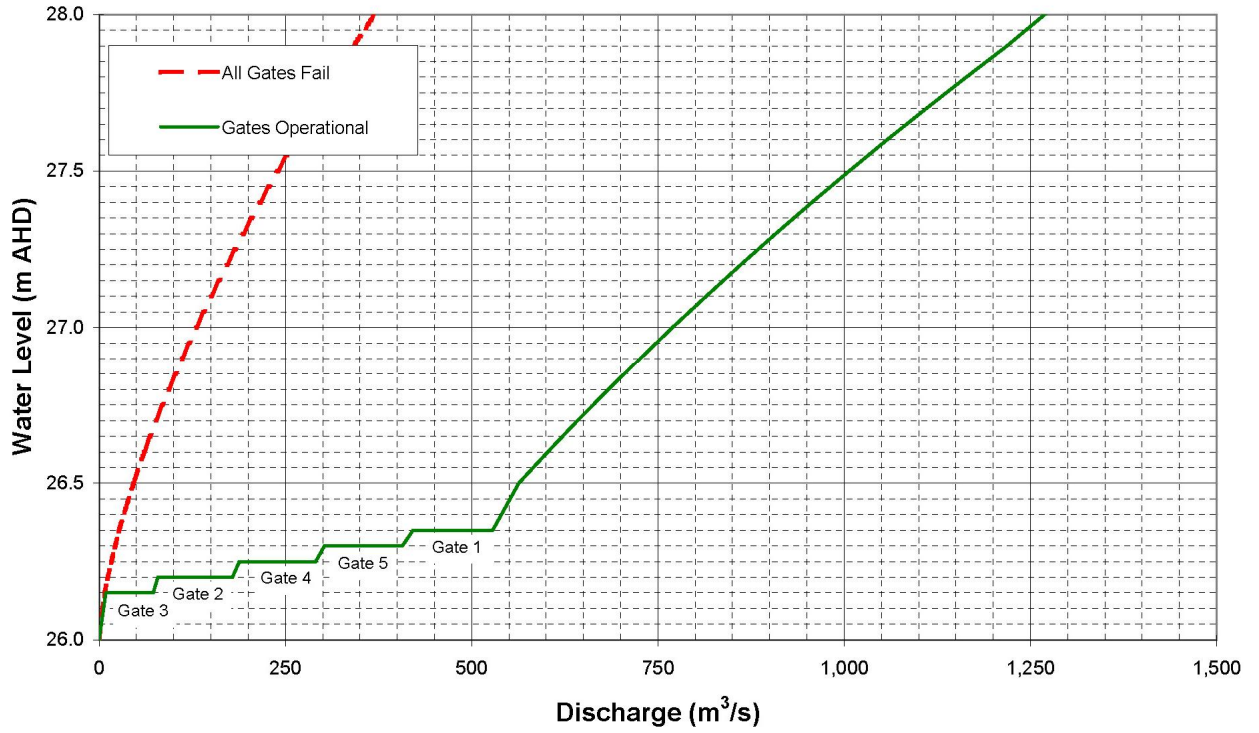
Figure 3-3: Discharge Data for Lenthalls Dam with Crest Gates Fully Operational and Fully Non-Operational

Dam storage characteristics and rating curves for the spillway Crest Gates were obtained from the 2009 report. The discharge curves, for scenarios with all the crest gates opened, and all the crest gates closed, are shown in Figure 3-3.

The event log indicated that the crest gates did not function as designed or intended, and that only four of the five gates were operable. This meant that neither of the design discharge curves presented in Figure 3-3 was applicable during the December 2010 event.

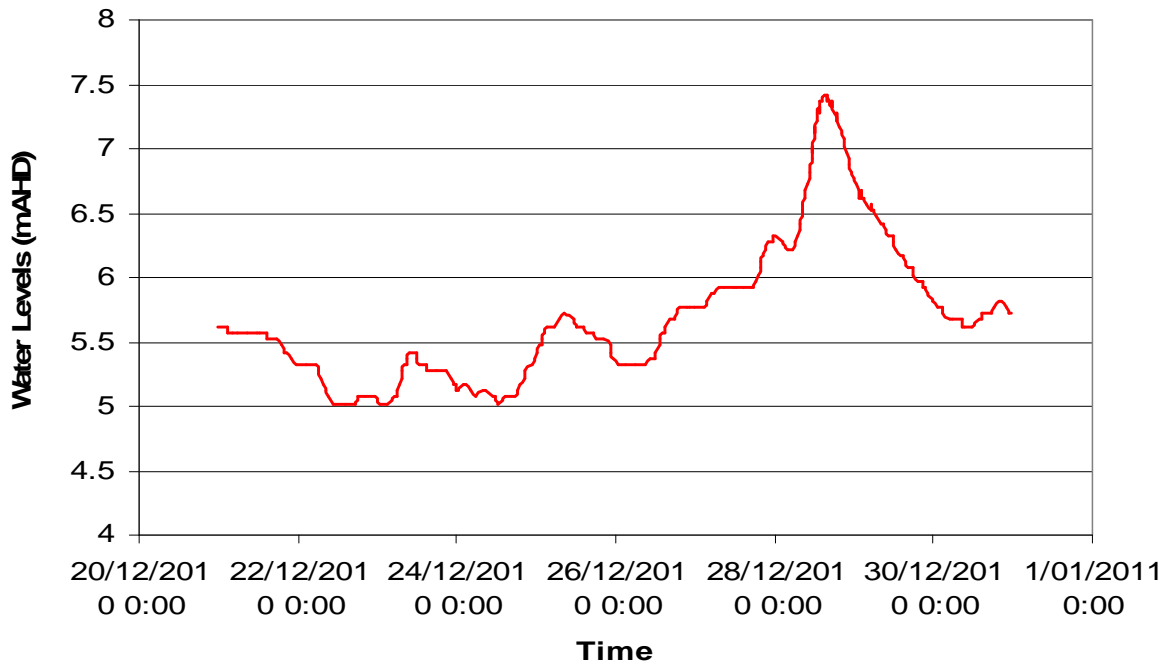
Figure 3-6: Water Level Data Recorded at Howard Alert for December 2010 Event

Based on Figures 3-5 and 3-6, the recorded peak water level at Lenthalls Dam was 28.183 m AHD (6 pm, 28 December), while that at Howard Alert was 7.42 m AHD (2 pm, 28 December).

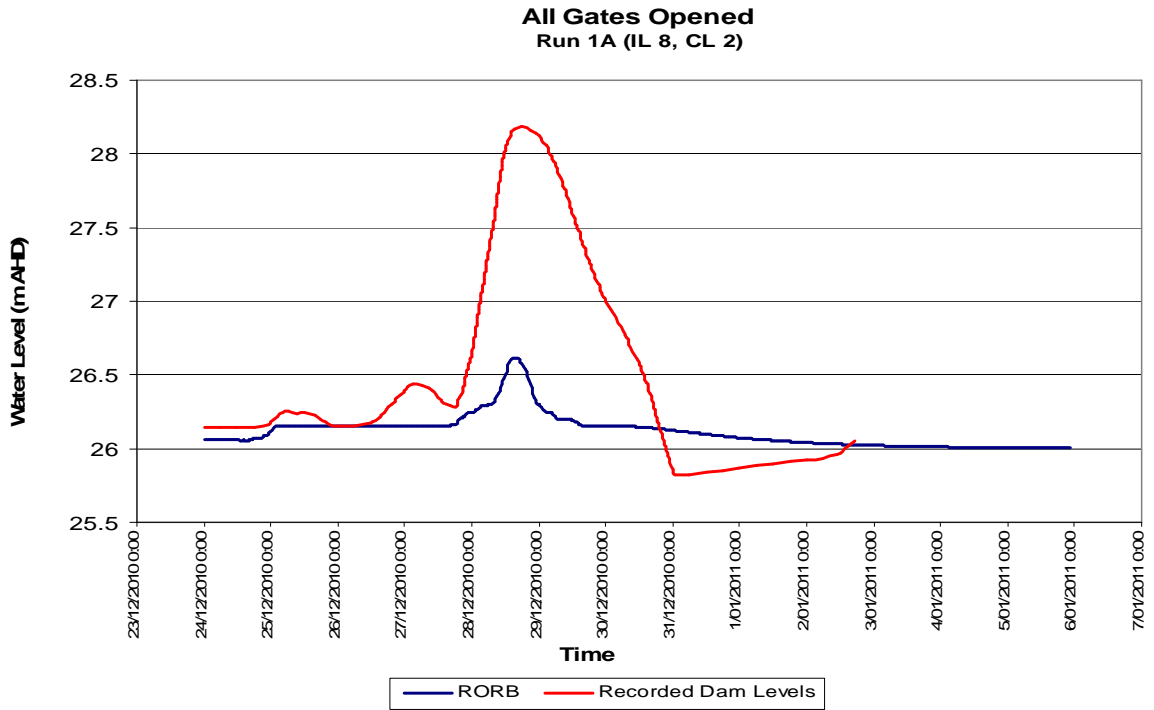
Figure 4-1: Scenario 1A (All Gates Opened) Dam Outflow Hydrographs

In Table 4-1, the results for Scenario 1 indicate that the peak water level at the dam could not possibly have reached the recorded peak of 28.18 m AHD, with all the 5 gates opened and operational. This was the case for the full range of model parameters tested. Example plots, for RUN 1A, RUN 1I and RUN 1J, are shown in Figure 4-1, Figure 4-2 and Figure 4-3,

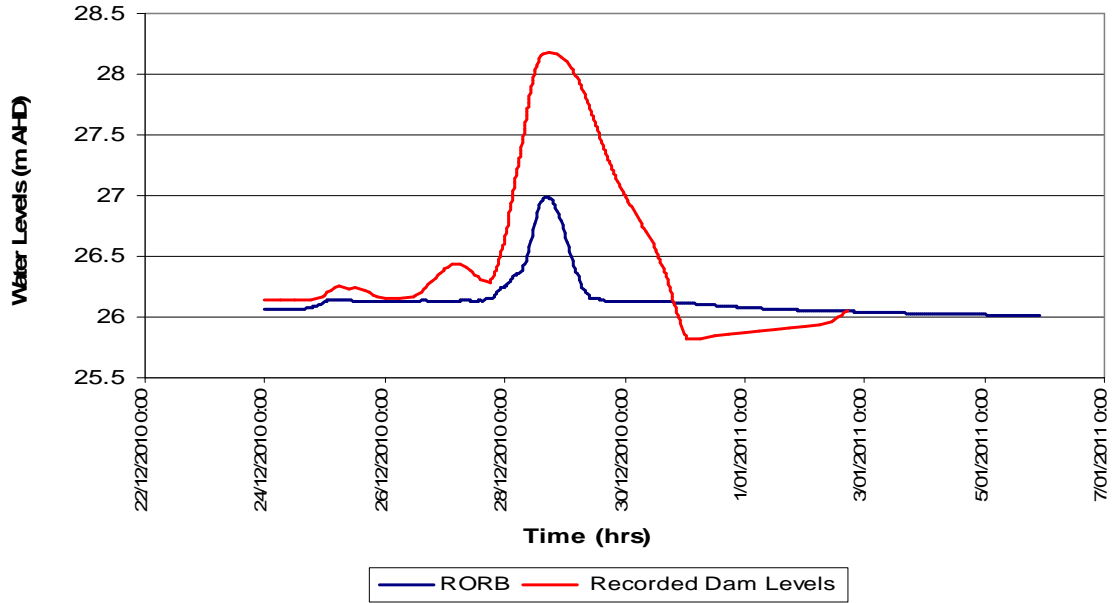
Figure 4-5: Scenario 3A (Event Log) Dam Outflow Hydrographs

The results, presented in Table 4-1, are rather surprising. Essentially, they showed that the recorded peak water level in the dam of 28.18 m AHD could not possibly be reached using the Event Log. This was the case for the full range of model parameters tested, including the use of impractical parameters. Example plots for RUN 3A and RUN 3E are shown in Figure 4-5 and Figure 4-6. In these two runs, the peak RORB model levels are between 0.6 to 1.2m lower than the recorded peak dam level.

This raises the possibility that all the gates had somehow failed to open during the peak of the storm, which would be consistent with the results for Scenario 2.
