# Queensland Floods Commission of Inquiry

**STATEMENT OF PETER HUGH ALLEN**

## WIVENHOE DAM

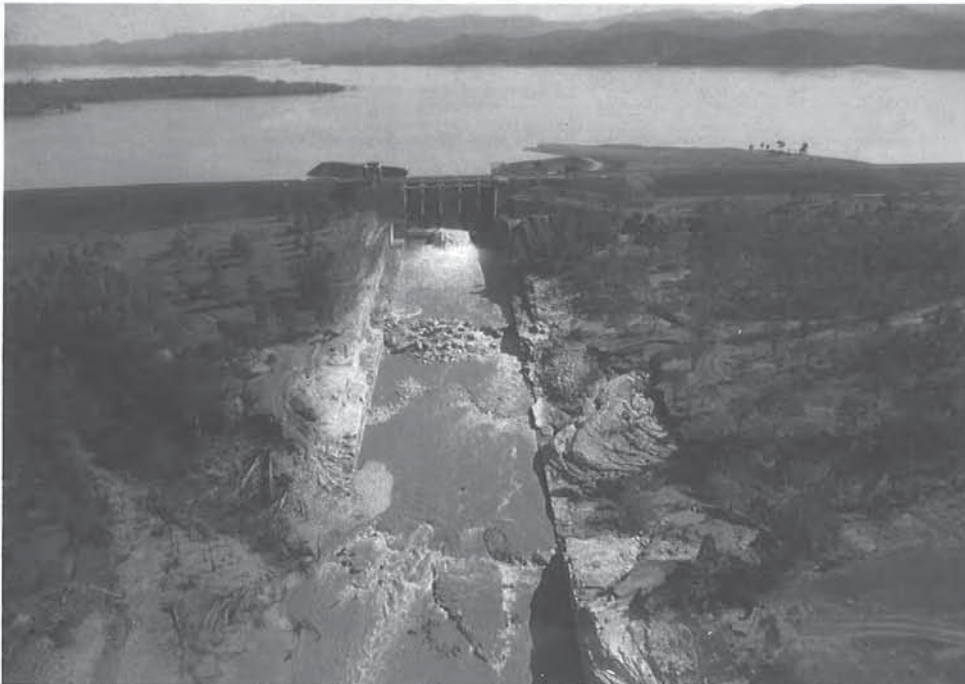
**Photo 2- Wivenhoe Outlet Channel and Spillway Post January 2011 Flood**

It can be seen from cross section A-A in Figure 4 (left to right represents upstream to downstream) that the majority of material removed from the base of the plunge pool was located at the downstream side of the excavation. The plunge pool depth was decreased to a depth of EL14m and up to 10m of rock was removed from areas of the spillway structure. However, it should be noted that there was minimal head cutting of the upstream side of the plunge pool.

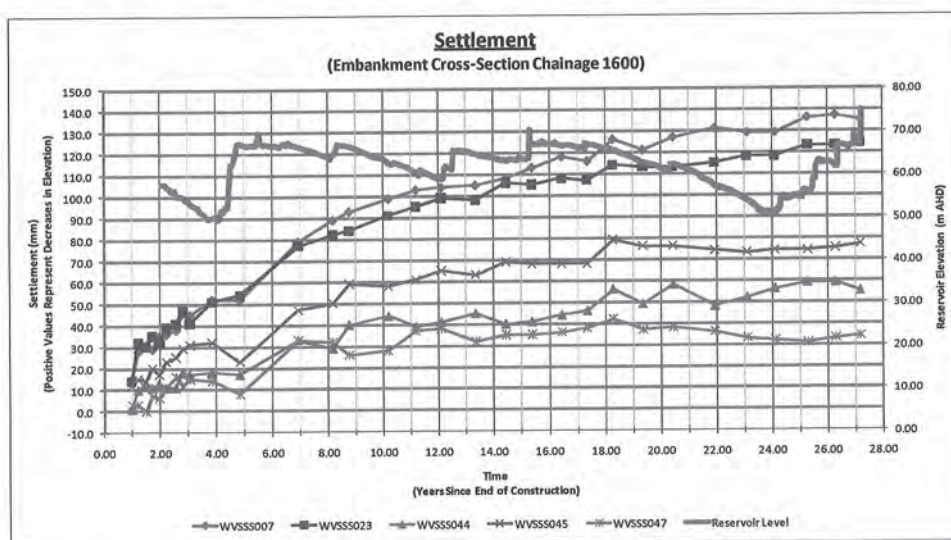
Figure 8 - Settlement of monuments analysed for chainages 1,600

Figure 8 and Figure 9 present the post construction deformation settlement versus time for both of the previously stated chainages. The maximum values of settlement at the two maximum sections are 138 mm, with an average settlement of 53.6 mm at ch. 1,600 and 43.8 mm at ch. 1,800. To note, the maximum settlement at each of the locations occurred on the upstream edge of the dam crest.

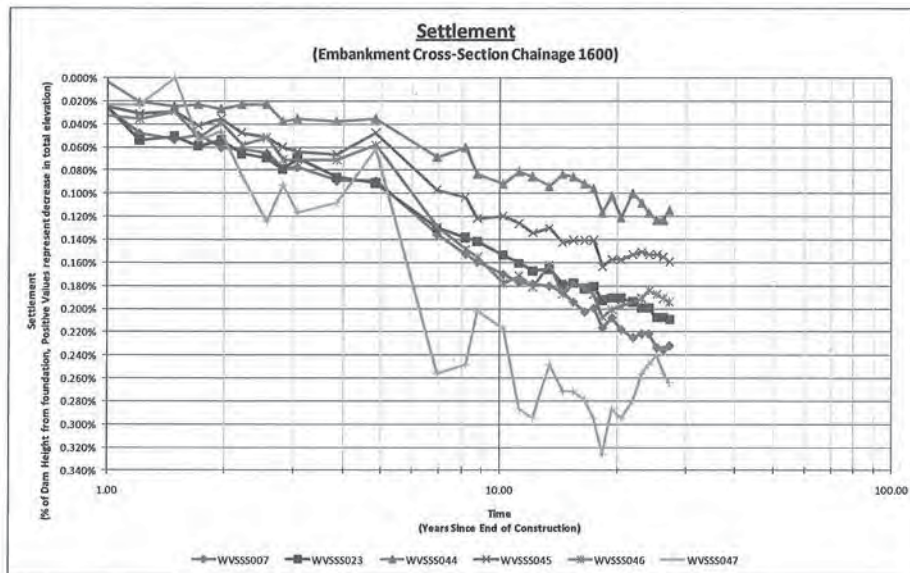
Figure 10 - Settlement of Monuments Analysed for Chainages 1,600

Figure 10 and Figure 11 present the same monument settlement but is displayed as a % of the dam height. This provides an additional tool to analyse the data trending of deformation. This settlement is in line with similar embankment sizes and designs. A point of concern to be noted regarding the settlement monuments WVSS036, WVSS037 at chainage 1,800 and WVSS047 at chainage 1,600. The monuments are located on the downstream slope of the embankment near the dam toe. Within

the last 15 years, these monuments are showing a trending of increasing in elevation. The maximum value of increased elevations of the previous mentioned monuments is 15 mm.

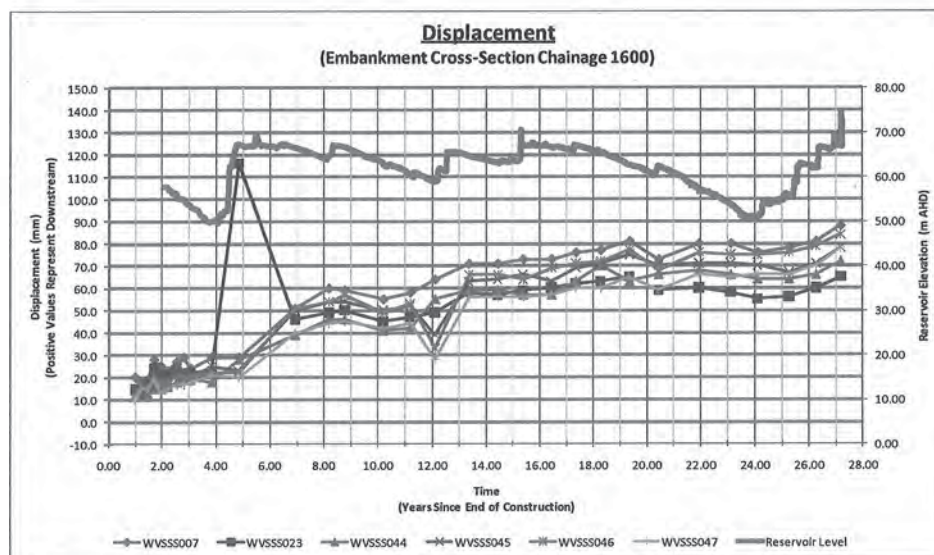
Figure 12 - Displacement of Monuments Analysed for Chainages 1,600

Figure 12 and Figure 13 present the post construction deformation displacement, normal to the dam, versus time for chainages 1,600 and 1,800. The maximum value of displacement, at the two maximum sections is 116 mm, with an average settlement of 25.3 mm at ch. 1,600 and 27.7 mm at ch. 1,800. Similar to the dam settlement, the maximum displacement at each of the chainages occurred at the monuments located on the upstream edge of the dam crest.
