**Toowoomba Regional
Council**

**Report for Cooby Dam
Special Dam Safety Inspection
following January 2011 Flood**

Rev 1 – February 2011

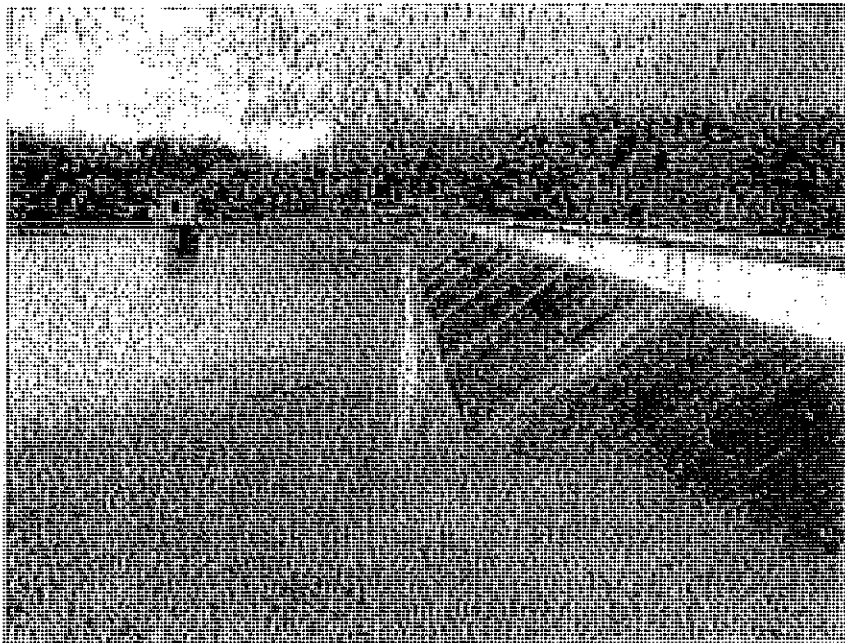
Photo 2 Upstream face of dam from right abutment (Note straight waterline)

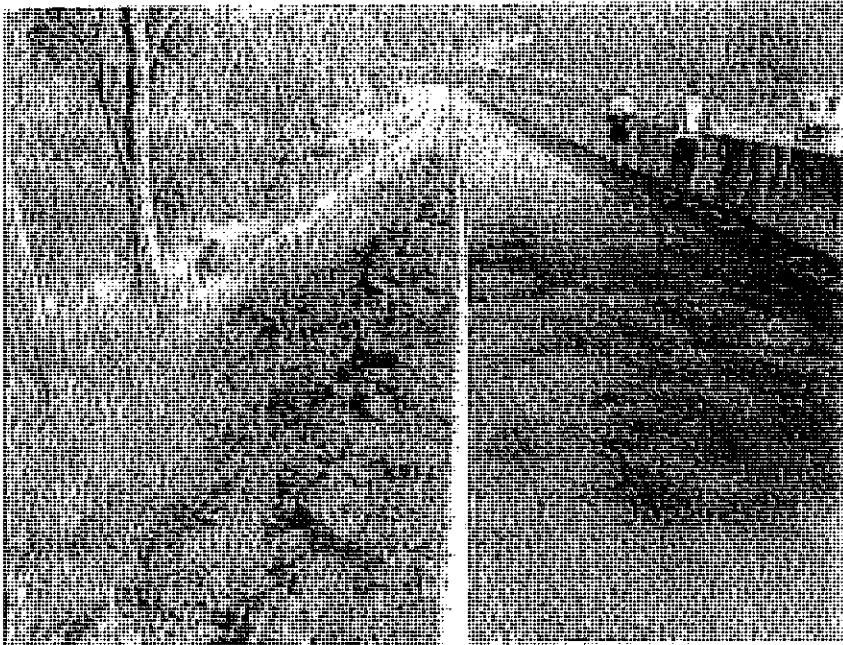
Pavement general condition	Bitumen seal generally in good condition
Cracks	No change noted in previously-noted cracks in bitumen (Photo 7).
Sinkholes	None evident
Alignment	Wave wall on the upstream side (Photo 5) and the fence on downstream side (Photo 6 and Photo 8) of the crest are generally straight. No change evident.
Erosion	None significant
Vegetation	None evident
Depressions	None evident
Settlement	None evident

Photo 6 Looking along fence on downstream side of dam crest from left abutment

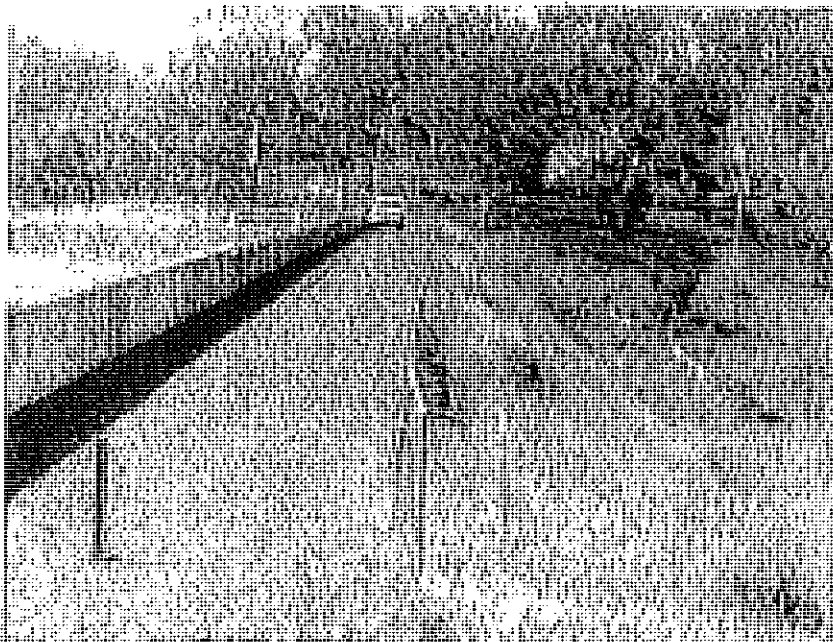
Photo 8 Looking along fence on downstream side of dam crest from right abutment

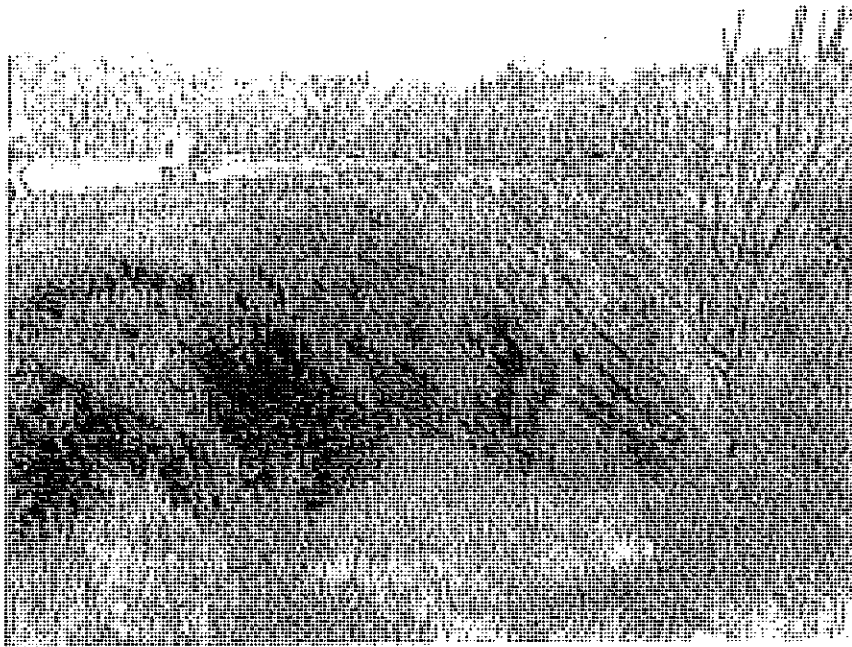
Cracks	None evident – downstream face is rockfill
Sinkholes	None evident
Slides	Minor ravelling noted on downstream face, but no change evident
Bulging	Occasional undulations at toe due to minor slides (Photo 12 and Photo 13)
Wet spots	None evident
Boils	None evident
Depressions	None evident
Deterioration of the slope protection	None evident
Erosion	None evident
Vegetation	Grass cover and small shrubs (Photo 9).
Animal burrows	None evident

Photo 9 Overview of downstream face from right abutment

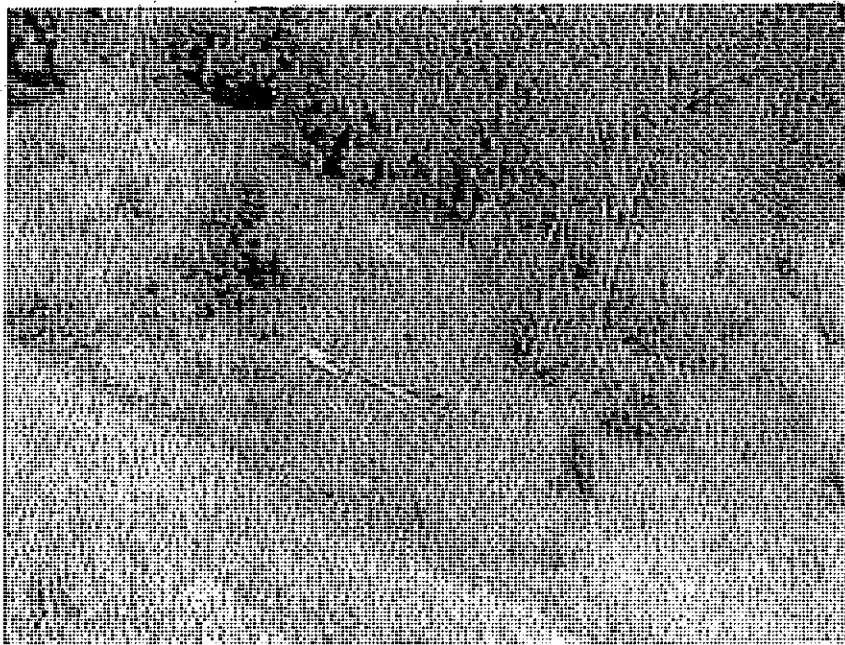
Cracks	None evident
Wet spots	None evident
Vegetation	Grass small shrubs and trees (Photo 14 and Photo 15)
Slides	None evident
Erosion	None evident

Photo 14 Downstream left abutment viewed from dam crest

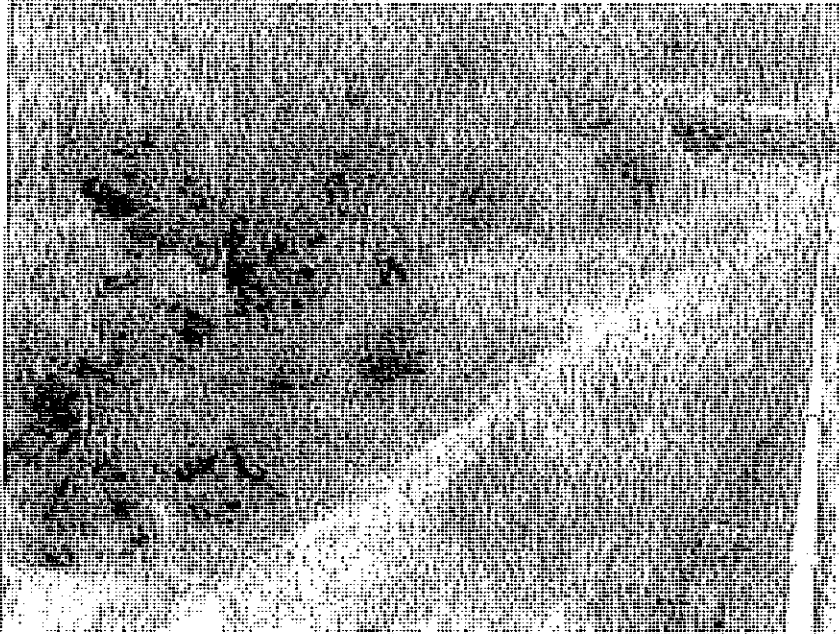
Photo 15 Downstream right abutment viewed from dam crest

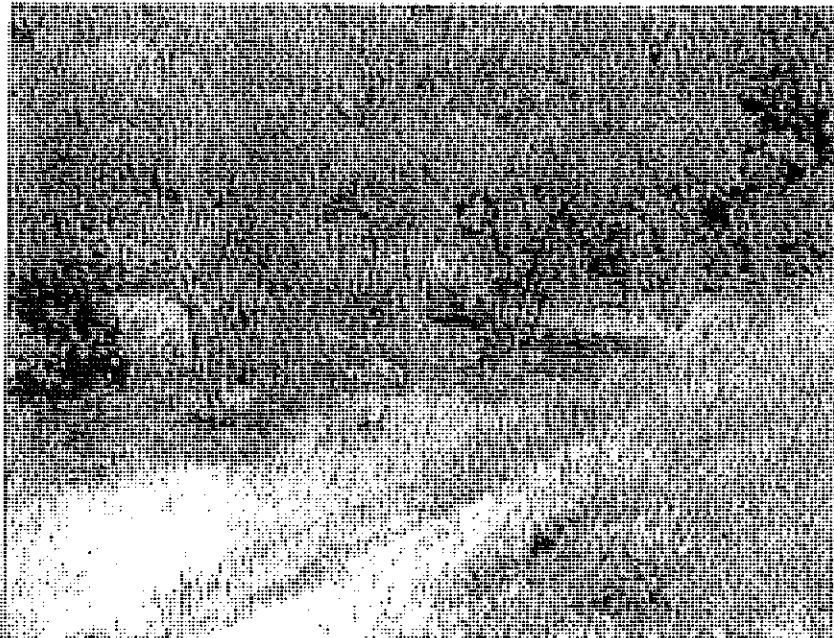
- ▶ A concrete drainage pit was noted in the middle of a garden bed approximately 10 m from the downstream toe of the dam (Photo 17). It is likely that this forms part of the foundation drainage network under the toe berm and is connected to the concrete pit at the toe of the toe berm (below the toilet block).

Photo 17 Drainage pit in toe berm (likely to be part of foundation drainage system)

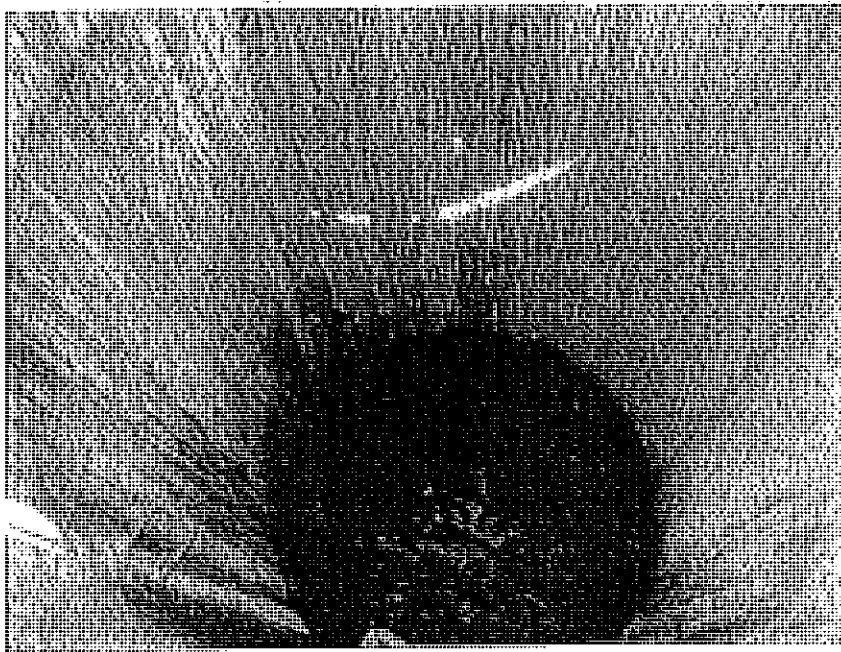
- ▶ Downstream toe area was inundated by the backwater from the spillway at the time of the inspection (Photo 19).
- ▶ Damage to the road on the left bank of the river channel evident from pieces of bitumen amongst debris.

Photo 19 Downstream toe area viewed from toe berm

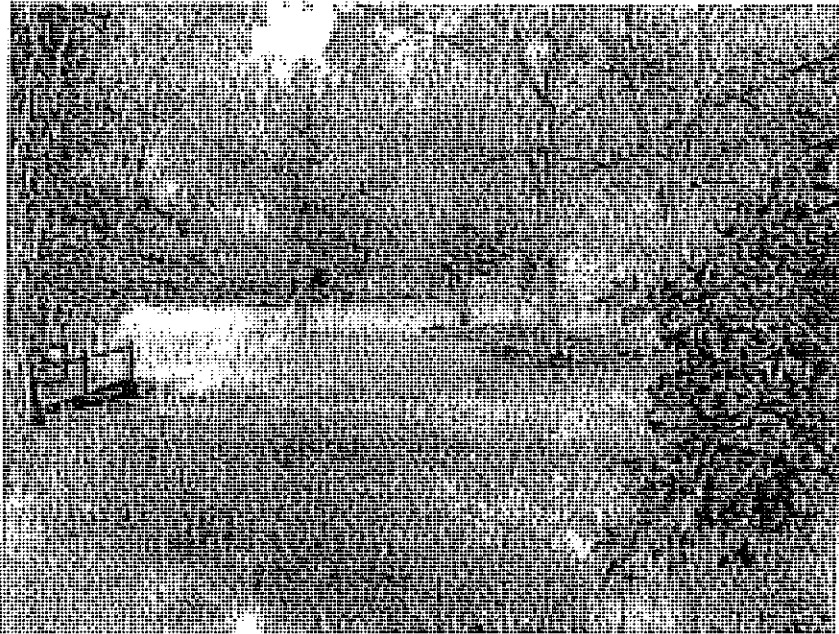
General condition Not inspected, but no blockage evident (Photo 24 and Photo 25).

Photo 24 Spillway crest and approach channel viewed from left bank – Photo 1 of 2

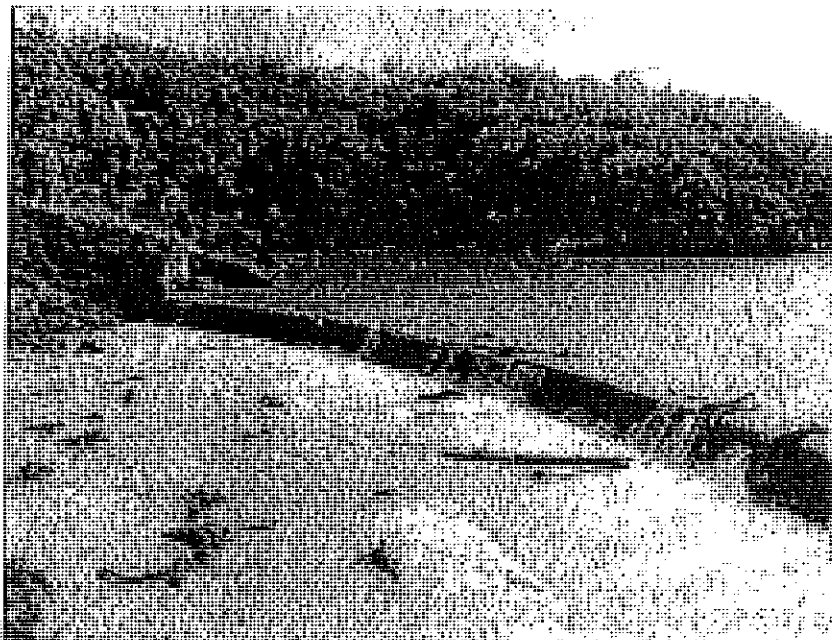
Photo 25 Spillway crest and approach channel viewed from left bank – Photo 2 of 2

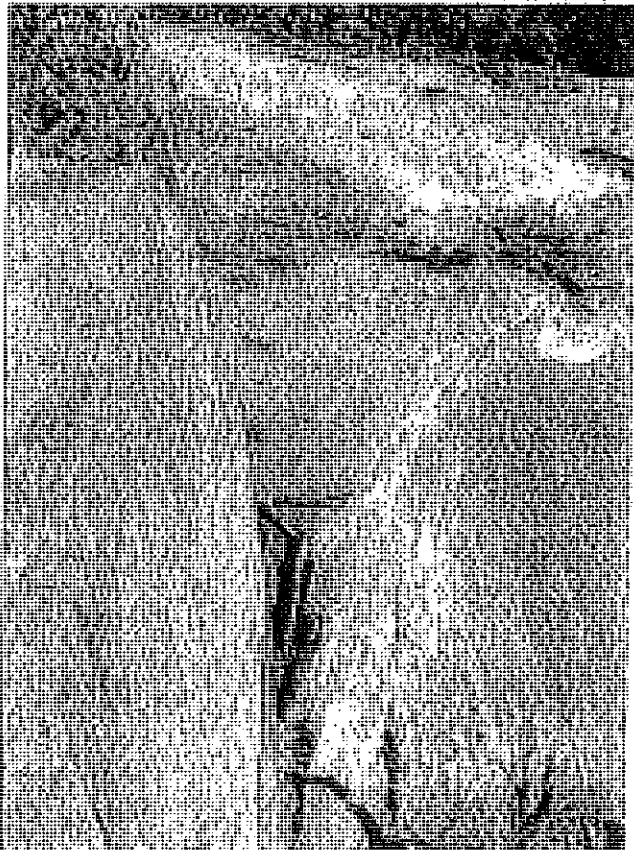
General condition	Not inspected in detail, but no significant damage observed.
Erosion	Erosion evident particularly in lower right side of chute (Photo 34).
Debris	Collection of debris from flood evident in spillway chute (Photo 29)
Loose rocks	
Vegetation

Photo 29 Flow in upper section of spillway chute viewed from left bank

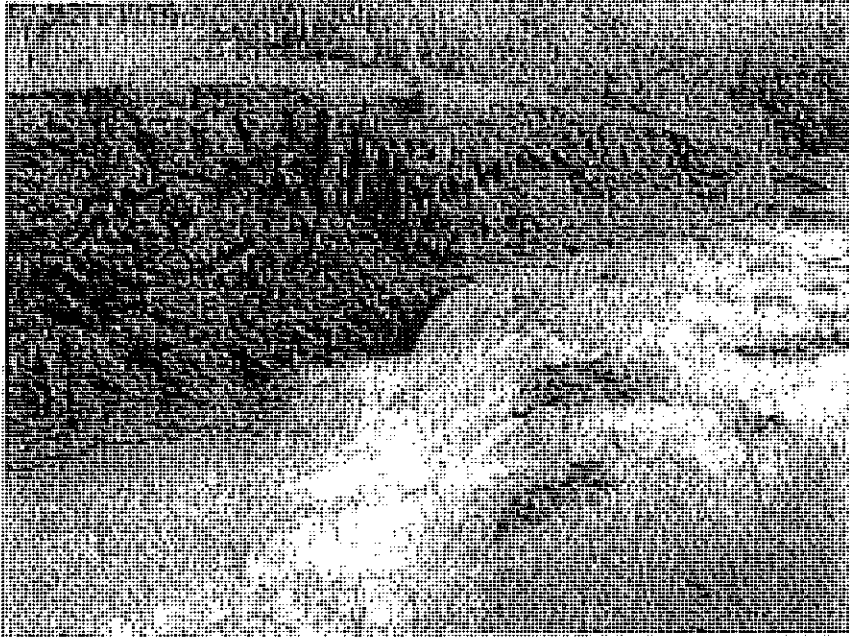
Photo 34 Flow in lower section of spillway chute looking downstream viewed from left bank
