Hydrological Advice to Commission of Inquiry Regarding 2010/11 Queensland Floods

TOOWOOMBA AND LOCKYER VALLEY FLASH FLOOD EVENTS OF 10 AND 11 JANUARY 2011

- Report to Queensland Floods Commission of Inquiry
- Revision 1
- 12 April 2011

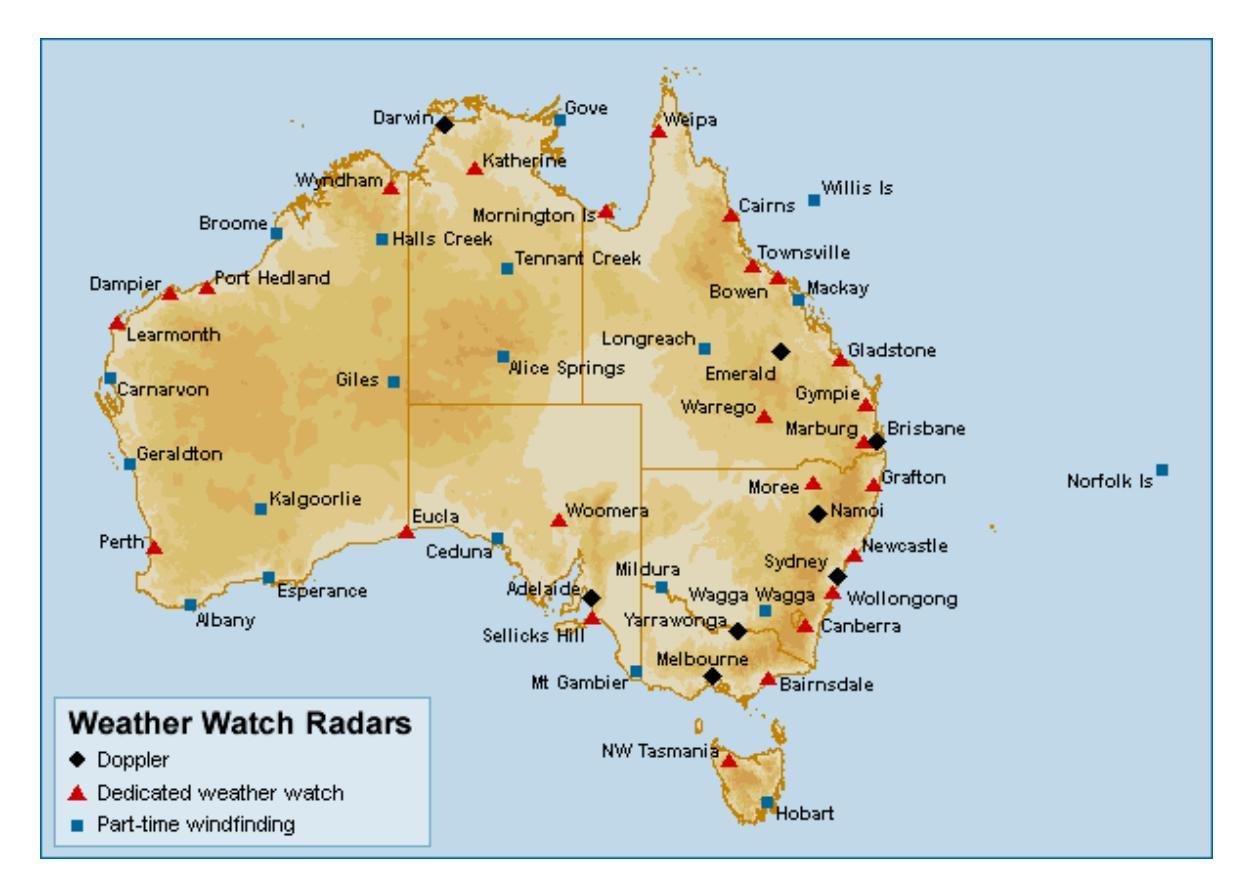
The Bureau of Meteorology currently operates a network of 53 weather watch radars across Australia, with locations shown in Figure 1. Fourteen of those radar are located in Queensland. The weather watch radar at Marburg and Mount Stapylton (shown in Figure 1 as Brisbane) provided coverage of rainfall occurring across South East Queensland during the January 2011 event. Both radars provided continuous coverage for the entire rainfall event.

Figure 1 Location of weather watch radars in Australia (Australian Government Bureau of Meteorology, 2011a)

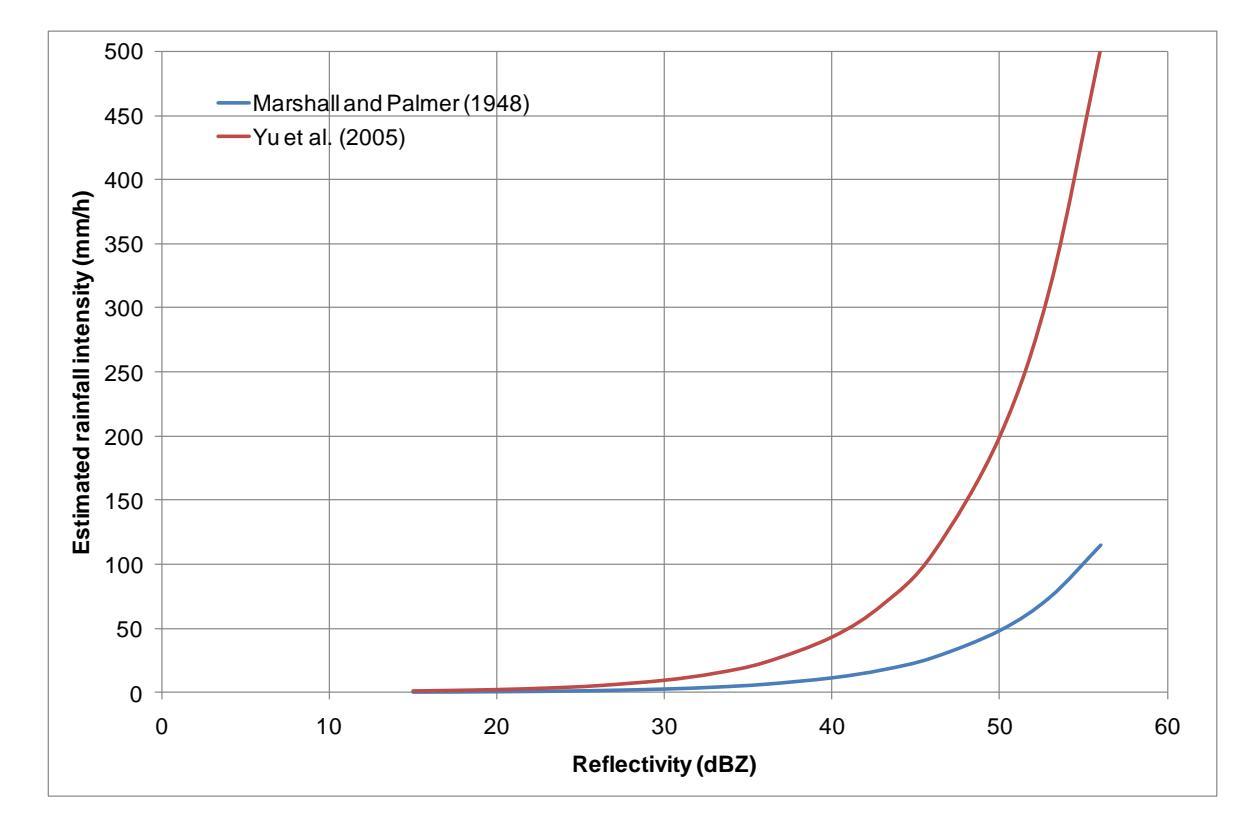
Figure 2 shows that the rainfall rates estimated using the equation of Yu et al. (2005) lie between a multiple of three and four times the rainfall rates that would be estimated using Marshall and Palmer (1948). Because both events contained thunderstorm cells located in South East Queensland, the conversion of reflectivity to rainfall intensity for the January 2011 event is likely to be more closely represented by the equation of Yu et al. (2005) than by Marshall and Palmer (1948). Rainfall intensity estimates from weather radar imagery for this report have been inferred using the equation of Yu et al. (2005). This also demonstrates the importance of calibrating weather radar to rain accumulations from gauges for the purposes of quantitative rainfall estimation.

Figure 2 Comparison between the equations of Marshall and Palmer (1948) and Yu et al. (2005) for estimation of rainfall intensities from radar reflectivity.

$$Z = 35.3 R^{1.5}$$
 Equation 3

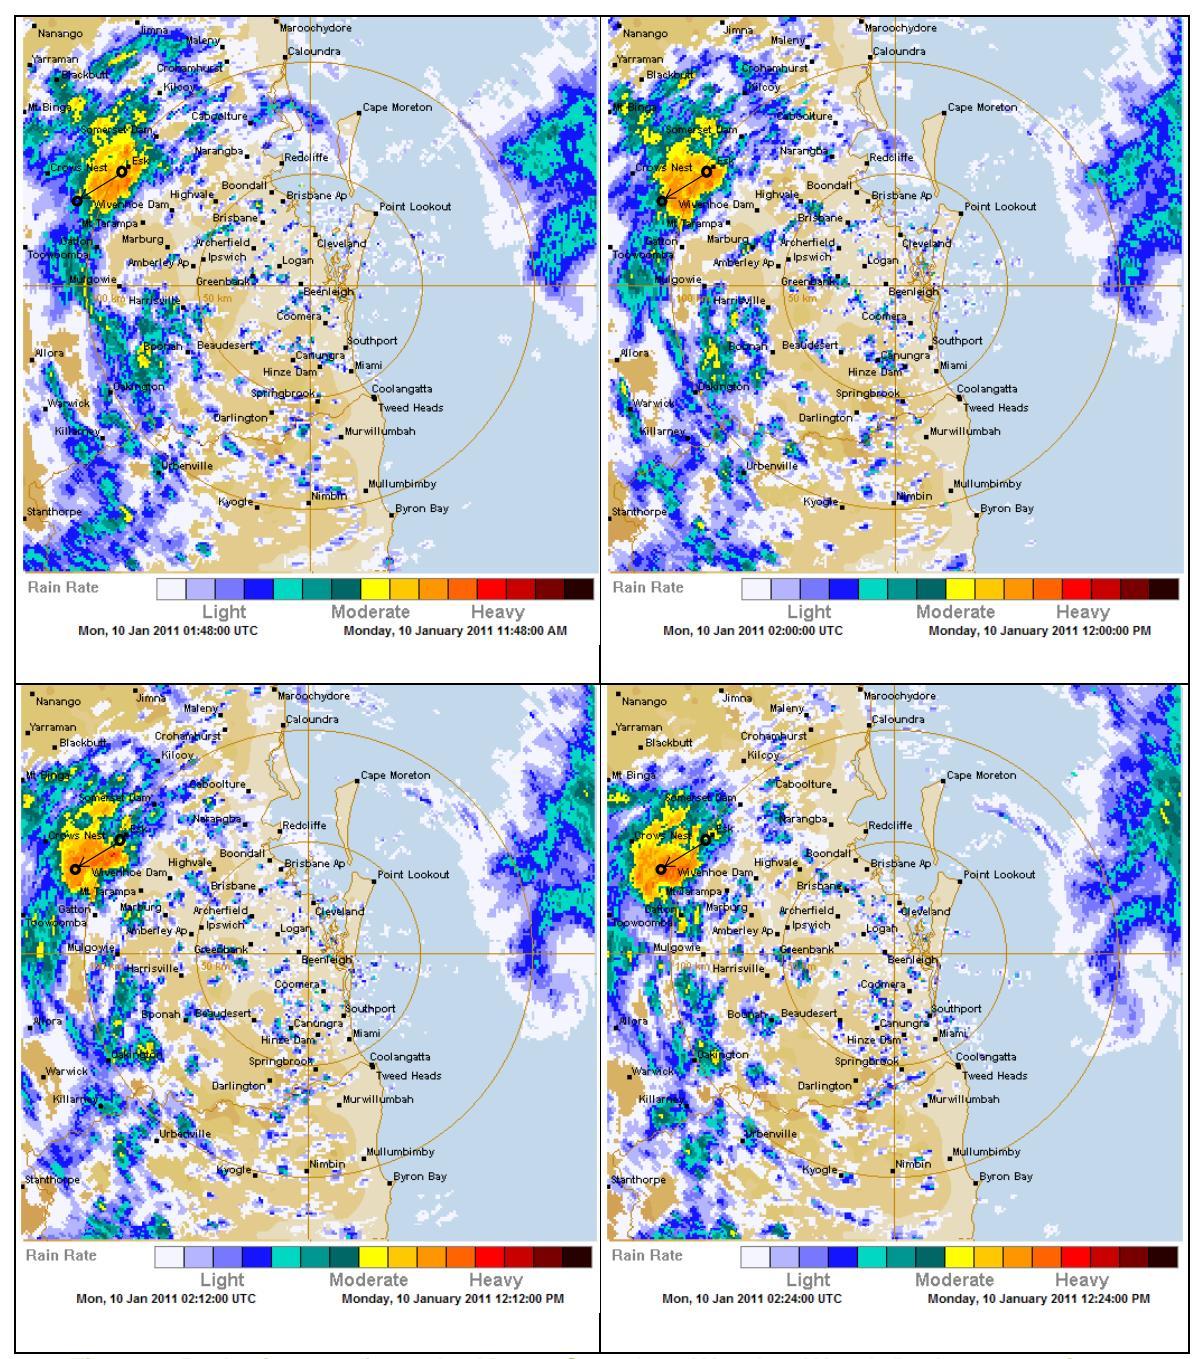
Figure 3 shows that the area of high intensity rainfall was located over the Upper Brisbane River valley on the 11:48 am radar scan and was moving in a south-westerly direction toward the Toowoomba Range. Ground elevations along the projected path of the high intensity rainfall increase from around 160 m AHD at Esk to about 620 m AHD at the top of the Toowoomba Range due to orographic enhancement of the rainfall, with high humidity air forced upward by the rising terrain and driving more rainfall out of the humid air mass.

Figure 3 Radar images from the Mount Stapylton Weather Watch Radar at 12 minute intervals between 11:48 am and 12:24 pm on 10 January 2011. The track of the approximate centre of the highest intensity core of the thunderstorm during this period is shown on each image by black circles and the arrow.

The area of high intensity rainfall was located over the Upper Brisbane River valley on the 11:48 am radar scan and was moving in a south-westerly direction toward the Toowoomba Range. Ground elevations increase from around 160 m AHD at Esk to about 620 m AHD at the top of the Toowoomba Range. The increase in ground elevation could reasonably be expected to cause orographic enhancement of the storm as it approached the Toowoomba Range. The combined effects of strong low level inflows to the storm from the southeast, indicating strong updrafts, and the reasonable expectation of orographic enhancement of the storm as it approached the Toowoomba Range should have indicated by the time that the 11:48/11:49 am radar scan³ was available that rainfall intensities would increase from those observed on this radar scan.
