Jocelyn Bailey Flood Commission Inquiry Submission

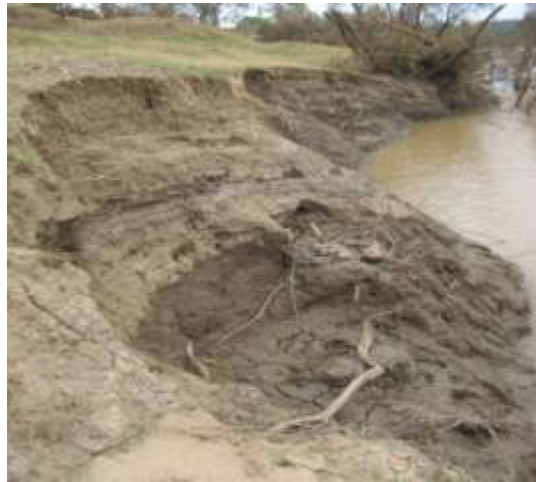
Photo 001 – Oct 11 Riverbank Slump

The mid October 2010 flood caused by the 700,000 megalitres water release caused significant riverbank slumping on this property (**refer photo 001**) & other properties along the mid Brisbane River. The Mid Brisbane River Irrigators (of which I am a member) had meetings with Seqwater in late 2010 in relation to their water release pattern causing riverbank slumping. However Seqwater said they were unable to alter this pattern as it is set by the Manual.

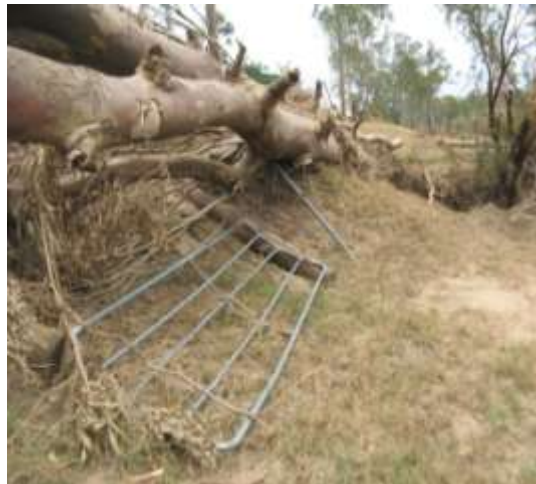
Photo 002 – Jan 11 Fence & Tree Destruction

The resultant high velocity of water caused the immense damage downstream. Damage caused by the 1974 flood was minimal compared to this. Old man bluegums which had withstood the 1974 flood were torn out & many were carried away by the sheer force of the water. Fences which withstood floods since 1974 were torn away or disappeared entirely (**refer photo 002**).

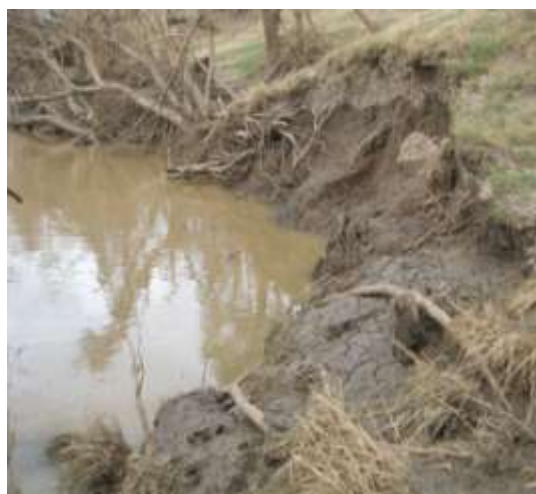
Photo 003 – Jan 11 Riverbank Slump

In keeping with the Dam operators previous practice, the drain down phase of the 2011 flood was far too rapid. A natural flood of this magnitude would take weeks to recede gradually. Riverbank slumping occurred on a major scale along the entire 60kms of the mid Brisbane River.

To date more than 60% of the riverbank on my property has slumped (**refer photos 003 & 004**). The slumps have carried large trees and the pump site (**refer photos 005 & 006**) into the middle of the river. Therefore it is not possible to pump water for irrigation or stockwater until the site is repaired in winter when conditions are drier thus safer. Cost of riverbank repairs to date is \$10,000. With further water releases of the same rapid pattern more damage will occur.
